STORMWATER REPORT

CRESTWOOD STORMWATER

MASTER PLAN

CRESTWOOD, MISSOURI 63126

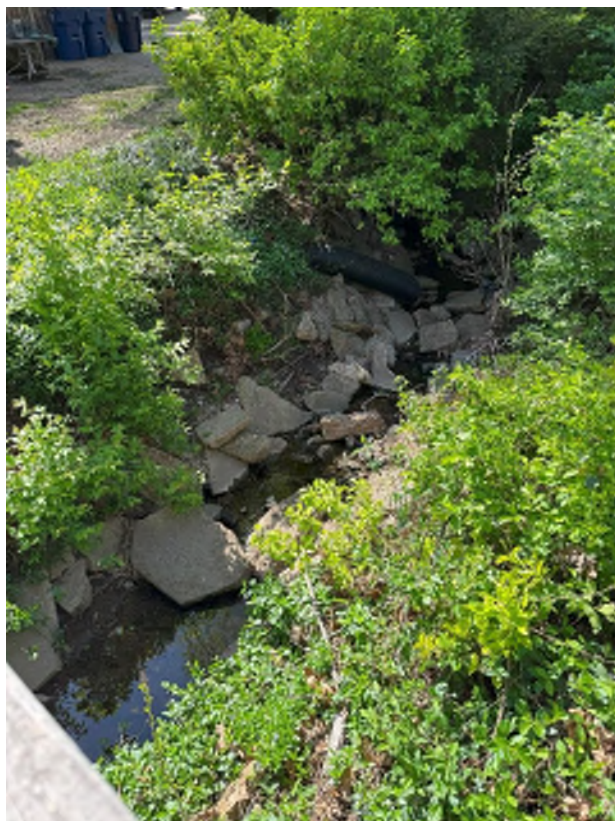
Figure 6.a.iii-2 9107 Grant Park Drive

The resident at 9107 Grant Park Drive has reported recurring flooding in the rear yard area where the existing open drainage channel transitions into an enclosed stormwater conveyance system. The source of the flooding has been identified as insufficient hydraulic capacity at the junction where the open channel enters the 54-inch Reinforced Concrete Pipe (RCP), identified as structure 25K4-052D. This location lacks the necessary headwater depth and is not equipped with an overflow channel to accommodate excess flow during peak storm events, resulting in surcharge conditions and localized flooding that adversely affects adjacent structures.

The alternative solution is to upsize approximately 270 linear feet of existing 54-inch RCP to a five-foot by five-foot RCBC. Without additional information for stormwater calculations, this solution is not recommended unless capacity issues have been observed within the existing system beneath Grant Park Drive. Survey and analysis of the existing structure and stormwater facilities must be conducted to determine the headwater depth in comparison to the lowest finish floor elevation. Additionally, analysis of downstream facilities is needed prior to proceeding with Alternative 2. This option would need to be constructed in conjunction with project GC-1 improving the capacity beneath Whitehaven Drive. The estimated probable project cost for the improvements is approximately \$482,600. This estimates only the work necessary for upsizing the existing storm sewer beneath Grant Park Drive and does not include any off-site or downstream improvements detailed in GC-1 or which may be identified during further analysis. As such, Alternative 2 has been ranked using the prioritization form but not included in the project summary table.

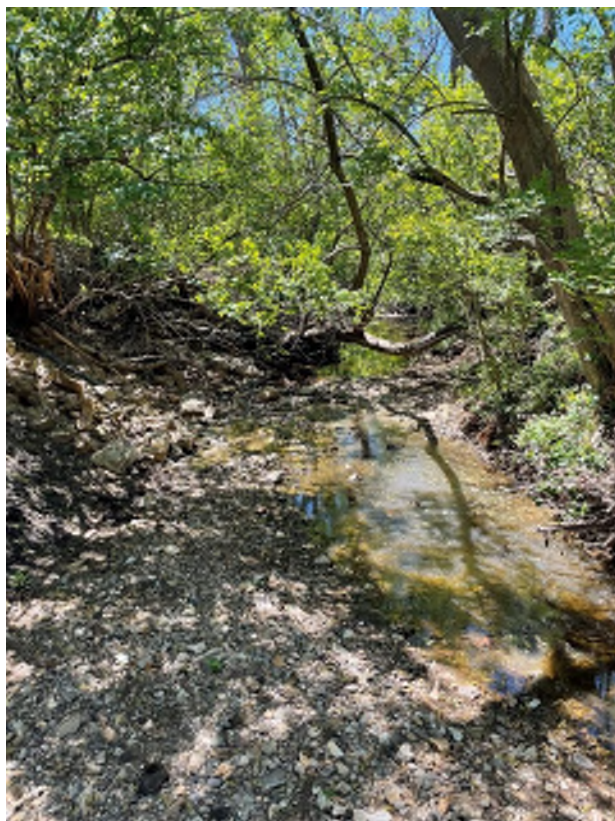
Based on the site visit conducted by Horner & Shifrin, it appears that the existing box culvert on Fournier Drive was recently constructed, as older reports indicate the original design called for a twin 48-inch RCP configuration. The installed box culvert consists of a double box design with dimensions of six feet by four feet. The outlet pipe of the box culvert requires maintenance, specifically the addition of riprap to address erosion control concerns. Downstream of the box culvert, the channel is generally in acceptable condition. It is likely that the culvert upsizing has mitigated previous erosion issues within the channel. While some cleaning and minor maintenance of the channel will be necessary, no significant problems were observed with the current state of the channel. The estimated probable project cost is \$69,000.

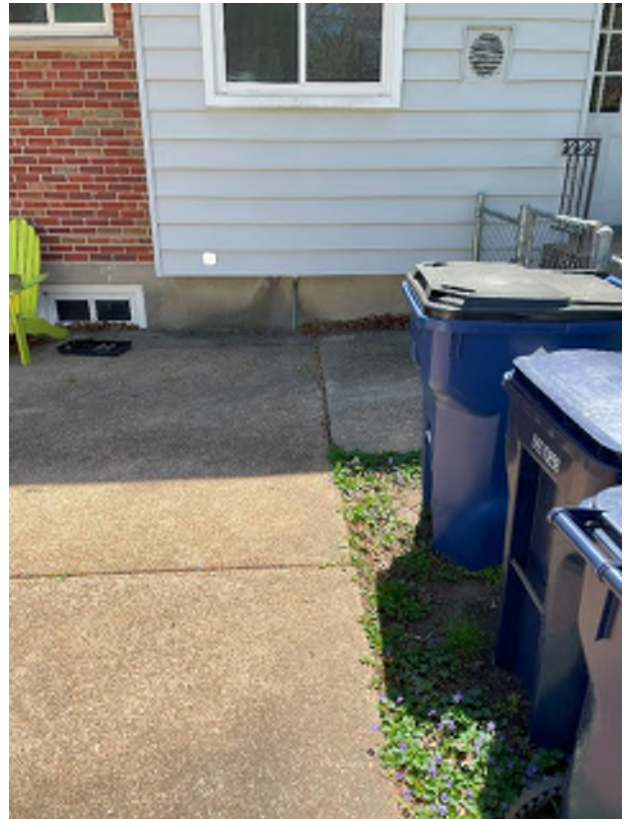
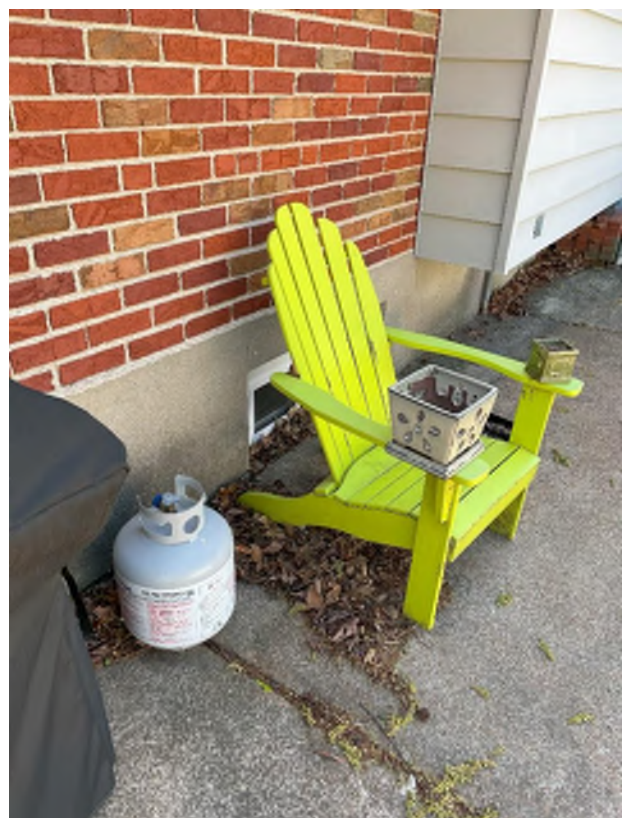
Figure 6.c.iii-2 9781-9783 Twin Vista Drive

Structural flooding is observed between 9781 and 9783 Twin Vista Drive as a result of hydraulic surcharge from area inlets 25L4-060D and 25L4-061D. The absence of an overflow conveyance system prevents the excess runoff from being redirected downstream without encountering structures. Furthermore, the existing 42-inch storm sewer line located between the two properties lacks adequate capacity, worsening the localized flooding conditions during storm events.

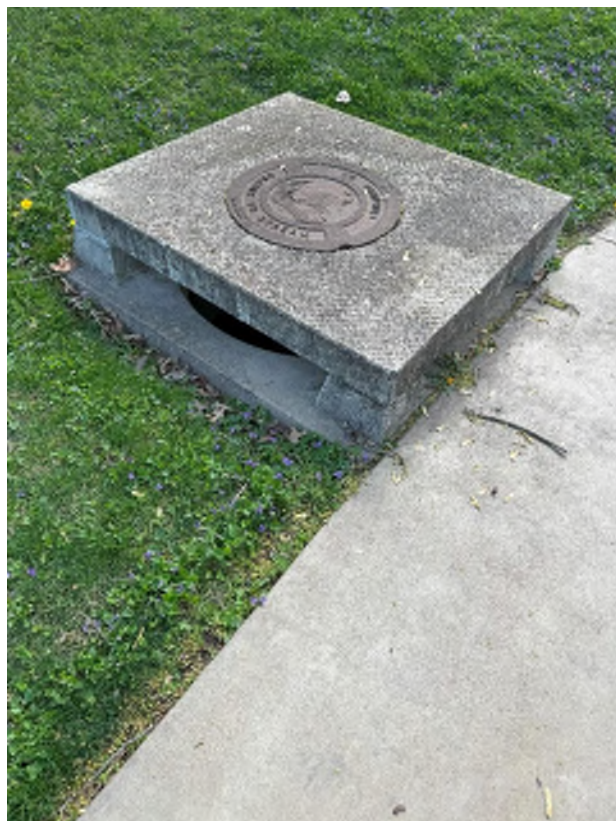
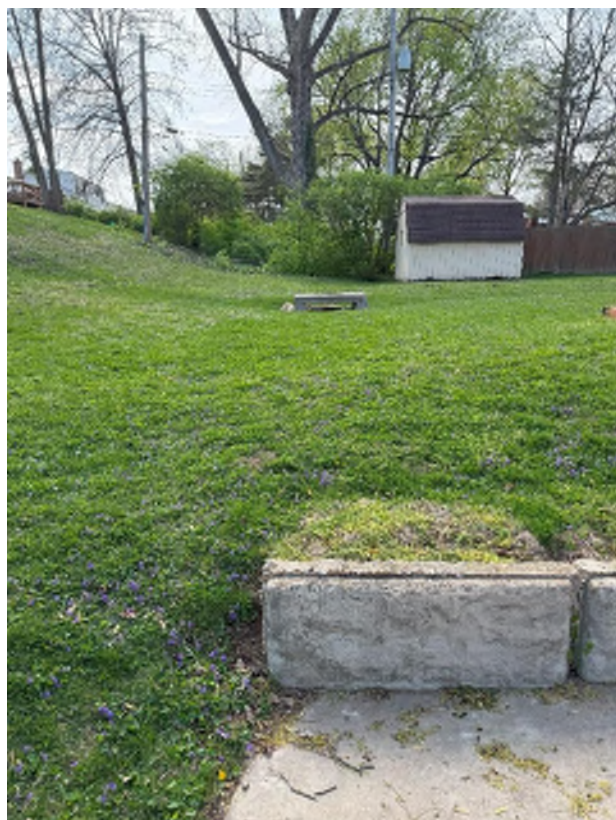
Figure 6.c.x-2 8901 Manda Lane

This project, in the original CDM report, was not identified as completed by MSD or the City. Therefore, a site visit was completed by Horner & Shifrin, and it appears the stormwater concerns have been repaired by adding two storm sewer inlets. The project has been left in the Addendum such that conformation can be received that this project has been completed and the new inlets have sufficient capacity. Additionally, the project has been ranked with a 0.00 benefit/cost ratio since no work is proposed.

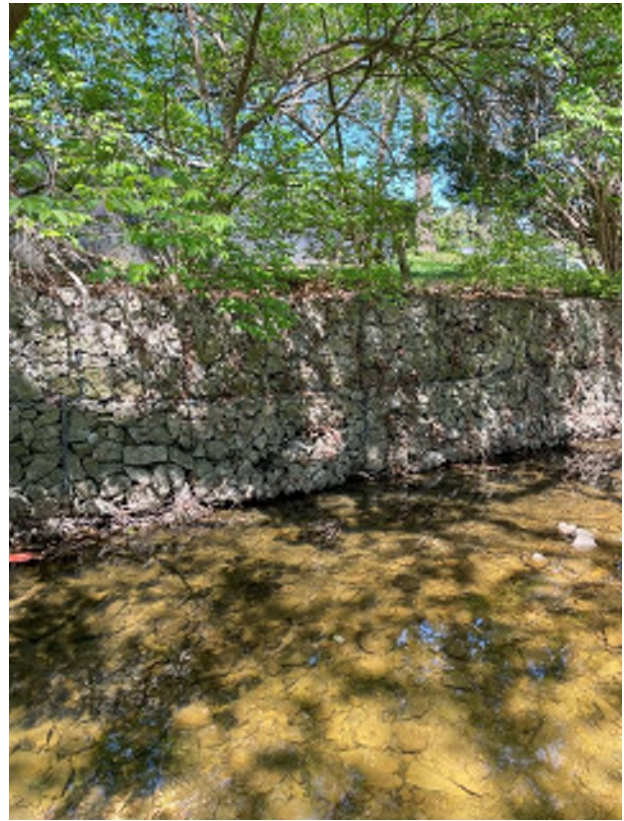
At the rear property line of 8841 Cornish Drive, a gabion retaining wall is installed along the north-facing slope adjacent to the creek. Structural distress has been observed in sections of the wall, primarily due to hydrodynamic forces from increased stormwater flow and root intrusion from nearby vegetation, which are exerting lateral pressure and causing displacement toward the watercourse. Additionally, failure at the toe of the structure has been identified, attributed to inadequate embedment and improper installation of the initial gabion course. The recommended corrective action involves full replacement of the existing gabion wall, constructed per recommended engineering standards for toe embedment to enhance structural stability and prevent future undermining. The estimated probable project cost is approximately \$63,400.

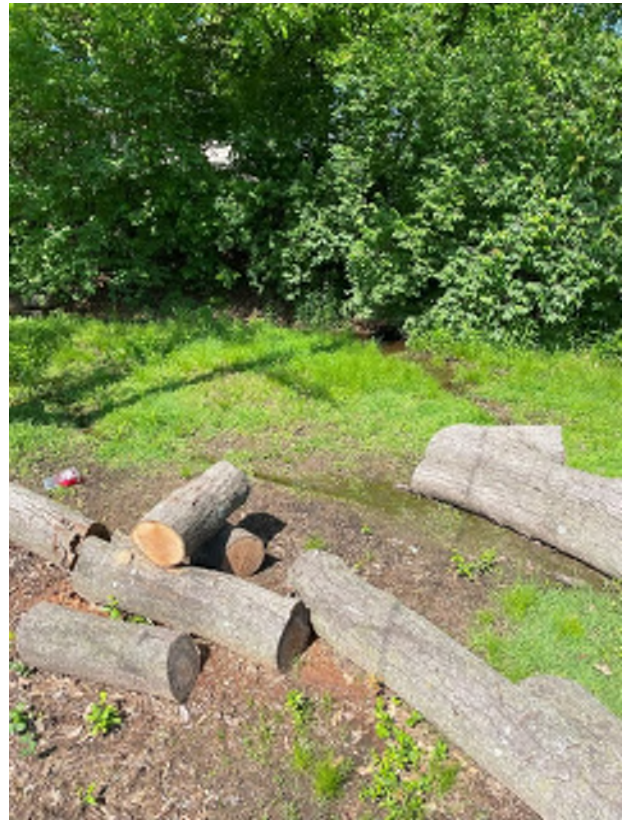
The properties located at 8701 through 8715 Gayle Avenue were inspected following reported issues. No deficiencies related to stormwater drainage were observed at 8701 and 8715. However, significant drainage concerns were identified at the rear yard of 8709. The backyard area of this lot exhibits multiple locations of standing water, indicative of poor surface drainage and the absence of a defined outfall or positive drainage path for stormwater runoff. Additionally, the accumulation of tree logs and other vegetative debris along the rear yard further impedes stormwater flow and will require removal as part of remediation.

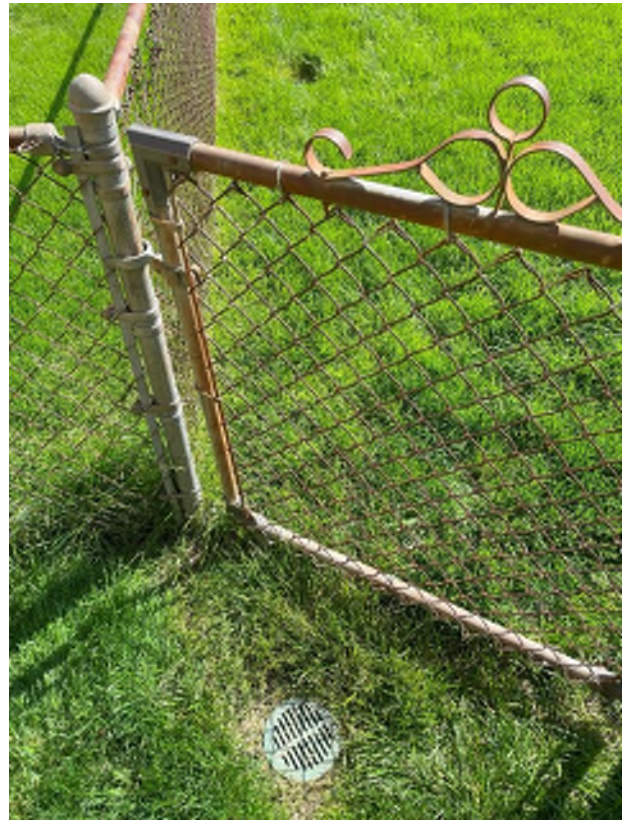
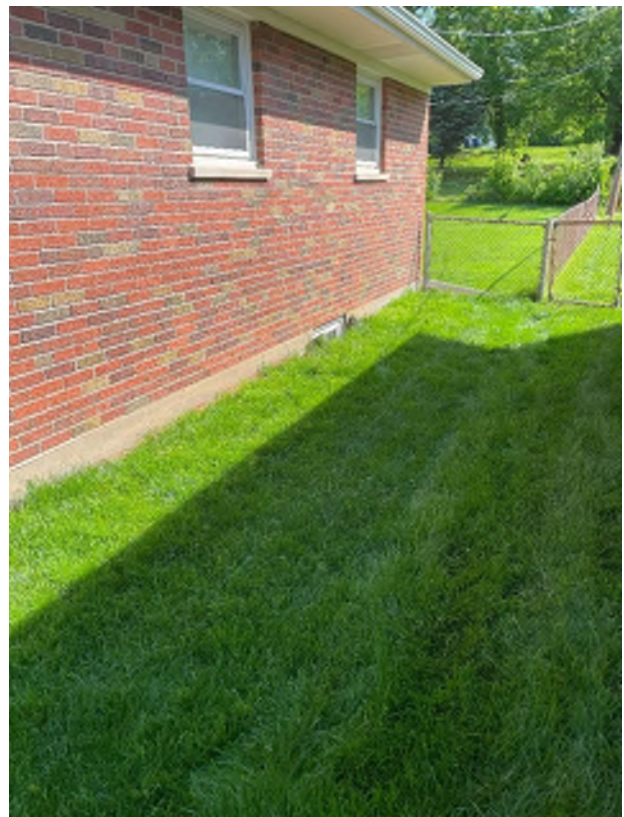
Figure 6.c.xiii-2 8718-8722 Villa Crest Drive

A shallow swale is situated between the residential properties located at 8718 and 8722 Villa Crest Drive. Based on field observations, the swale lacks sufficient depth to effectively convey stormwater during higher intensity storm events. Both residences have basement windows that are recessed within window wells. Due to the limited depth of the swale, there is a potential risk that during significant rainfall, stormwater may overtop the window wells and enter the basement areas. Additionally, subsurface drainage infrastructure was observed within the swale, consisting of private grate inlets located near the upstream end adjacent to the fence line. These drains are connected via piping and discharge to the existing public roadway at the downstream terminus of the swale.

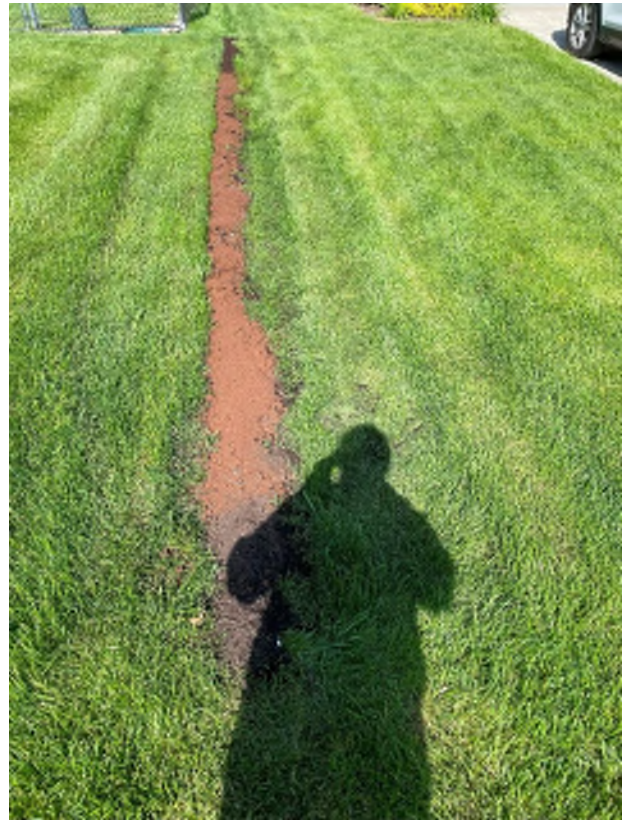
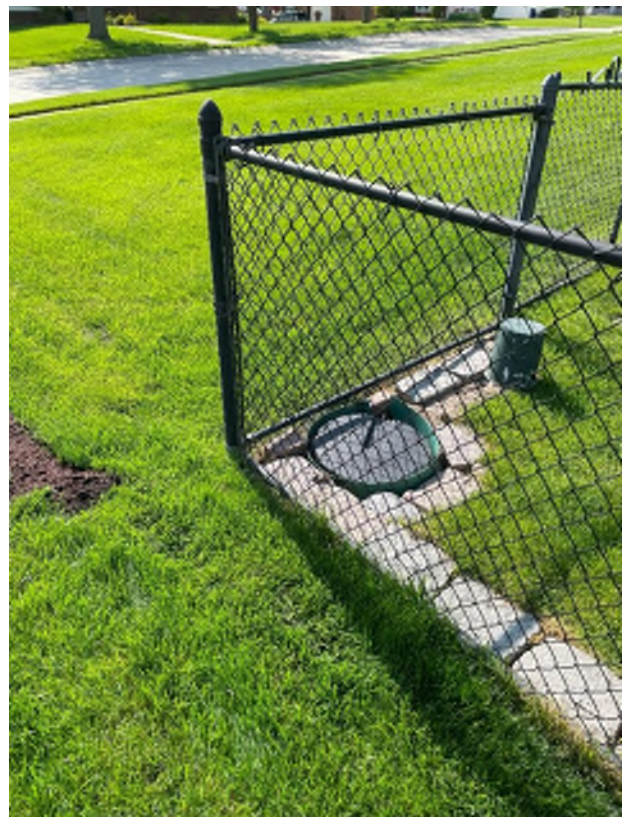
Figure 6.c.xiv-2 9409 Sappington Greens Lane

The property owner at lot 9411 Sappington Greens Lane is having a flooding issue on the side yard. From the field investigation carried out by Horner & Shifrin, it was noted that there were two external sump pumps located in the side yard. One was found in the back yard of 9411 Sappington Greens Lane and the other was found in the side yard of 9415 Sappington Greens Lane. These sump pumps were probably added due to the flooding issue in the side yard and discharge onto Sappington Greens Lane. The addition of the sump pumps appears to resolve the side yard flooding. MSD or the City will need to check if sump pumps added by the property owner meet their respective requirements. Another issue that was found was an existing transformer located between lots 9407 and 9411 Sappington Greens Lane is in a low point. The homeowner at 9407 Sappington Greens Lane has stated to Horner & Shifrin that water ponding occurs at the transformer. Grading up around the transformer and making a high point around it to direct the stormwater towards the existing area inlet on the west or to drain towards the street will resolve this issue. The estimated probable project cost is approximately \$9,200.

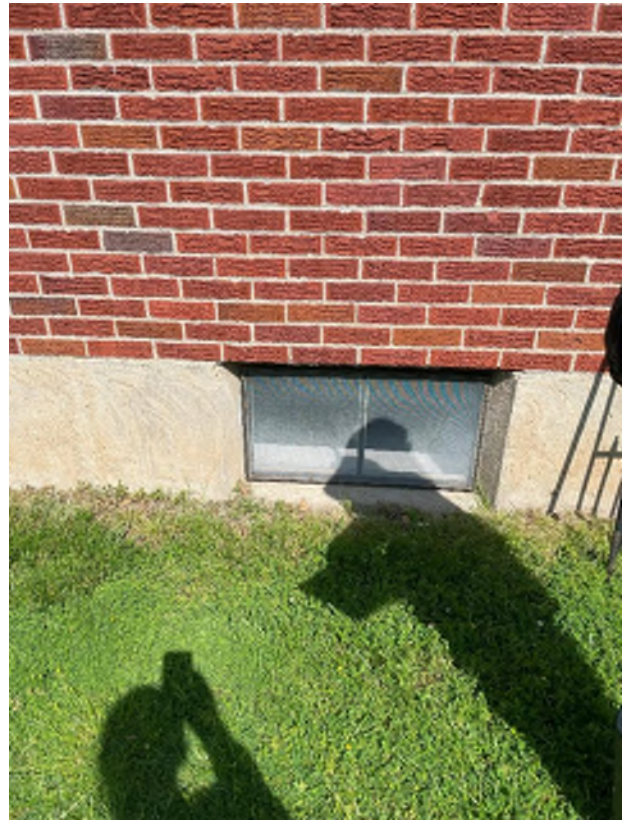
Figure 6.c.xv-2 8856 Glen Rose Drive

A field investigation was performed at 8856 Glen Rose Drive for stormwater drainage issues in the area. Along the side yard of 8856 and 8862 Glen Rose Drive, a shallow swale was found along with a low point along the swale. The low point is located near a basement window and could cause an issue if a higher storm event occurs. The swale does not have a positive slope to drain towards the roadway. The front and back yard downspouts are collected and are being discharged at the downstream end of the swale towards the roadway.

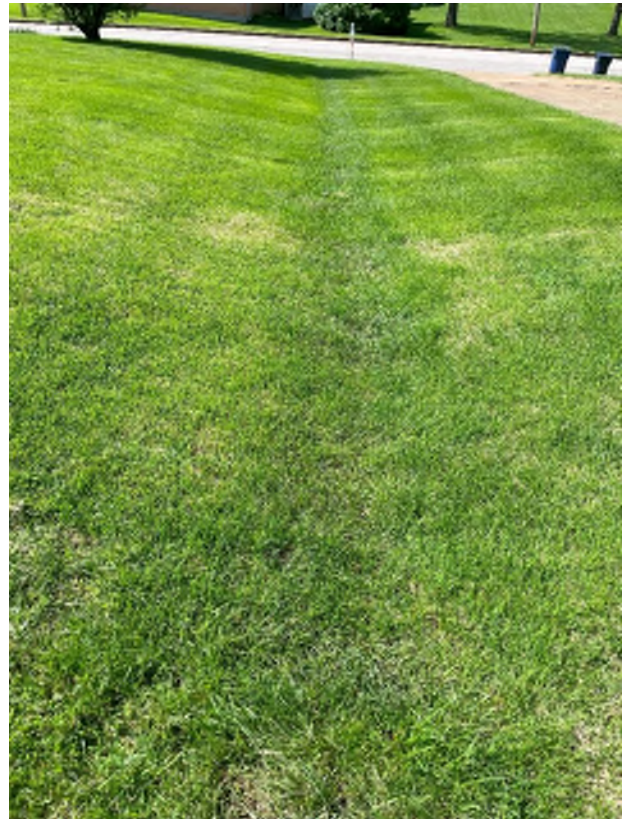
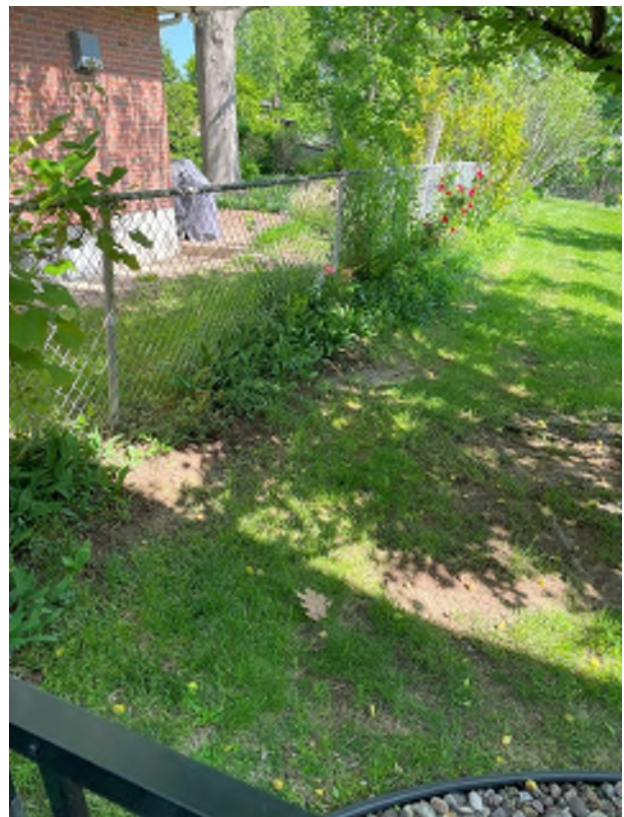
Figure 6.c.xvi-2 9875 Richter Lane

A swale is located along the side yard of 9875 Richter Lane. The swale is in good condition but does not have a constant slope along the length of the swale. Regrading the swale to have a constant slope will provide better drainage for the front yard and avoid ponding along the swale. The estimated probable project cost is approximately \$6,100.
