STORMWATER REPORT

CRESTWOOD STORMWATER

MASTER PLAN

CRESTWOOD, MISSOURI 63126

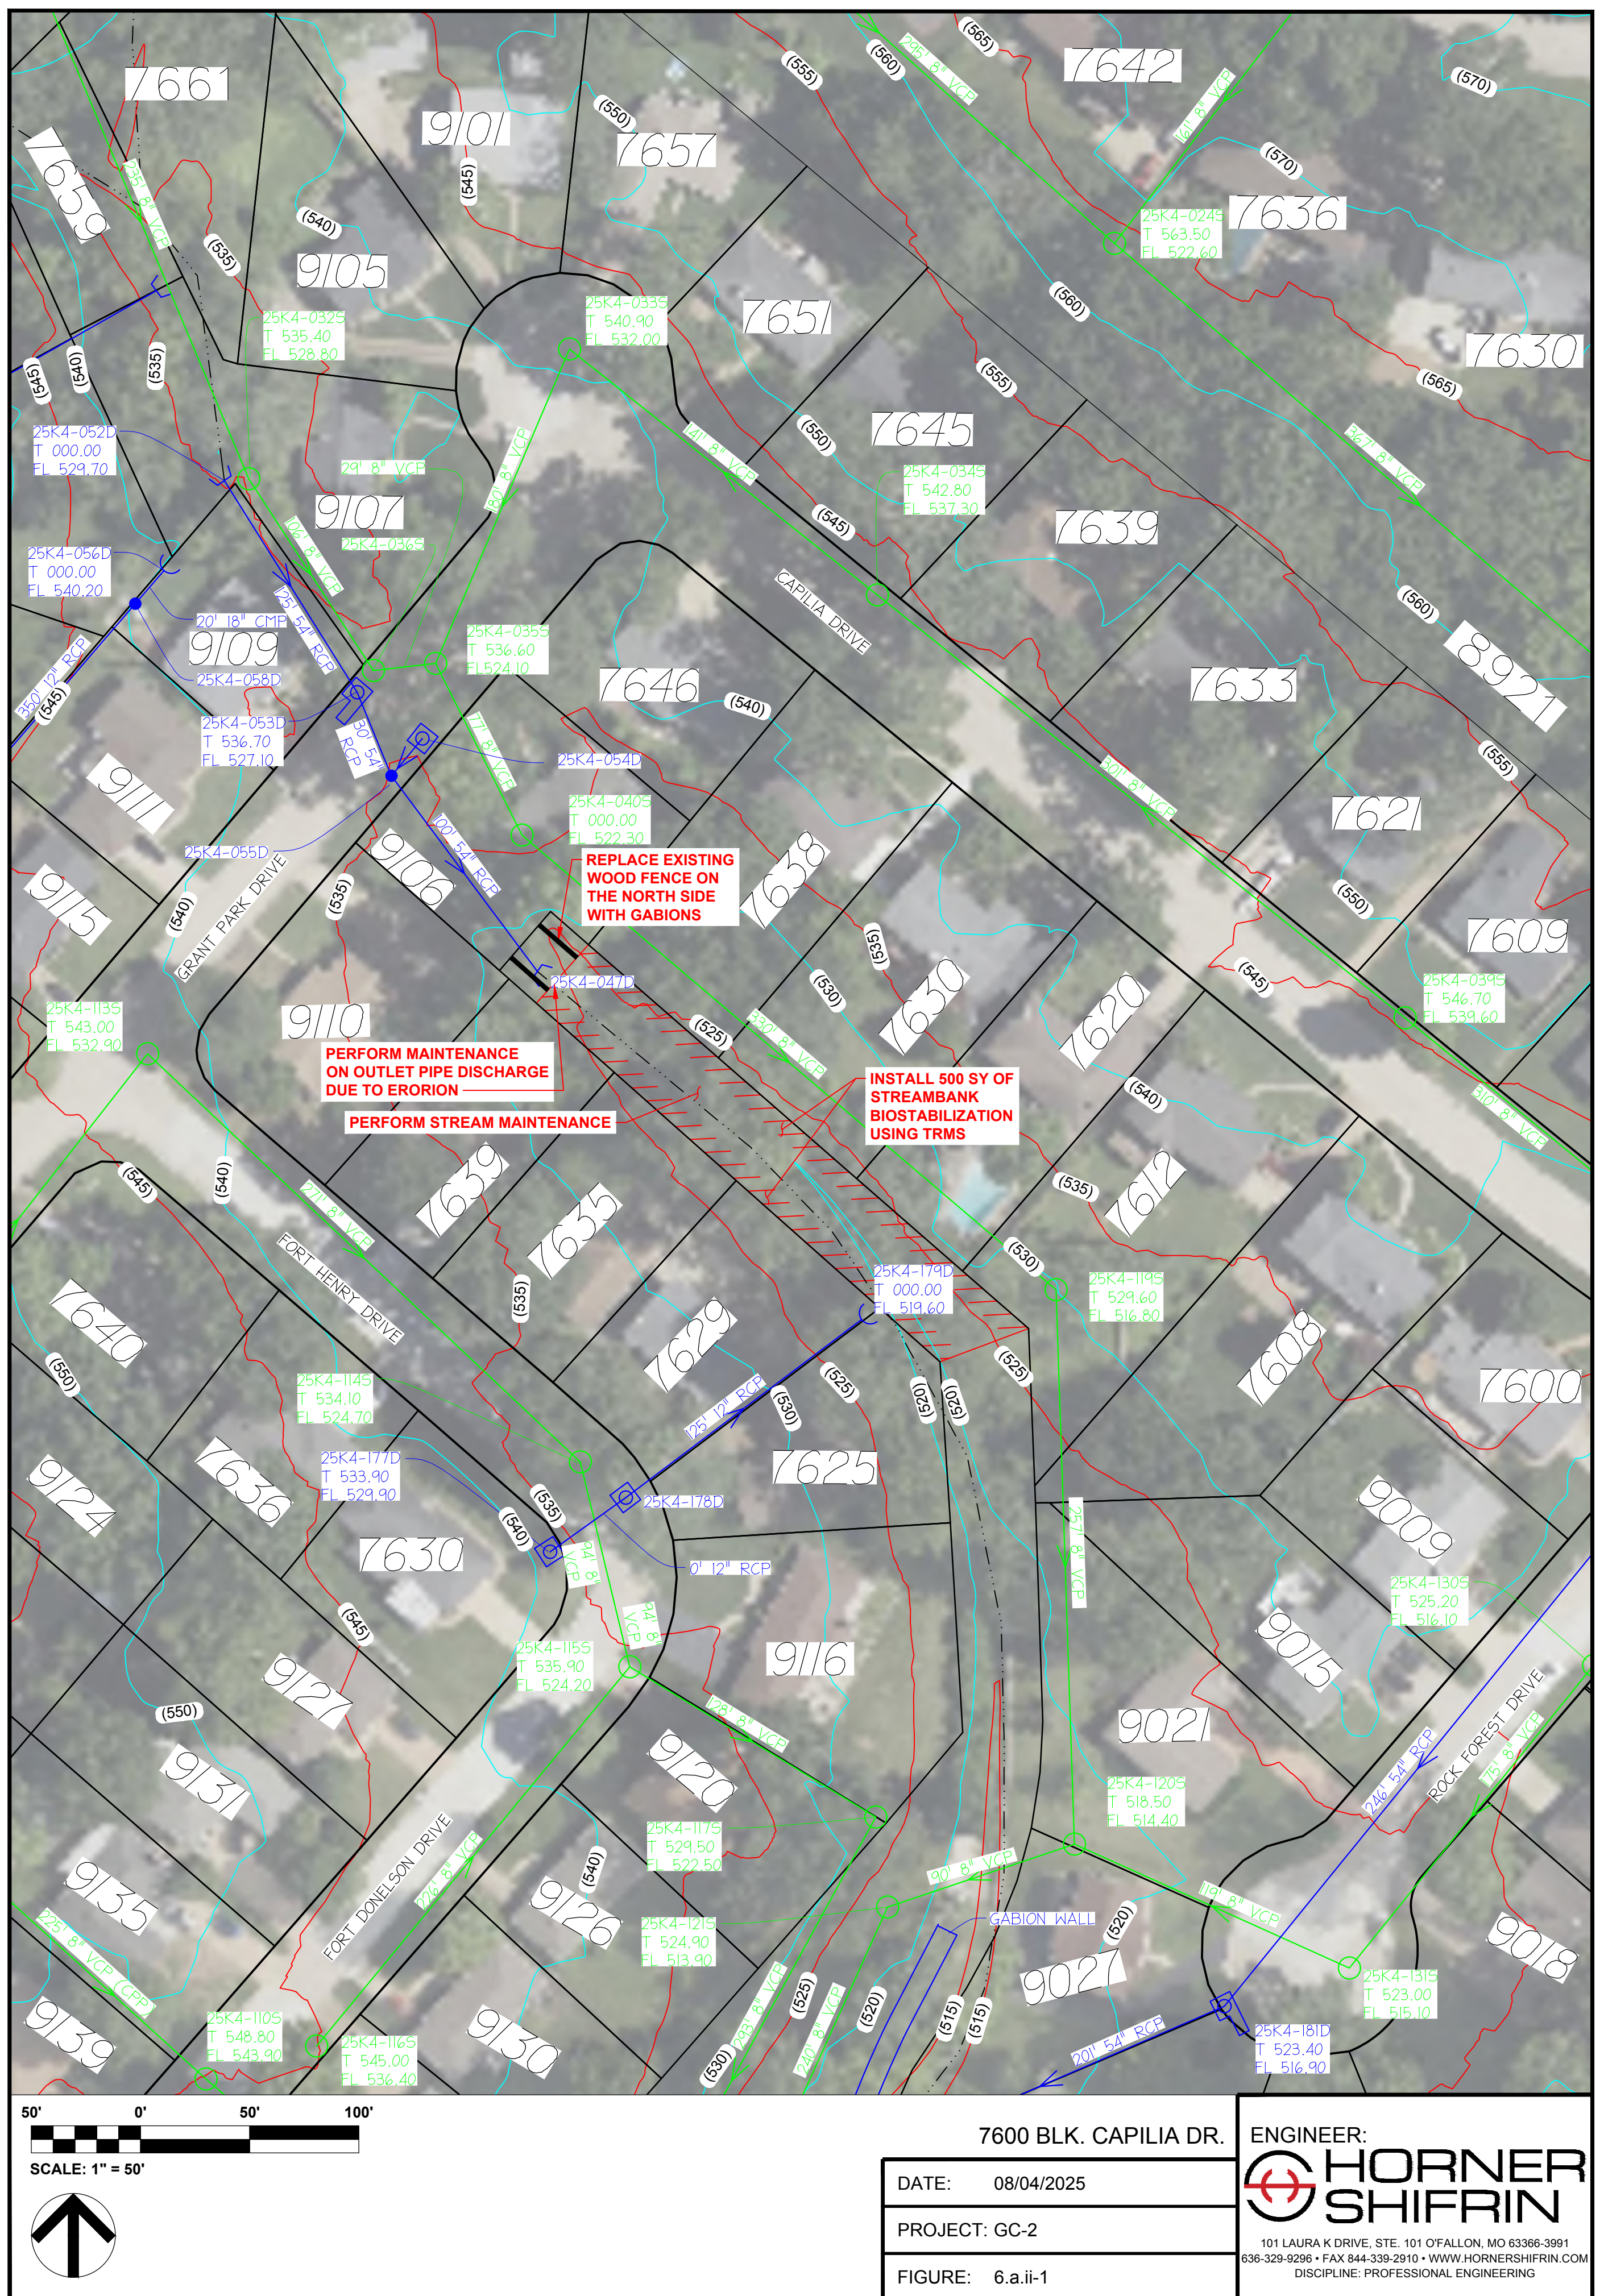
Figure 6.a.ii-2 7600 Block Capilia Drive

The channel located downstream of Grant Park Drive, between the properties at 7630 and 7638 Capilia Drive, is exhibiting signs of active erosion along the north bank. Additionally, the existing stormwater outlet pipe at this location is subject to localized erosion and will require remedial maintenance to ensure long-term functionality. Previous stabilization efforts have been implemented on the downstream segment of the channel, including the construction of a gabion wall and placement of riprap along the streambanks, which have contributed to mitigating further erosion in that area. By contrast, the upstream segment remains untreated and is currently experiencing noticeable bank and bed erosion. A preliminary site review indicates that the adjacent residential backyards provide sufficient space to accommodate the proposed engineered improvements necessary for establishing a stable, naturalized channel system.

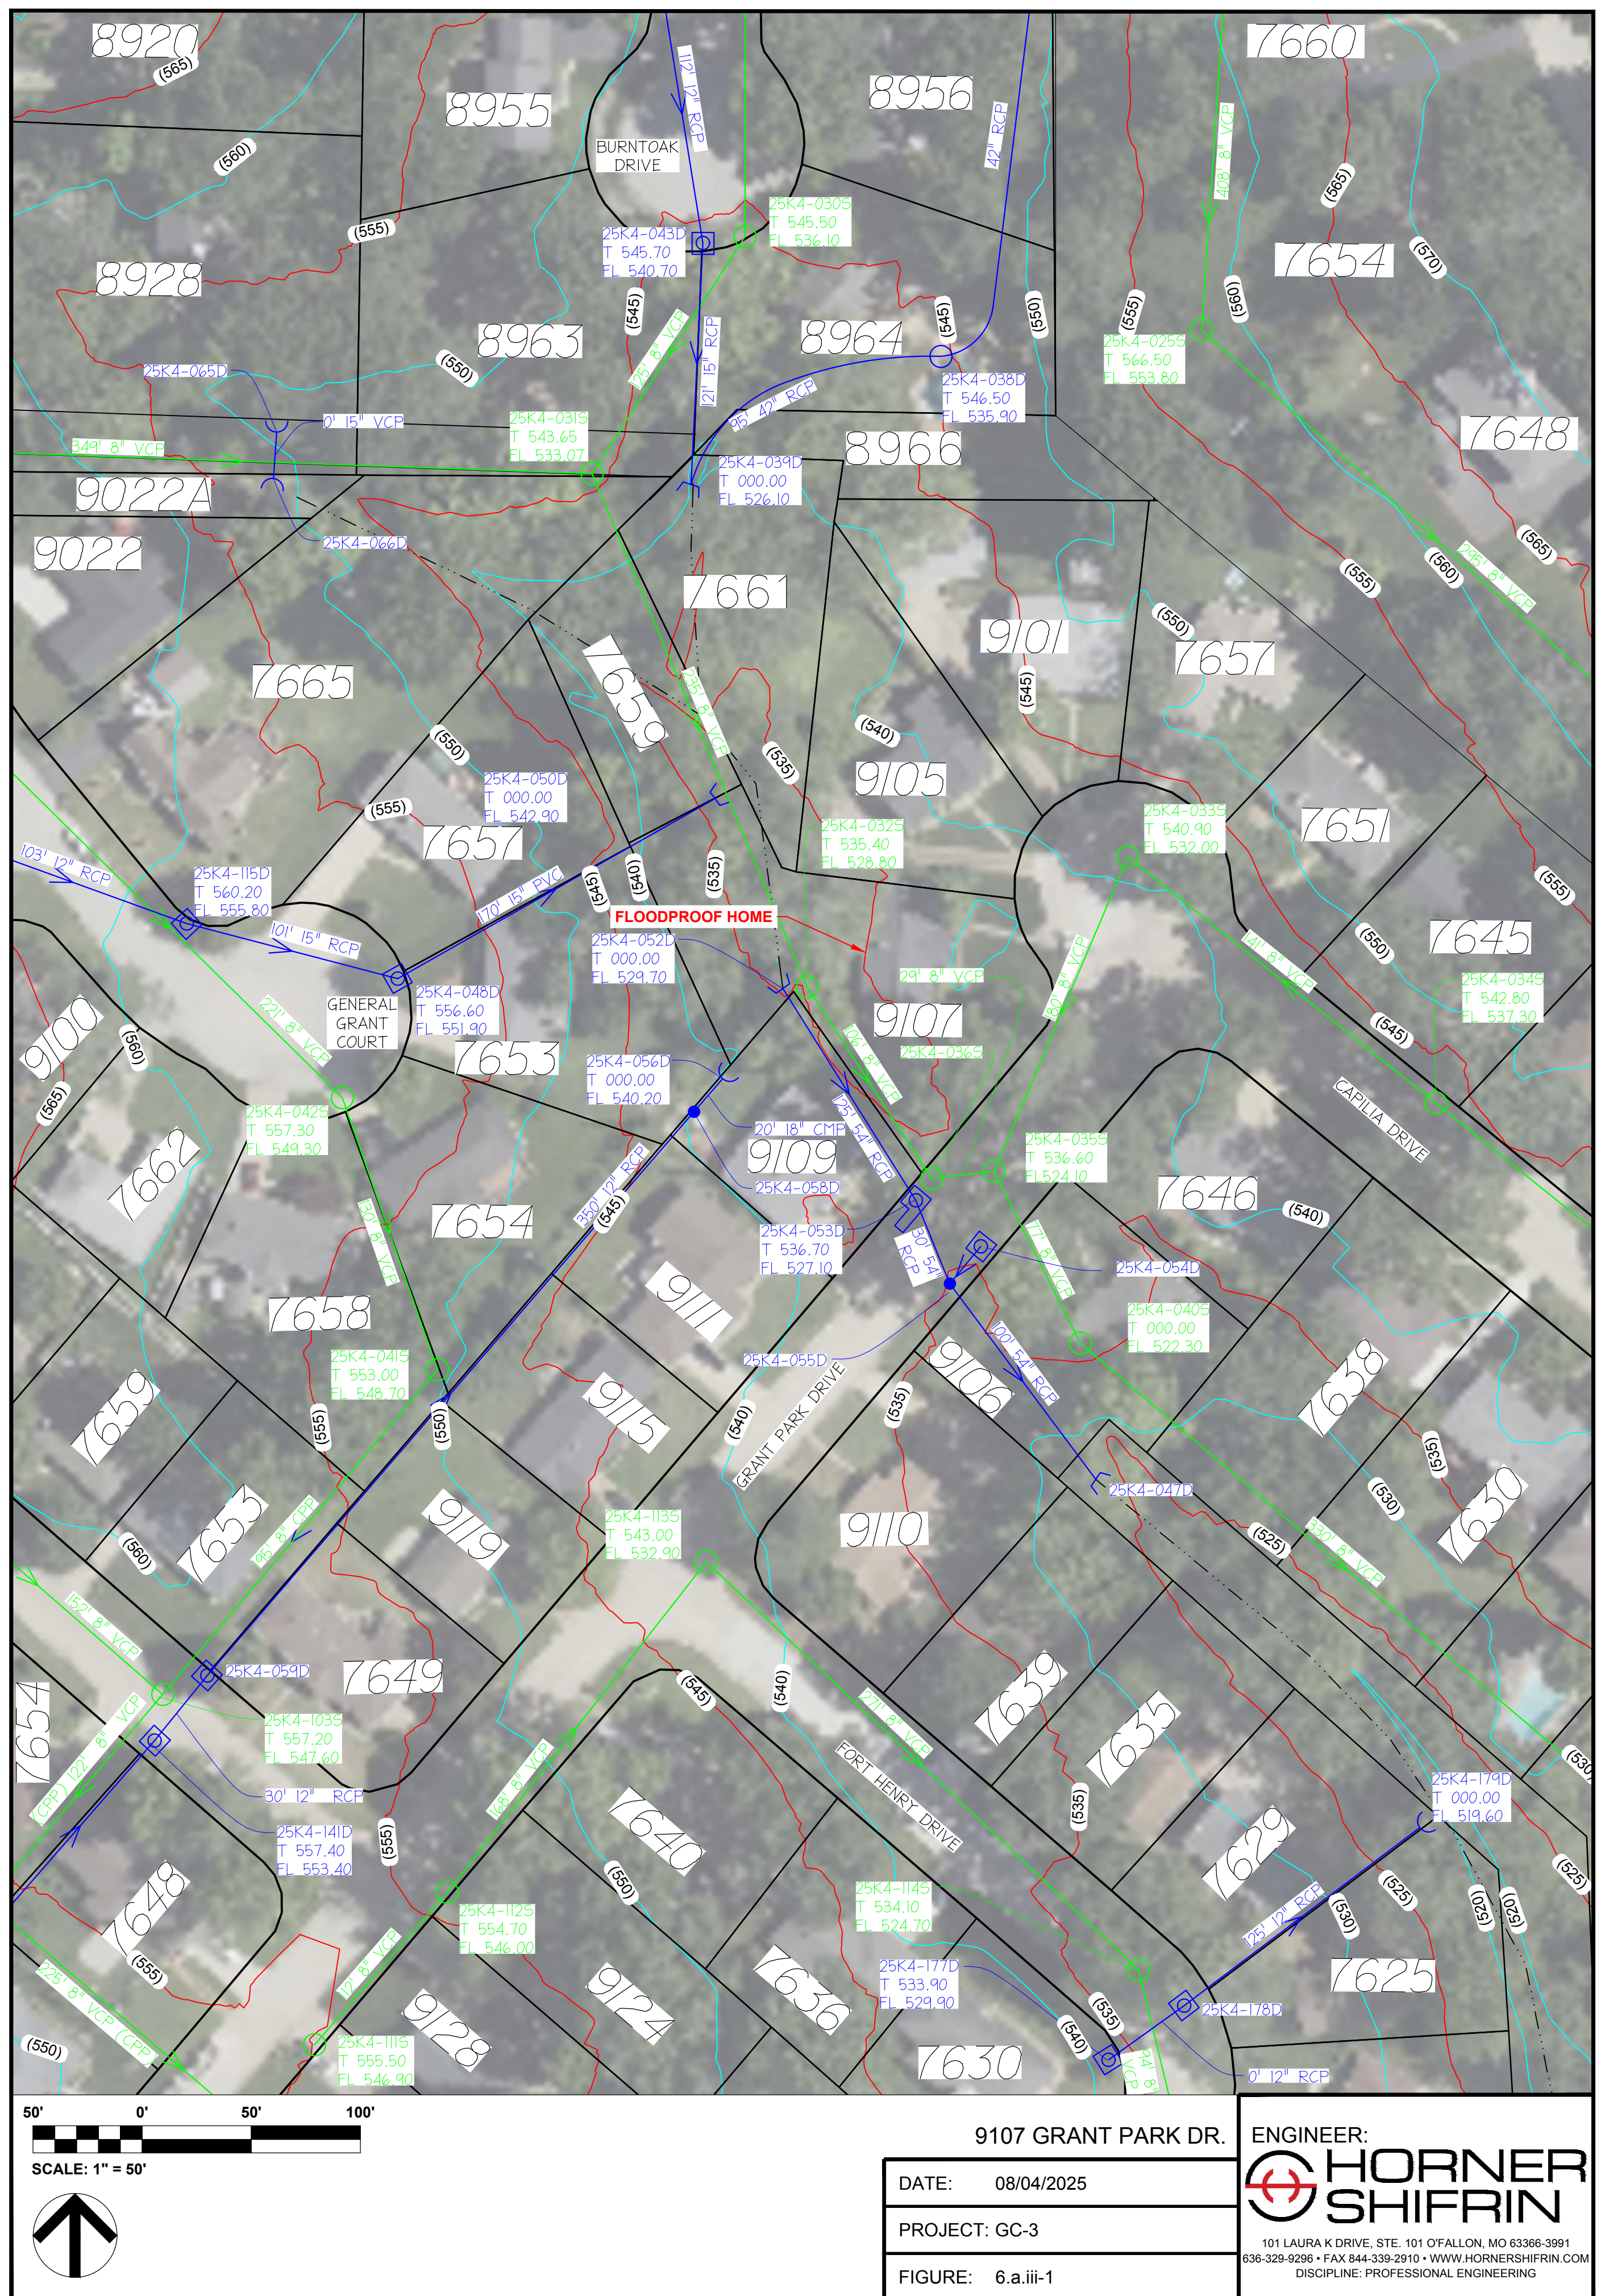
Figure 6.a.iii-2 9107 Grant Park Drive

The resident at 9107 Grant Park Drive has reported recurring flooding in the rear yard area where the existing open drainage channel transitions into an enclosed stormwater conveyance system. The source of the flooding has been identified as insufficient hydraulic capacity at the junction where the open channel enters the 54-inch Reinforced Concrete Pipe (RCP), identified as structure 25K4-052D. This location lacks the necessary headwater depth and is not equipped with an overflow channel to accommodate excess flow during peak storm events, resulting in surcharge conditions and localized flooding that adversely affects adjacent structures.

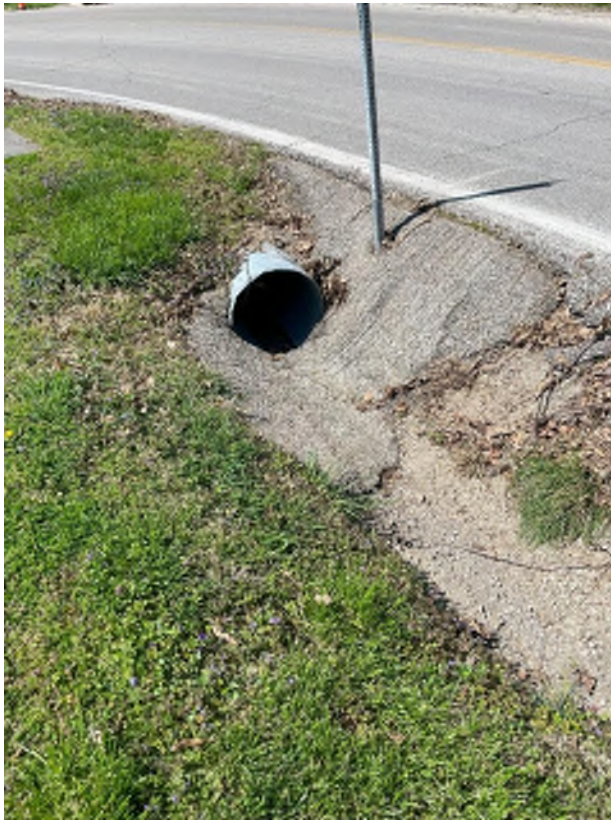
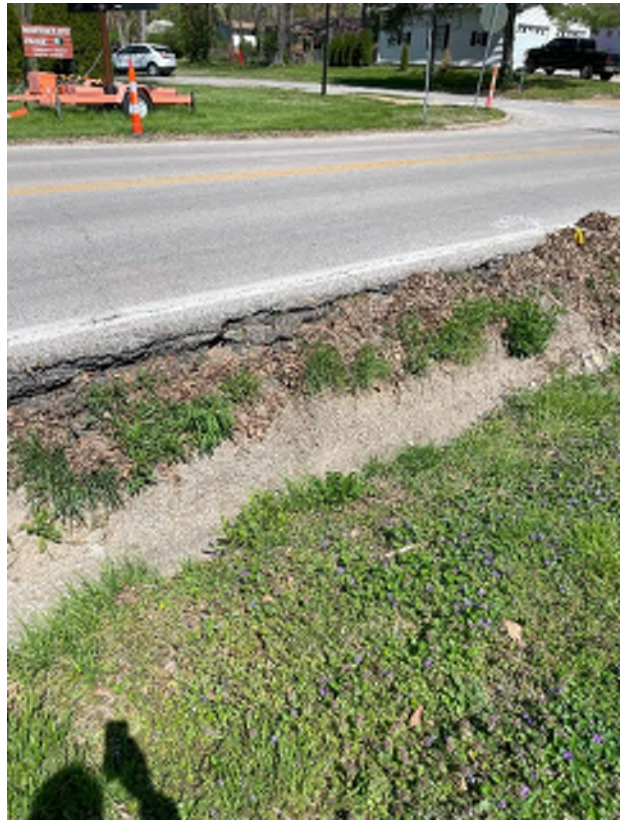
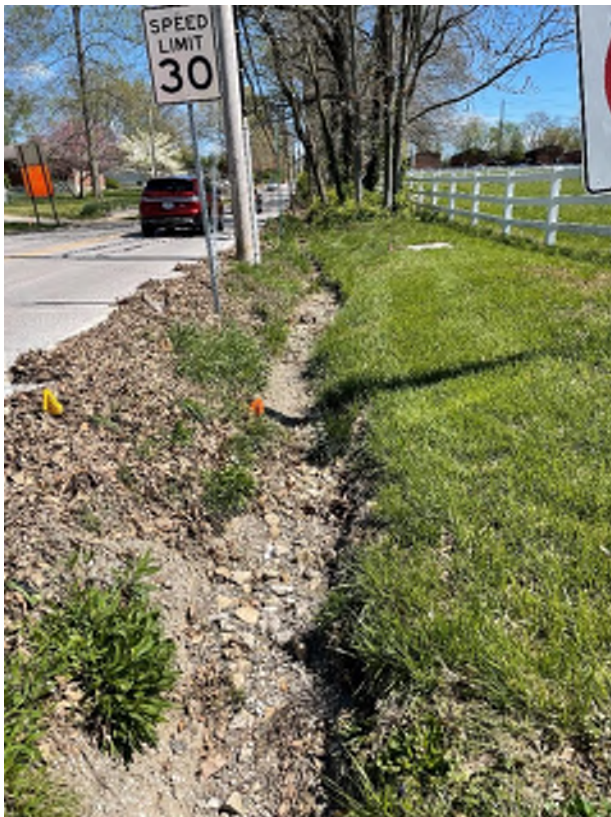
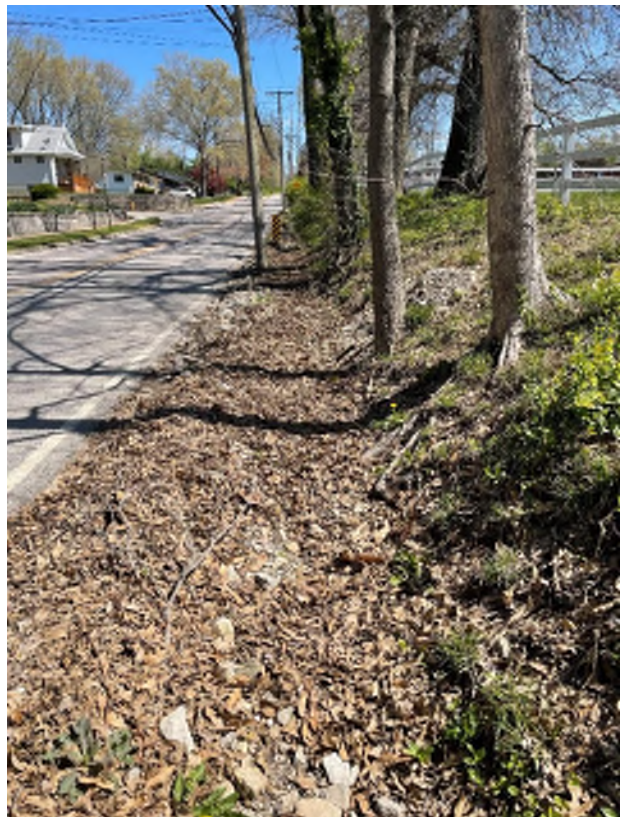
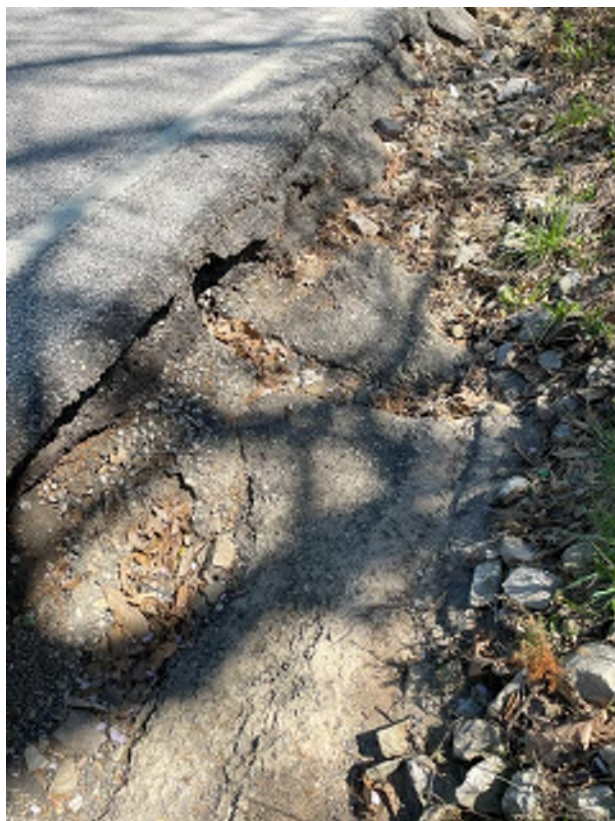
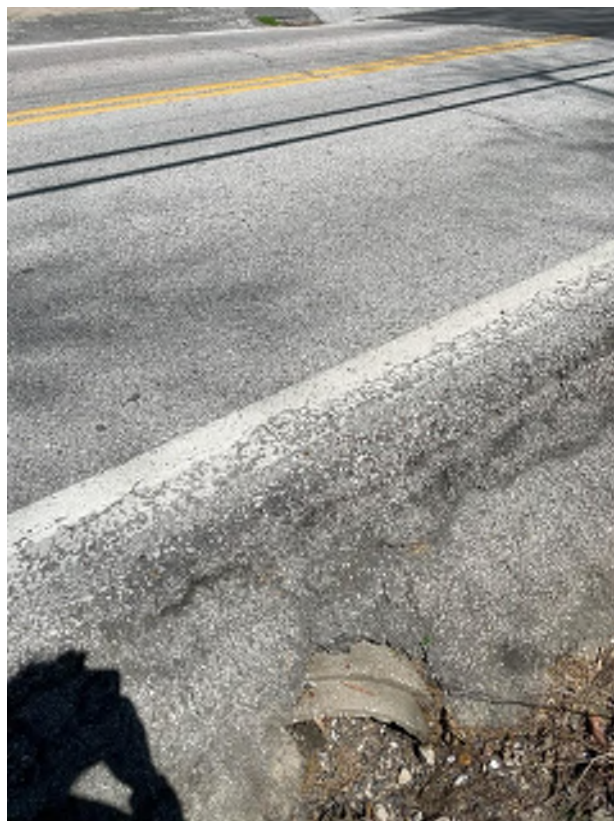
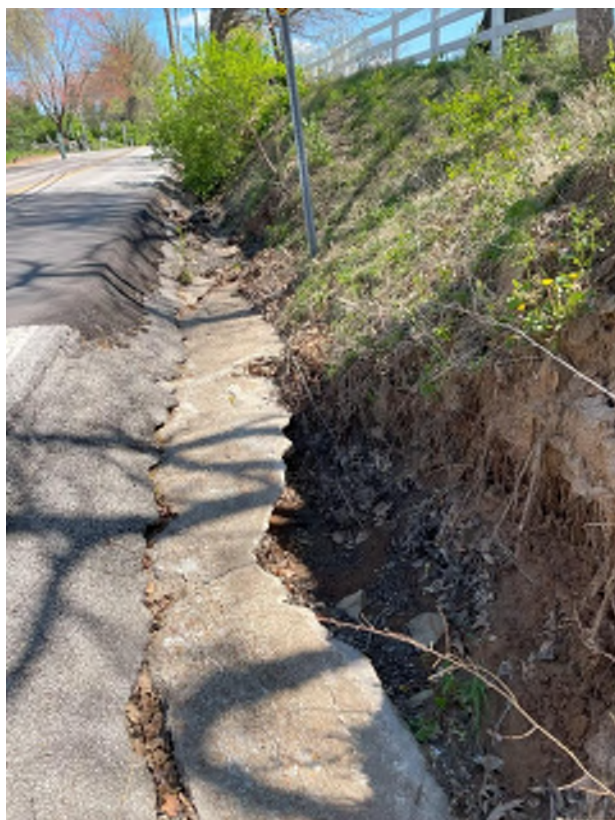
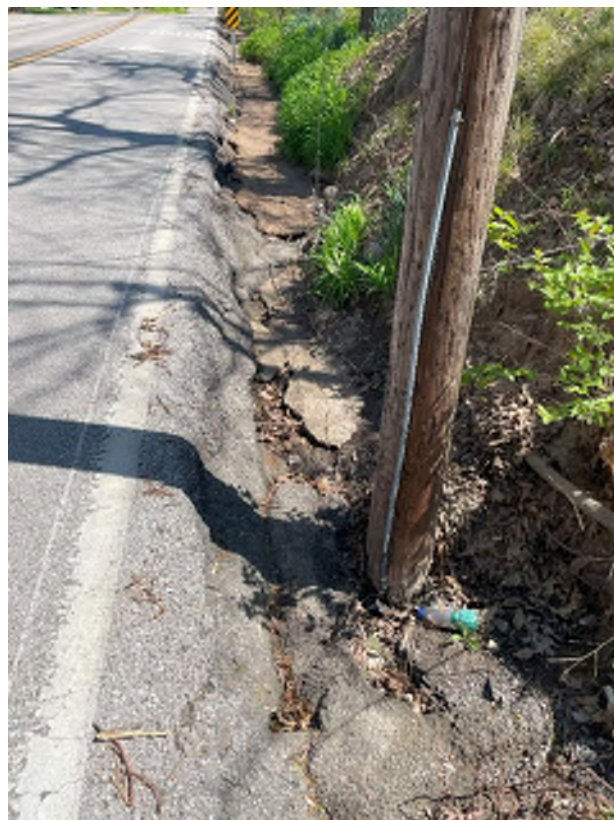
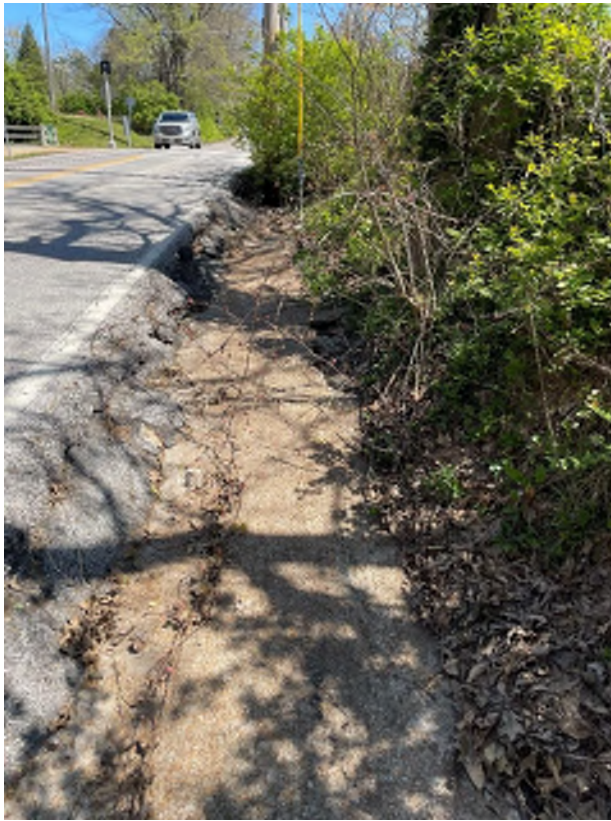
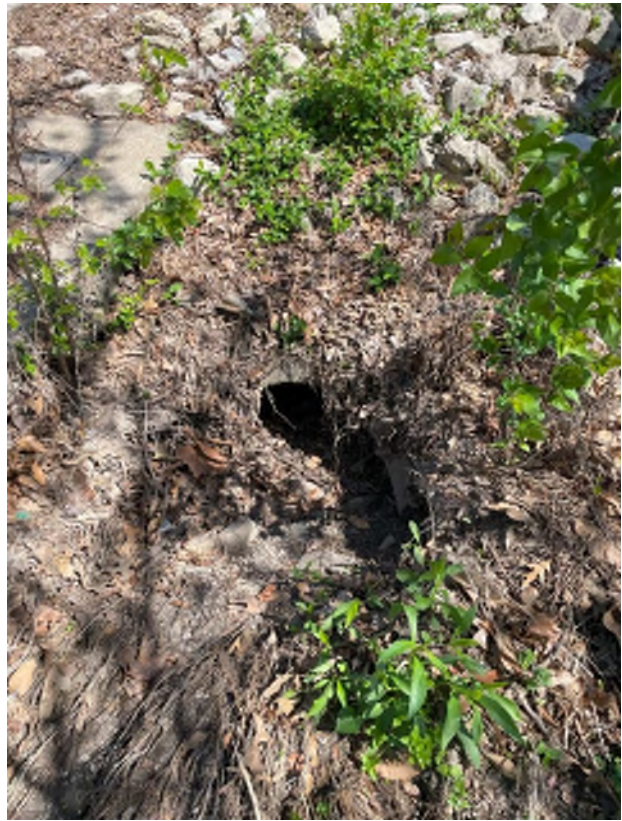
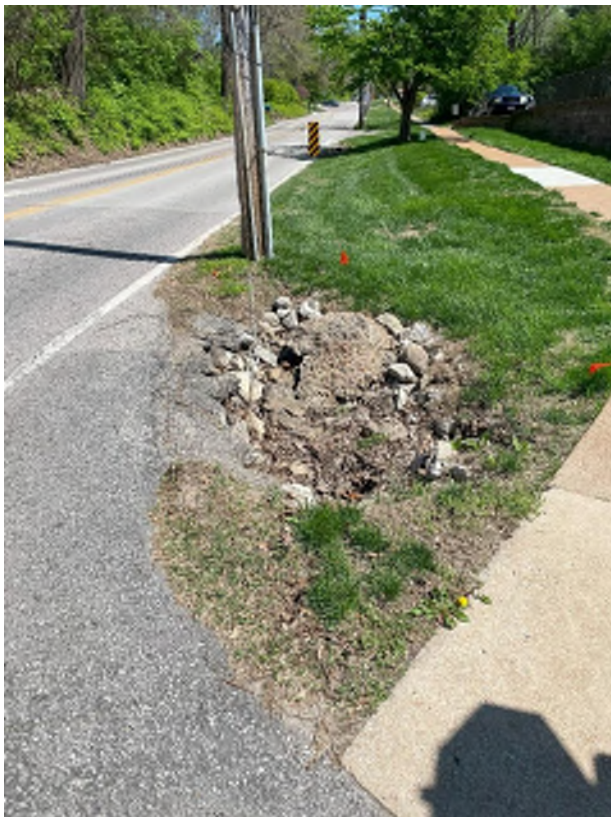
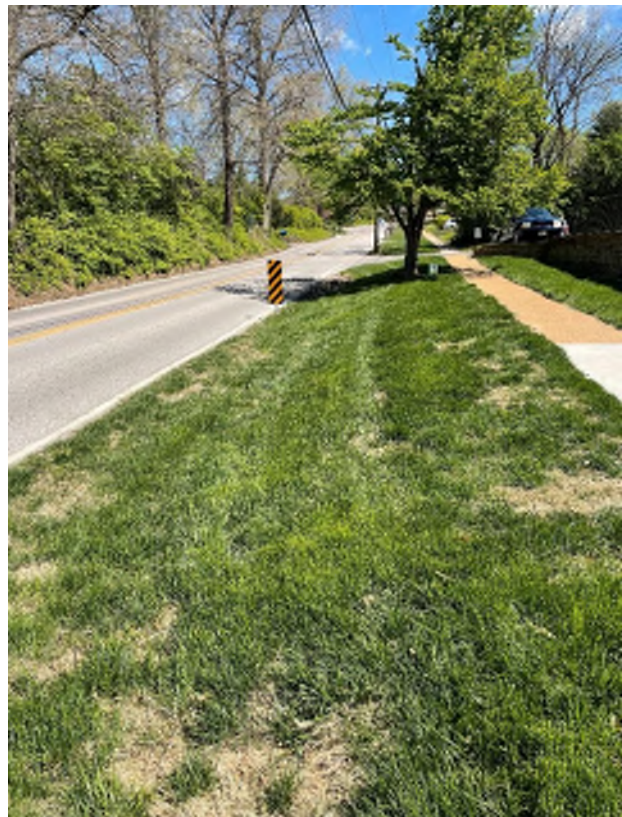
Figure 6.a.v-2 8951-9027 Pardee Road

The Pardee Road roadside drainage system does not have the capacity to handle surface runoff from the road, leading to flooding on the south side between 8951 Pardee Road and Gravois Creek. Several sections of the road are experiencing undercutting. The existing roadside ditch suffers from erosion and lacks the necessary capacity to effectively manage stormwater runoff. Additionally, utility infrastructure, such as power poles located along the road, complicates efforts to widen the roadway and install curb and gutter systems. As a result, the cost estimate includes provisions for utility relocation to accommodate the removal and relocation of these power poles. Construction requires closing one lane and traffic control is required during construction.

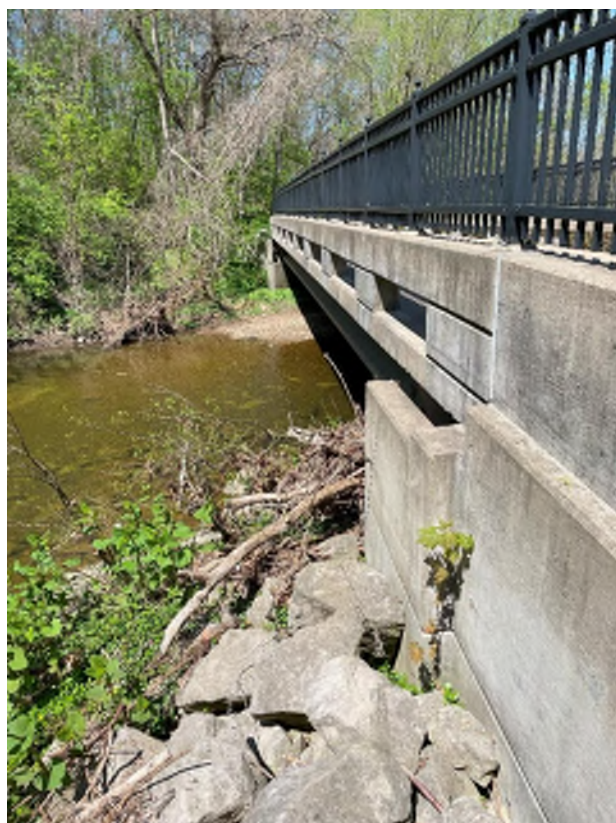
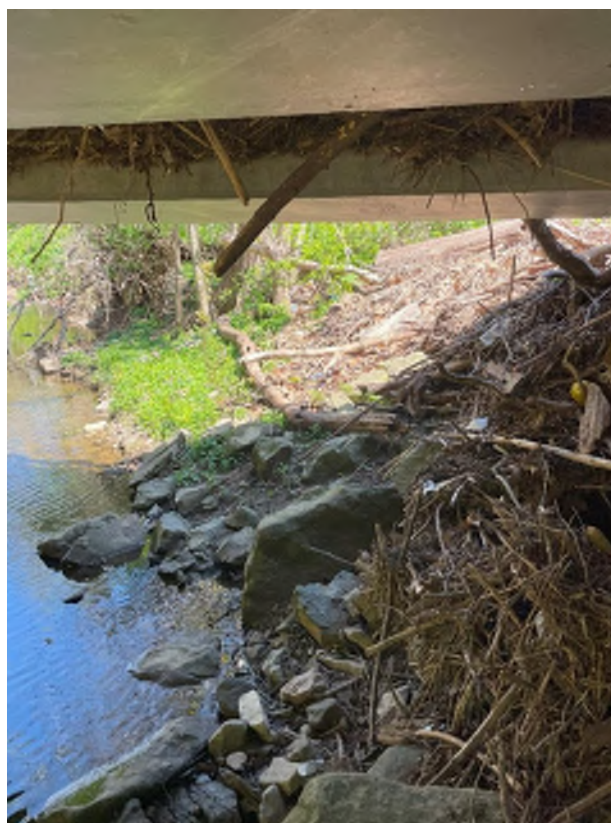
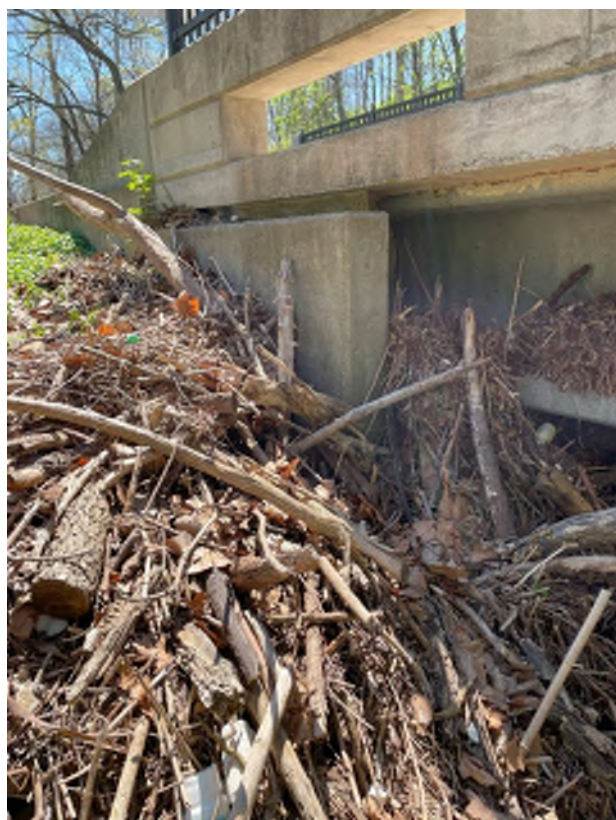
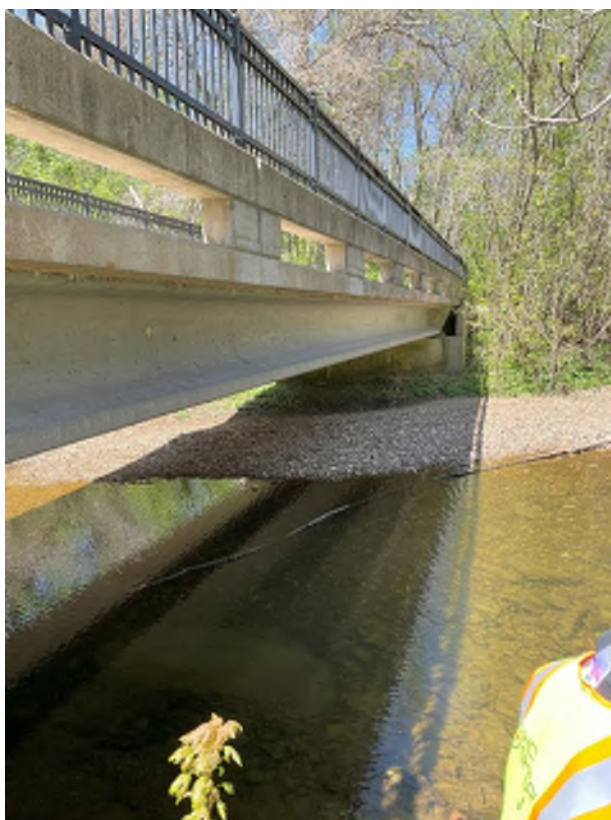
Figure 6.a.vi-2 Whitecliff Park/Pardee Lane

Two primary issues have been identified along Gravois Creek within Whitecliff Park, between the confluence with Mulberry Creek and the Crestwood city limits. This segment of the creek remains in a natural channel configuration. The first issue is progressive fluvial erosion, which is actively destabilizing the streambanks. The second issue involves overbank flooding, which impacts both the southeastern parking lot near the Park Service Road Bridge and the rear yards of residential properties located at 8711–8737 Pardee Lane. During a 15-year recurrence interval storm event, a substantial portion of the park is inundated, with floodwaters reportedly reaching elevations of approximately five feet above the bridge deck.

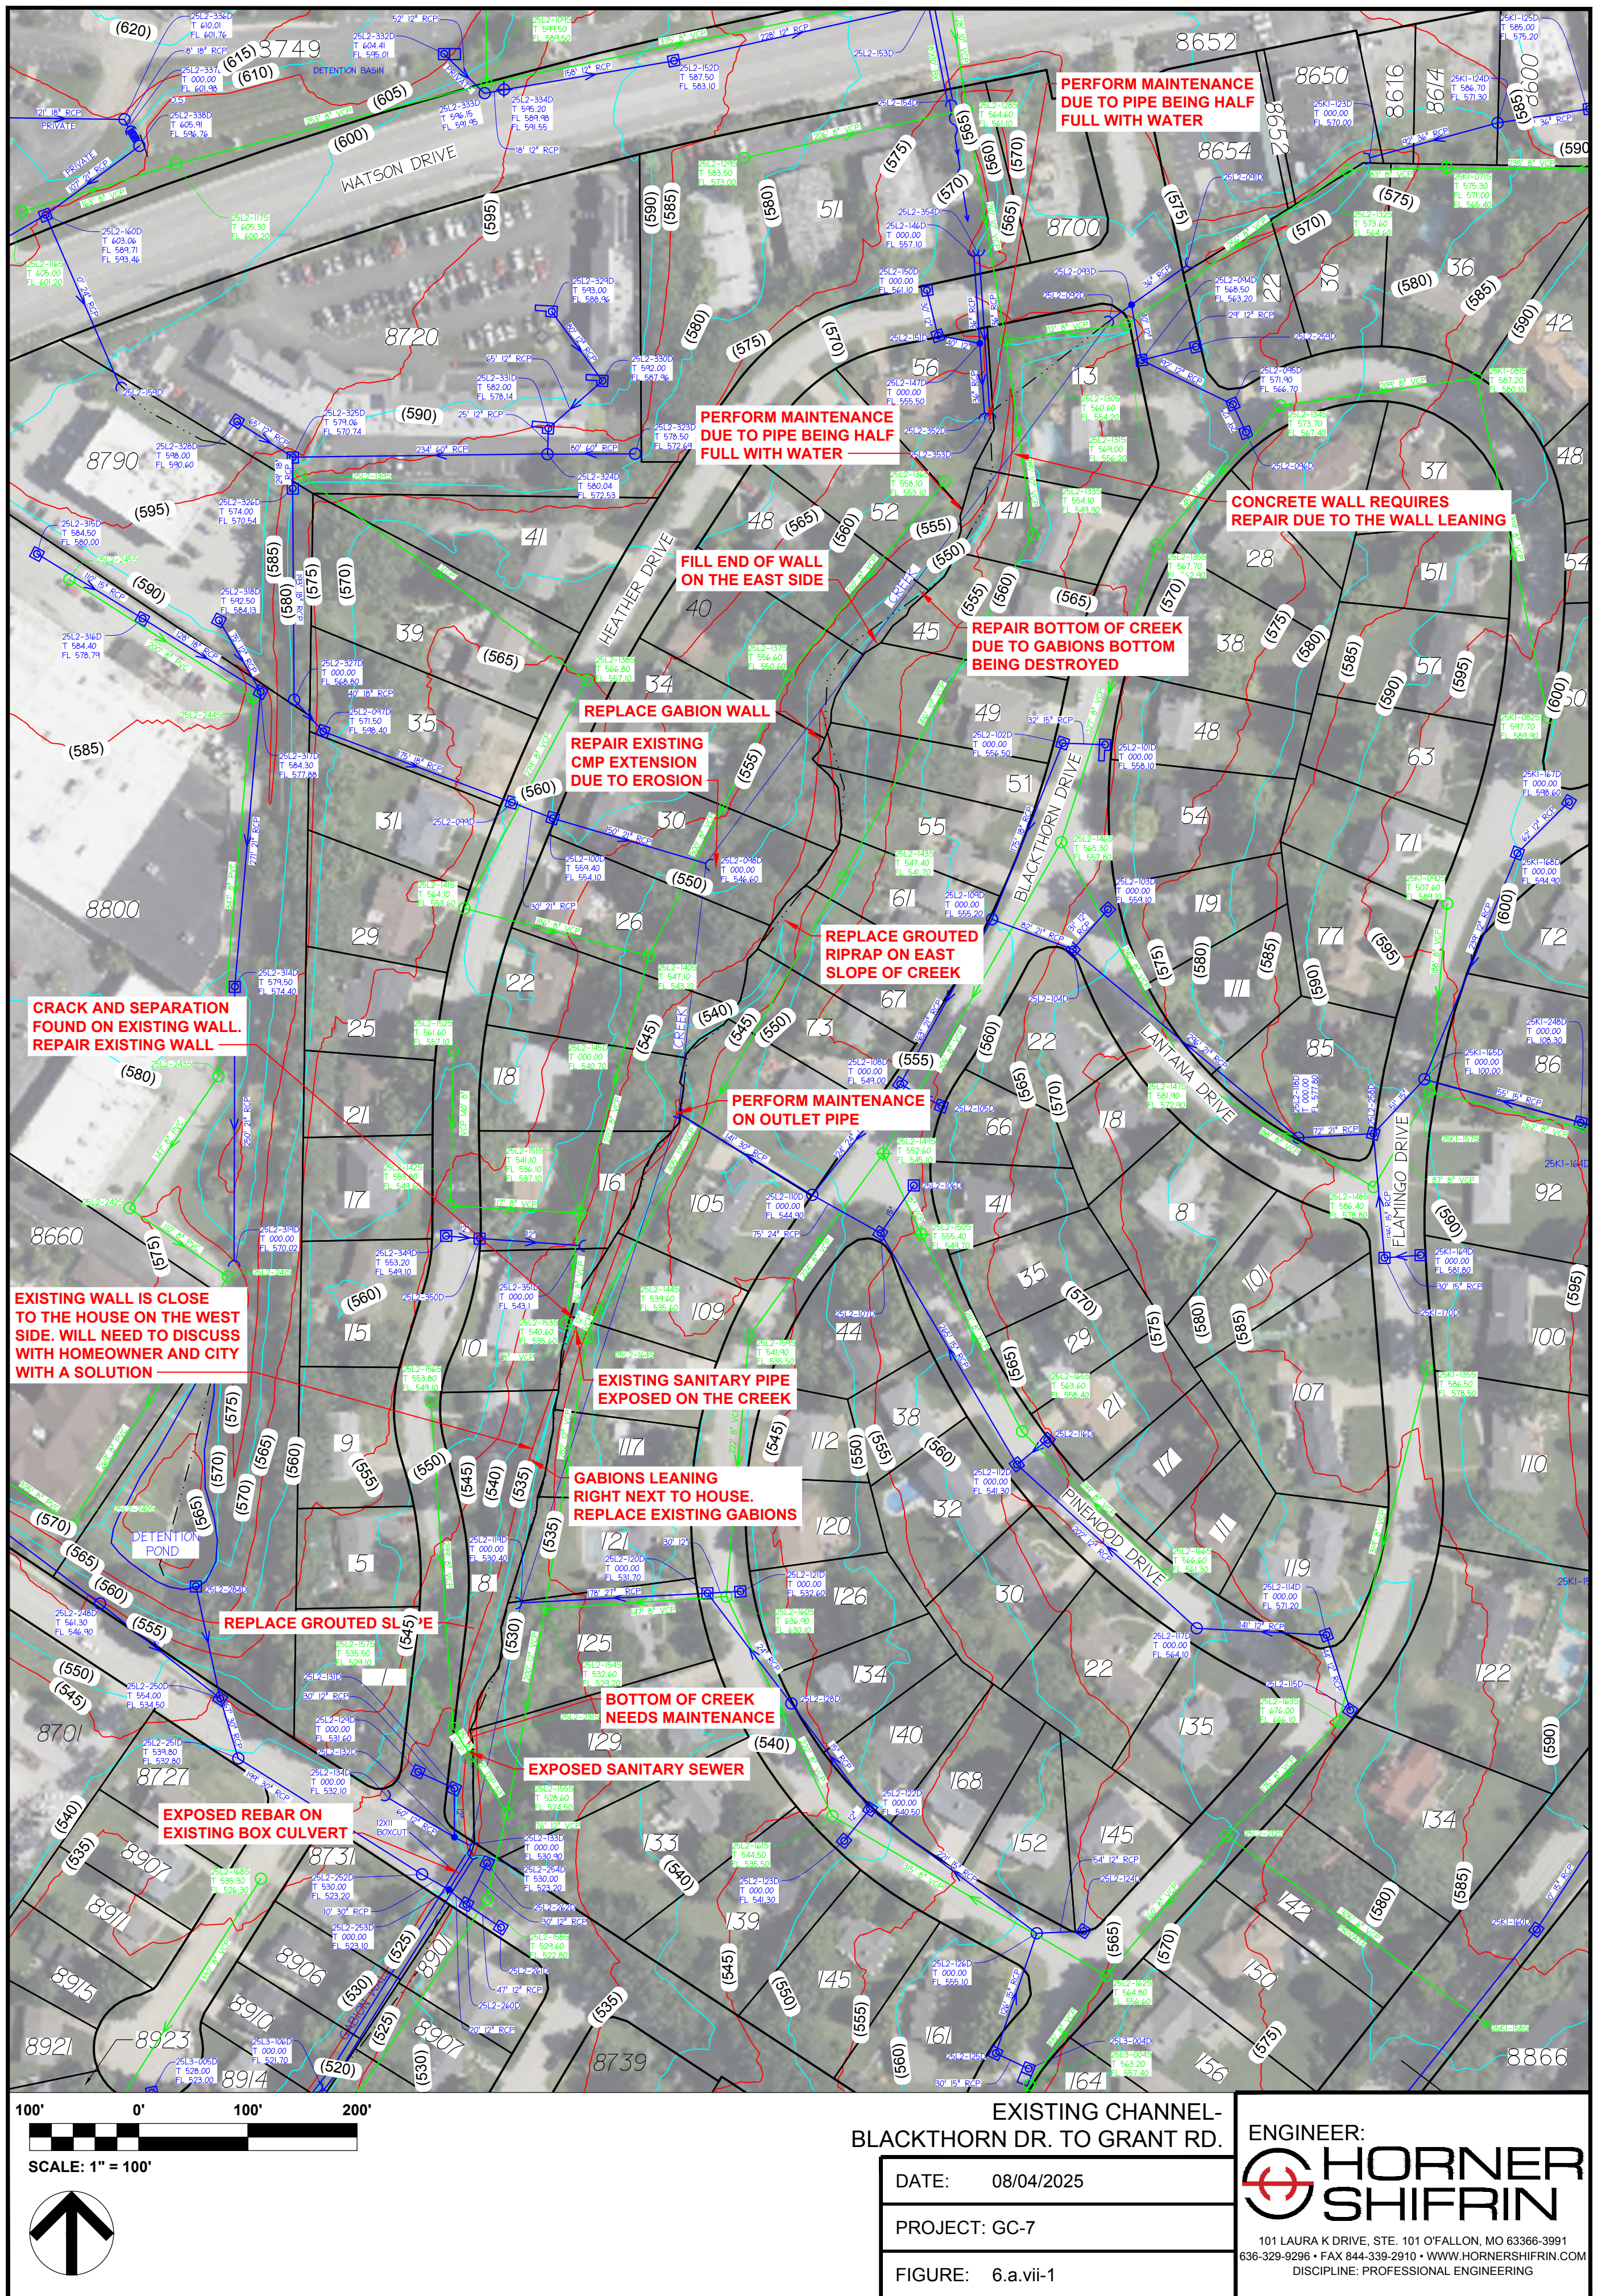
Figure 6.a.vii-2 Existing Channel Blackthorn Drive to Grant Road

The natural channel located between Grant Road and Blackthorn Drive, adjacent to the block parallel to Heather Drive, is experiencing erosion. The upstream section of the channel has undergone modifications, including the installation of riprap along the side slopes. Two outlet pipes, labeled 25L2-352D and 25L2-353D, are present in the existing channel, both of which remain partially filled with standing water. Erosion has been observed around these outlet pipes. Moving downstream, the west side of the channel features gabions that appear to be bulging, while the east side contains a retaining wall that remains in fair condition, except for localized undermining at the wall's end. The channel bottom near the retaining wall and gabion wall previously featured gabions, but high-water velocities have caused erosion of these structures.

At the point where the retaining wall is undermined, there is a drop of approximately two feet in the channel, with standing water present. Further downstream, additional erosion is evident on the side slopes of the channel, where some areas are stabilized with grouted riprap, while others are supported by gabion walls. Multiple outlet pipes discharging into the creek have been observed, with erosion around these pipes indicating a need for maintenance.

In the vicinity of 8 Heather Drive, a wall located in the backyard is in close proximity to the house. This 10-foot-high wall is in poor condition, with an exposed sanitary sewer main running through it and significant cracking and separation along its length. Sections of the wall will require inspection and replacement due to its deteriorated state. Immediately following this wall, the gabion structure adjacent to the house's driveway appears to be leaning. Further downstream, near the box culvert, another sanitary main line crosses the creek, with portions exposed and in need of maintenance. At this crossing, the channel features a one-foot drop. The box culvert itself has been inspected, and exposed rebar was found on the top surface.

The proposed stream bank treatments include bio-gabions to reduce velocities compared to those of a concrete-lined channel. The channel would be graded to a depth to convey the 15-year storm while preserving existing trees adjacent to the channel. Existing walls will be replaced with bio-gabions, and the existing degree of meandering of the channel will be preserved, which will help reduce velocities. Additional plantings
