STORMWATER REPORT

CRESTWOOD STORMWATER

MASTER PLAN

CRESTWOOD, MISSOURI 63126

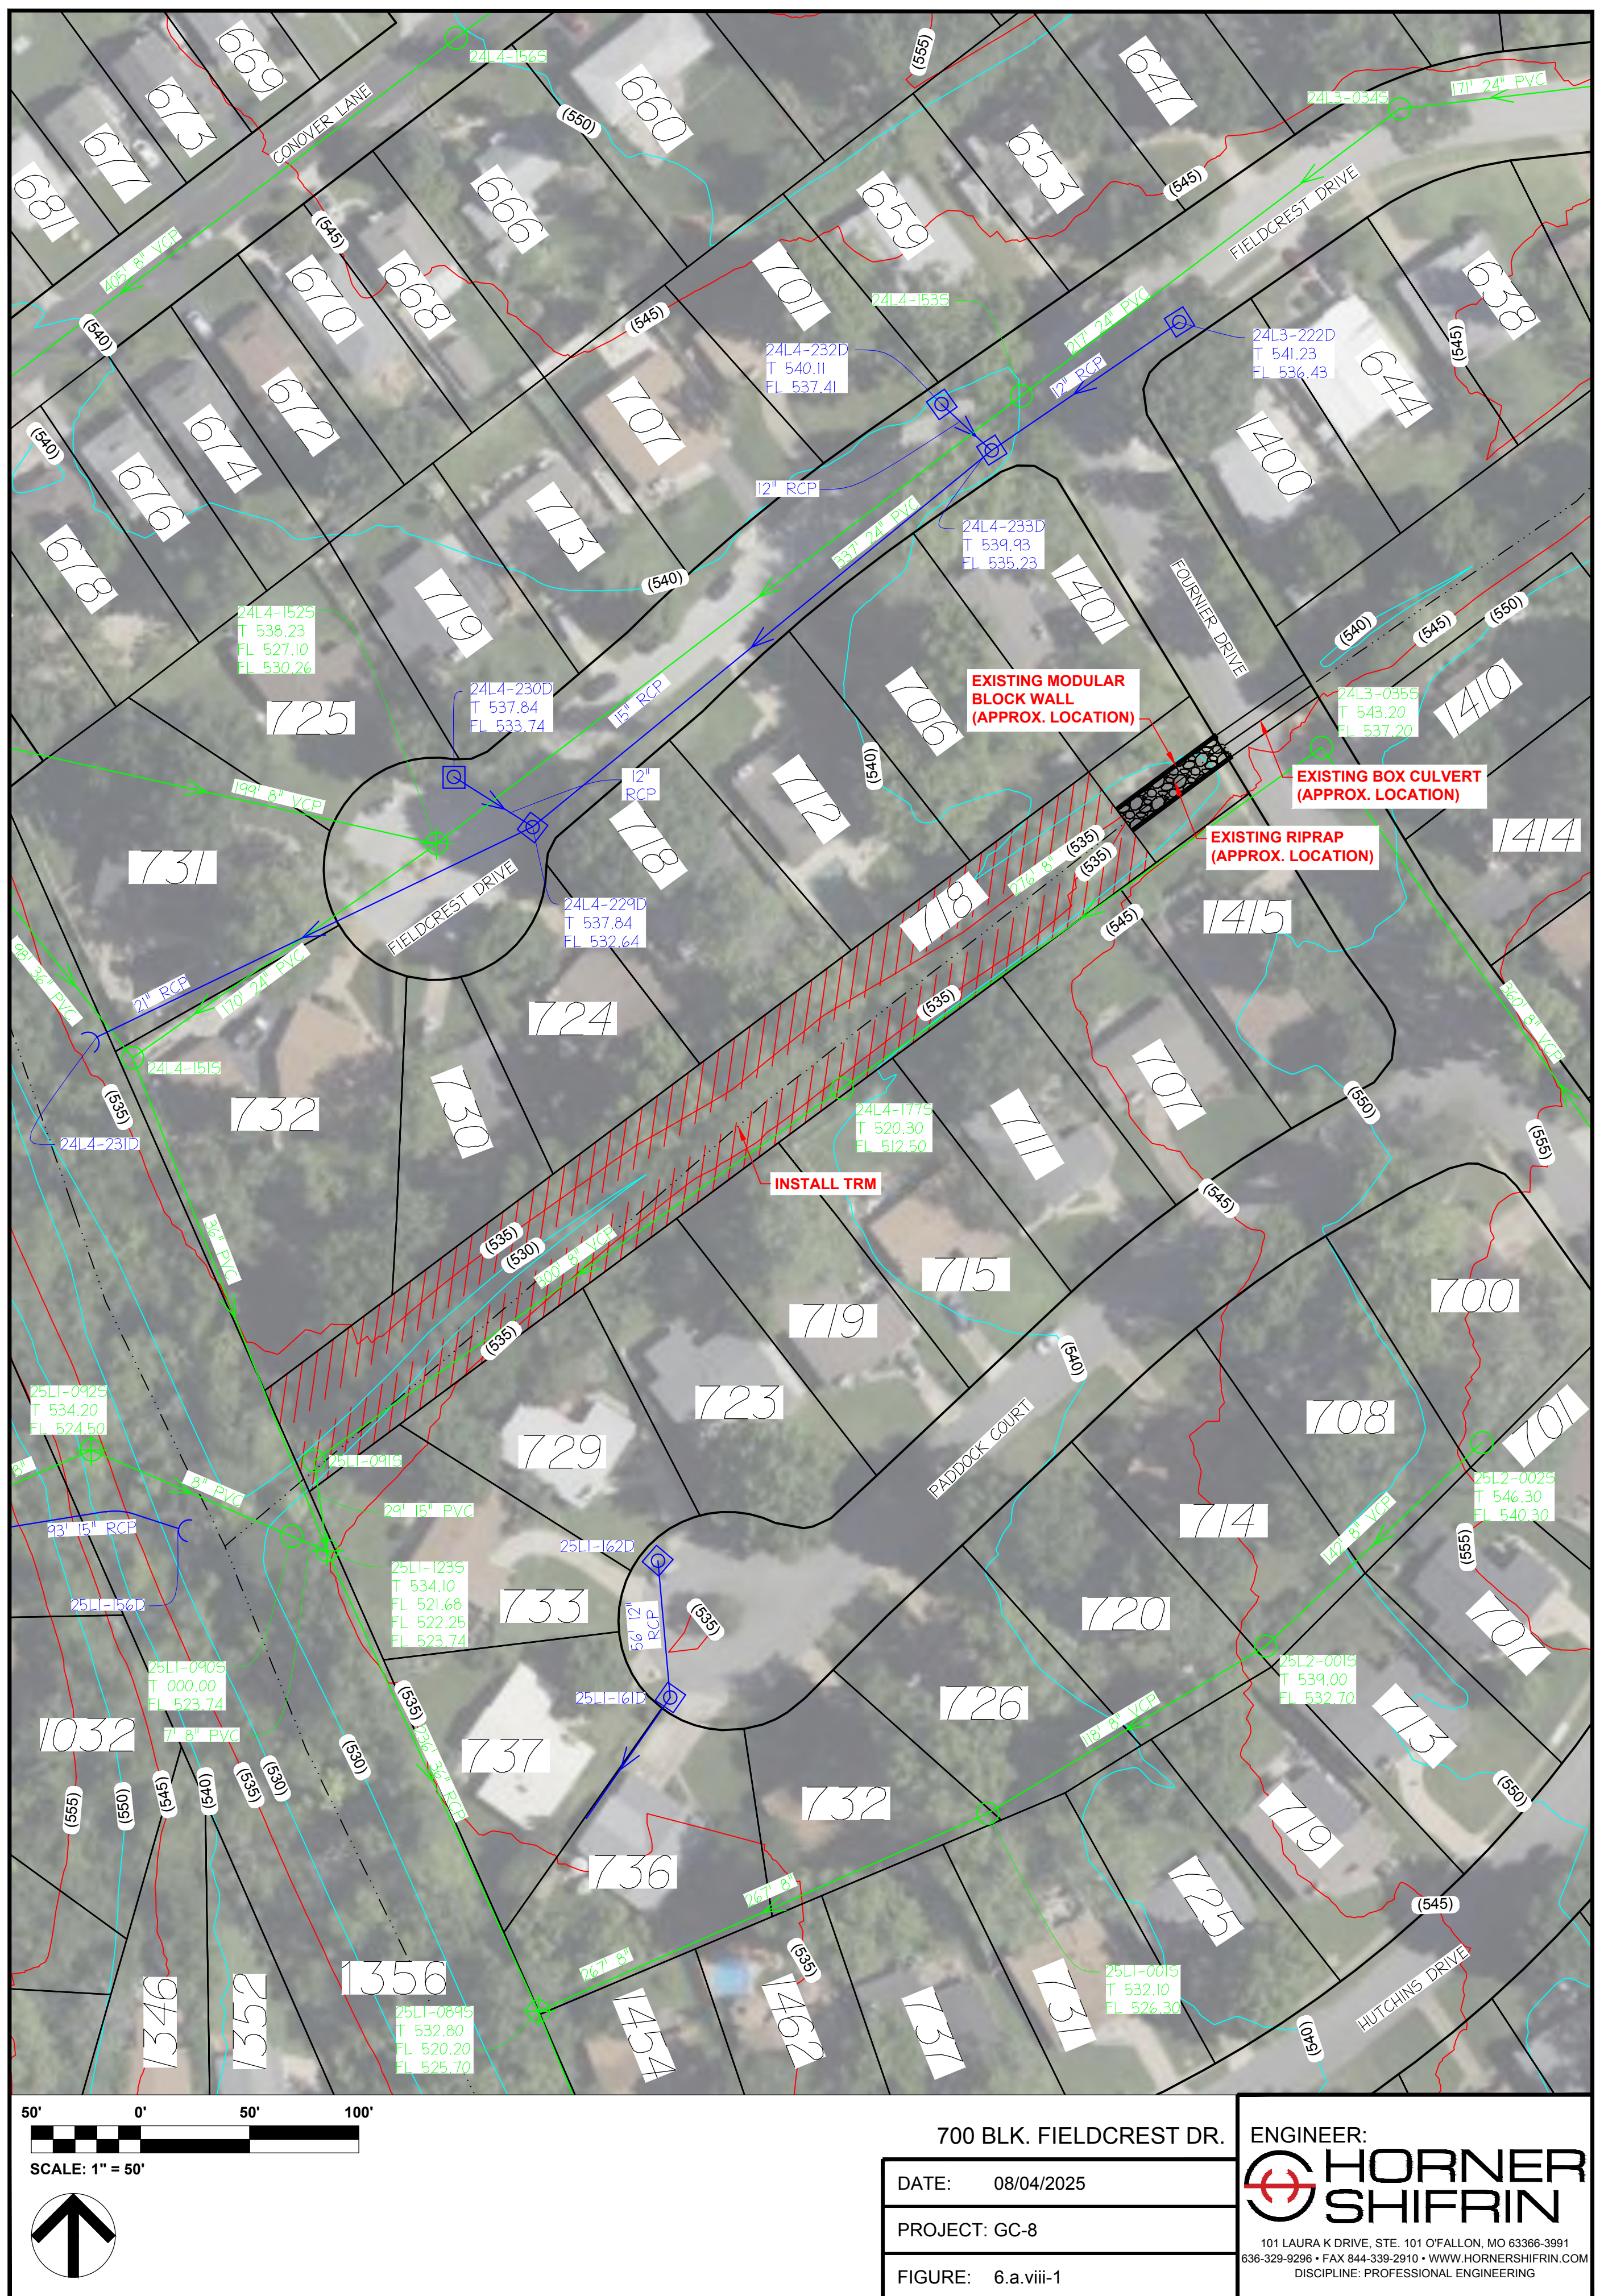
Figure 6.a.viii-2 700 Block Fieldcrest Drive

Based on the site visit conducted by Horner & Shifrin, it appears that the existing box culvert on Fournier Drive was recently constructed, as older reports indicate the original design called for a twin 48-inch RCP configuration. The installed box culvert consists of a double box design with dimensions of six feet by four feet. The outlet pipe of the box culvert requires maintenance, specifically the addition of riprap to address erosion control concerns. Downstream of the box culvert, the channel is generally in acceptable condition. It is likely that the culvert upsizing has mitigated previous erosion issues within the channel. While some cleaning and minor maintenance of the channel will be necessary, no significant problems were observed with the current state of the channel. The estimated probable project cost is \$69,000.

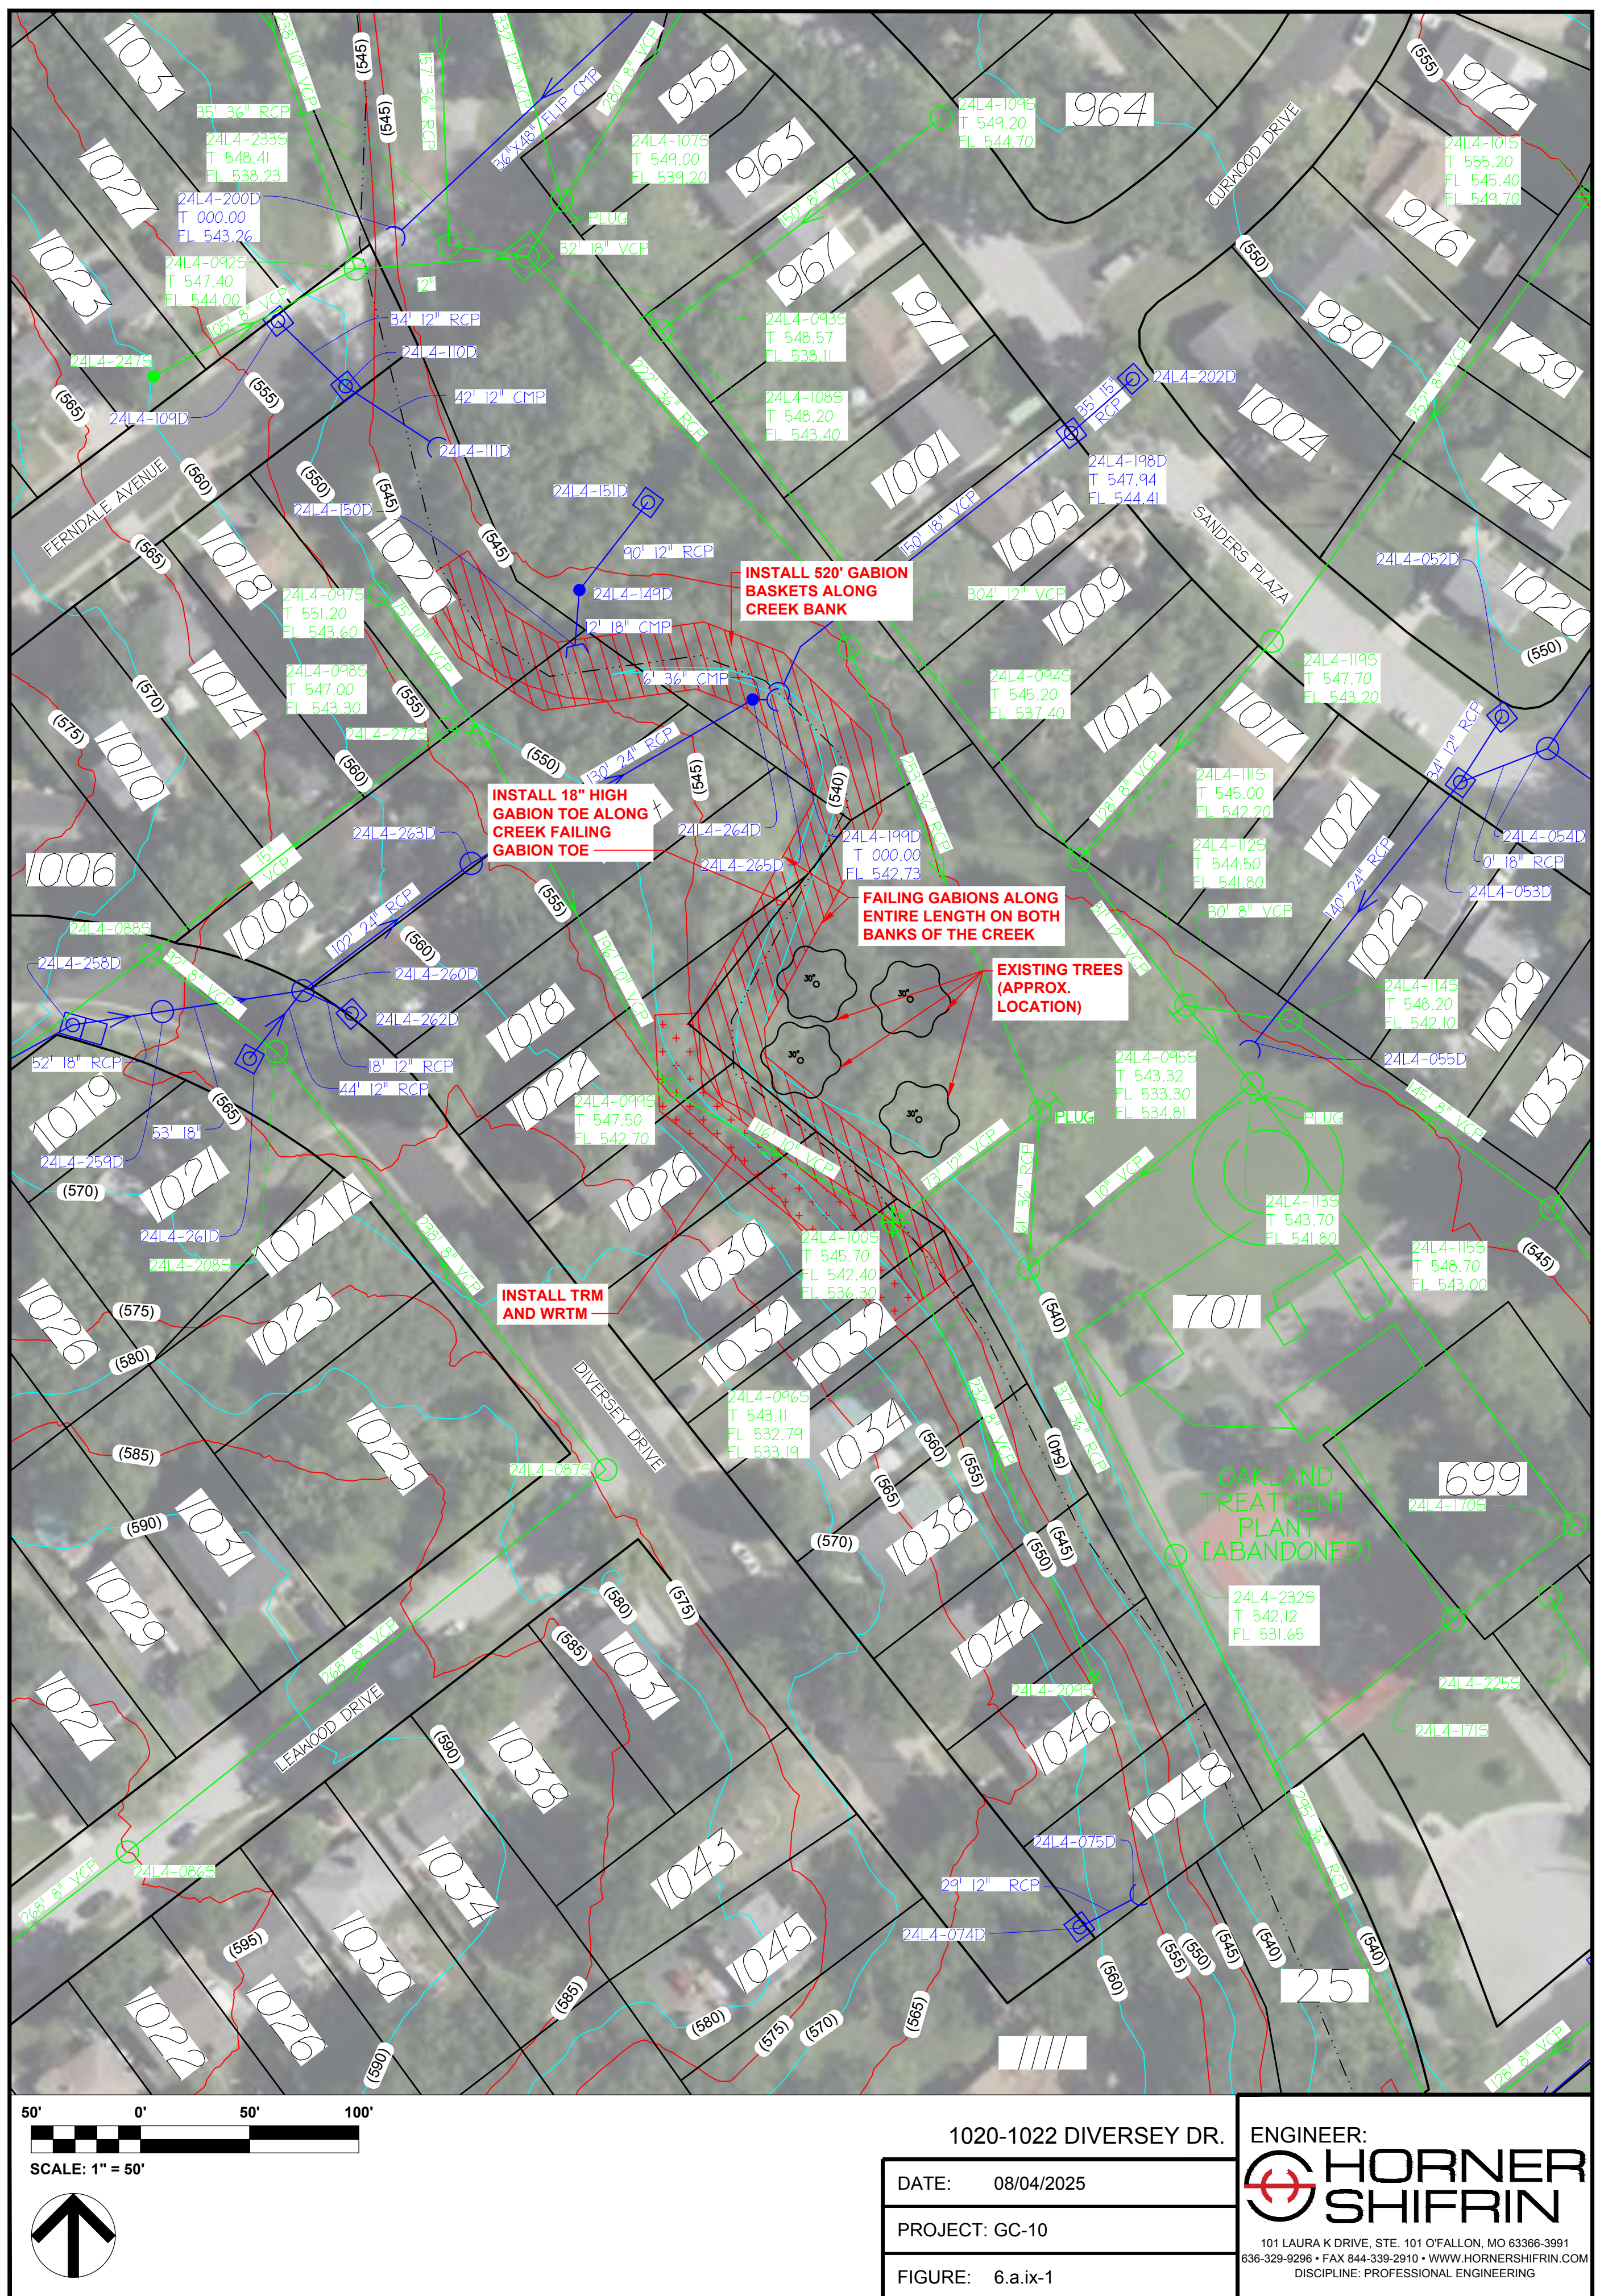
Figure 6.a.ix-2 1020-1022 Diversey Drive

A site investigation was conducted to assess the condition of the gabion walls along approximately 520 linear feet of creek channel. The gabion structures in this area were originally installed to provide bank stabilization and erosion control. Upon inspection, it was noted that the lower tier of gabion baskets is experiencing widespread corrosion. The steel wire mesh used in the construction of these baskets has deteriorated significantly, leading to the failure of the basket foundations. Additionally, multiple sections of the wall are visibly leaning, indicating potential undermining of the structural base and loss of lateral support. A critical failure has occurred in a 40-foot segment within this reach, where the entire gabion wall has collapsed. The failure is attributed primarily to increased hydraulic loading and erosion at the base of the wall, likely caused by high creek flows during storm events.

The failure of the gabion wall system can be attributed to a combination of long-term corrosion of the basket wire, inadequate foundation protection, and increased hydraulic forces. The lack of protective coatings on the wire baskets has accelerated deterioration, especially in an environment with high moisture and flow variability. The current structural integrity of the remaining gabion walls is compromised, and without intervention, additional segments are at risk of collapse. Hydraulic analysis is warranted to determine whether upstream development or changes in watershed hydrology have contributed to increased flow velocities or volumes. Such changes may exacerbate erosion at the toe of the bank, leading to undermining and structural instability.

The recommended approach to the full replacement of the existing gabion walls involves the implementation of streambank bio stabilization techniques. This method entails the removal of the deteriorated gabion baskets and the installation of bio-gabions, designed to provide both structural support and ecological benefits. To ensure long-term stabilization at the toe of the channel, it is recommended that traditional stone-filled gabions be used as a buried foundation. These would serve as the base of the bio gabion wall system and be constructed in conjunction with a wire Turf Reinforced Mat (TRM). This approach is known to be highly effective when installed on a solid base. The buried gabion toe should ideally be placed at or below the streambed grade, acting as an anchor and reinforcing the streambank toe. However, the feasibility of burying the toe may be limited by site conditions, particularly because the existing gabion wall rests directly on exposed bedrock. In such cases, only the uppermost portion of the toe may be visible during low-flow conditions.

(RPM) trees. All vegetation should be planted at an appropriate time and spacing based on site conditions and species' requirements. Where feasible, the use of engineered soil and soil amendments may be employed to enhance plant survival and growth. Alternative 1 from the original report is the recommended course of action. The estimated probable project cost is approximately \$583,000.

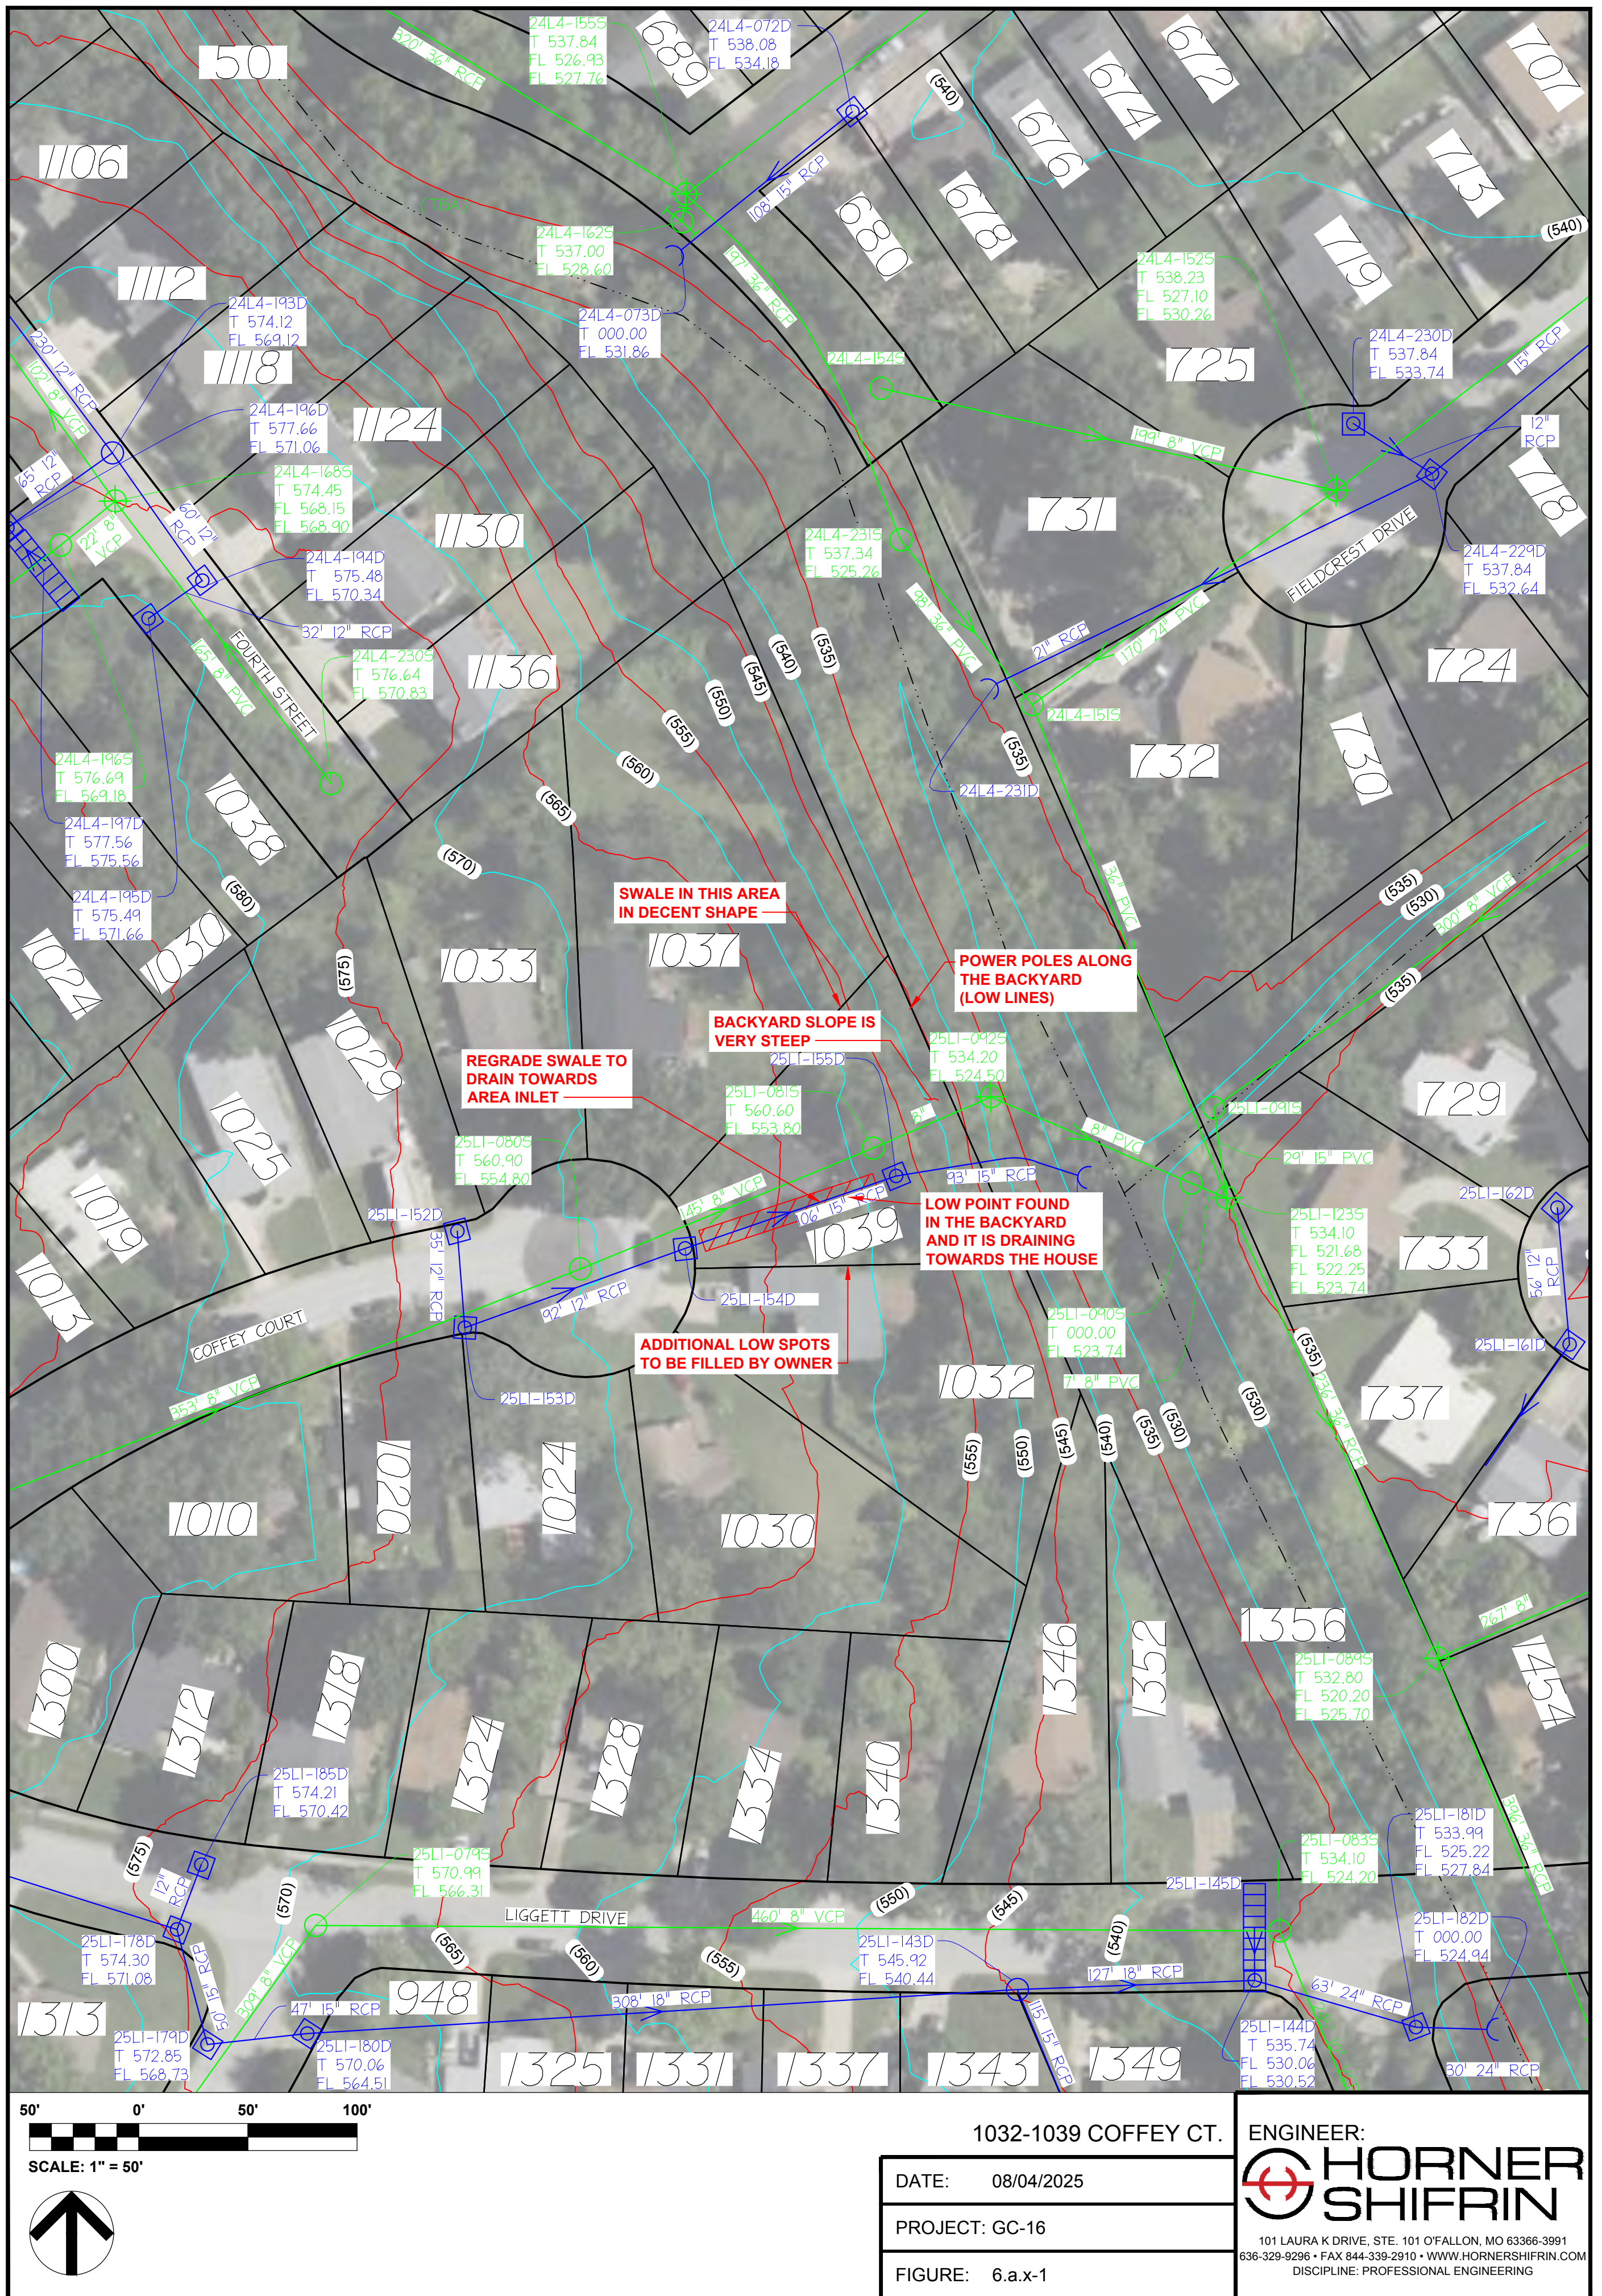
Figure 6.a.x-2 1032-1039 Coffey Court

A field visit was performed on the properties of 1037 and 1039 Coffey Court that showed drainage issues on the side yards. The side yard issue involves poor drainage that is directing the stormwater towards the basement of the house located at 1032 Coffey Court. An area inlet is located in between the lots of 1032 and 1039 Coffey Court. The area inlet is functioning properly, but the surrounding area will need to be maintained. Upstream of the area inlet is where the drainage issue occurs. A low point is located just upstream of the area inlet and the low point drains towards the house basement. The swale is not graded properly to direct stormwater away from the house. Another concern was found in the rear yard of lot 1039 Coffey Court. The grade on the rear yard is very steep and should be monitored just to make sure the slope does not fail. From the field visit, the slope seems to be in good condition, but it would be beneficial for the city and the homeowner to monitor the slope.

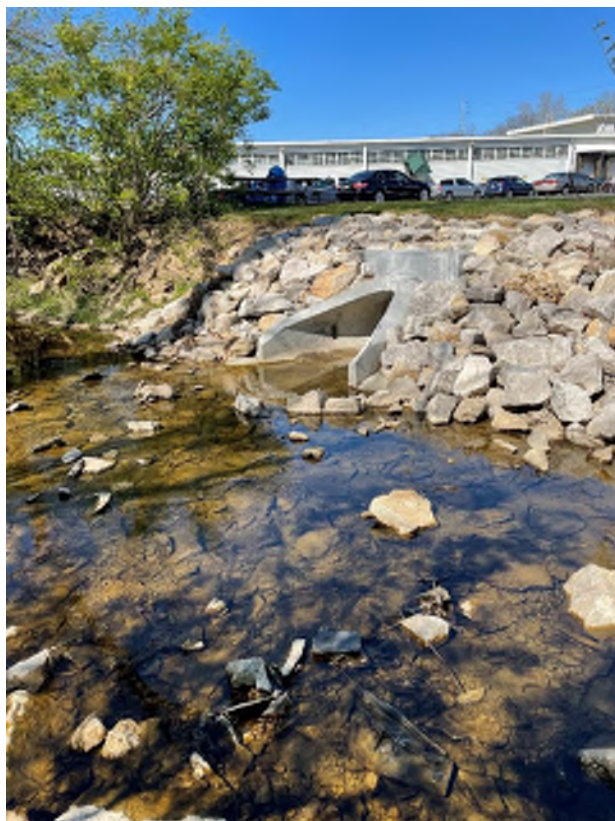
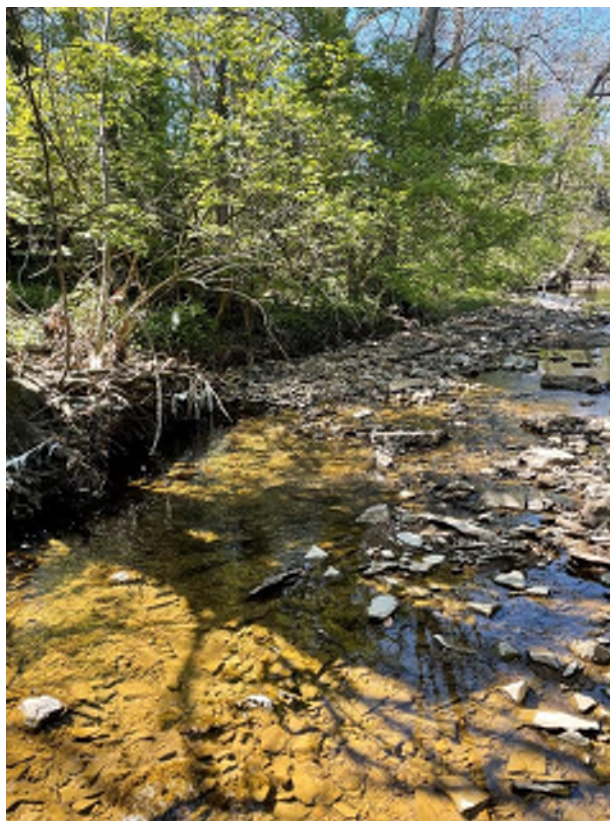
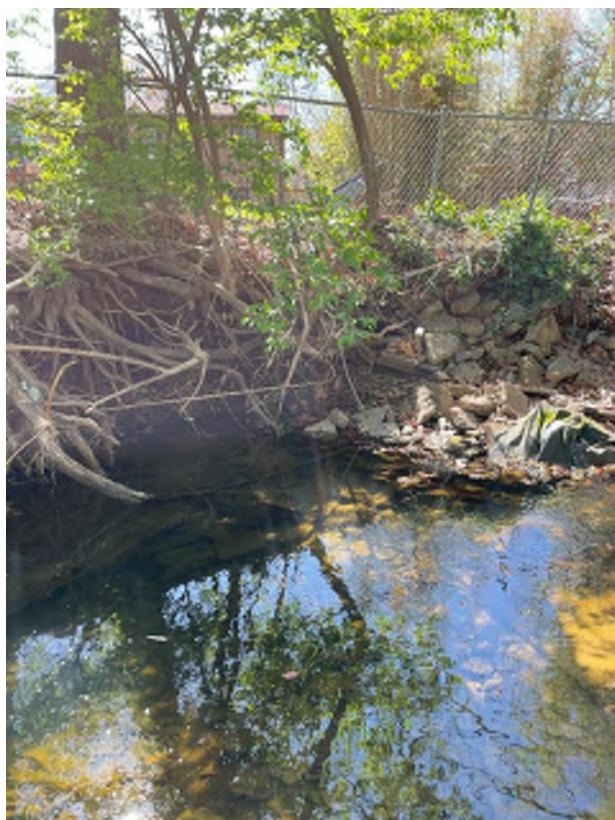
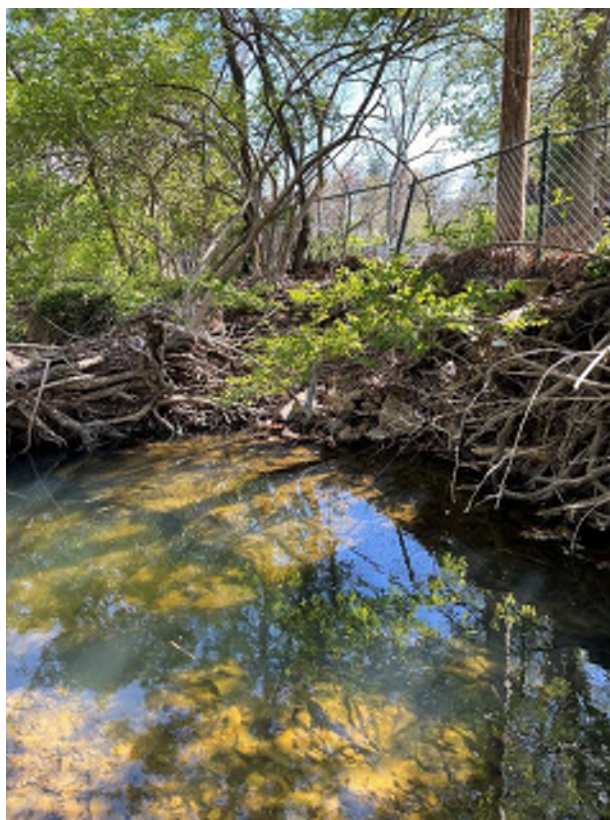
Figure 6.b.ii-2 1000-1028 Banyon Drive

Erosion along the banks of Kirkwood Creek is threatening fences and utilities along the rear yards between 1000 and 1028 Banyon Drive.

To enhance channel stability and prevent erosion, the installation of a buried rock gabion toe is recommended. Stone-filled gabions, when placed on a properly prepared and compacted subgrade, provide a durable and resilient solution for toe stabilization, particularly when integrated with a Wire Turf Reinforcement Mat (WTRM). The gabion structure should be embedded at or slightly below the streambed elevation to function as structural reinforcement for the streambank toe.

The bank slope above the gabion should be regraded and transitioned smoothly from the top of the gabion to the bank crest, with WTRMs installed over these regraded slopes to provide long-term erosion protection. Alternative 1 from the original report is the recommended course of action. The estimated probable project cost is approximately \$257,000.
