STORMWATER REPORT

CRESTWOOD STORMWATER

MASTER PLAN

CRESTWOOD, MISSOURI 63126

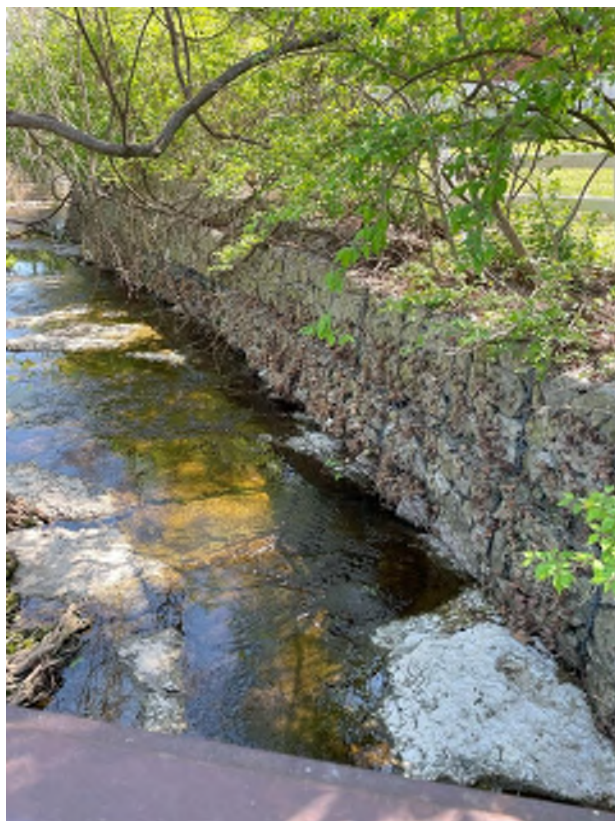
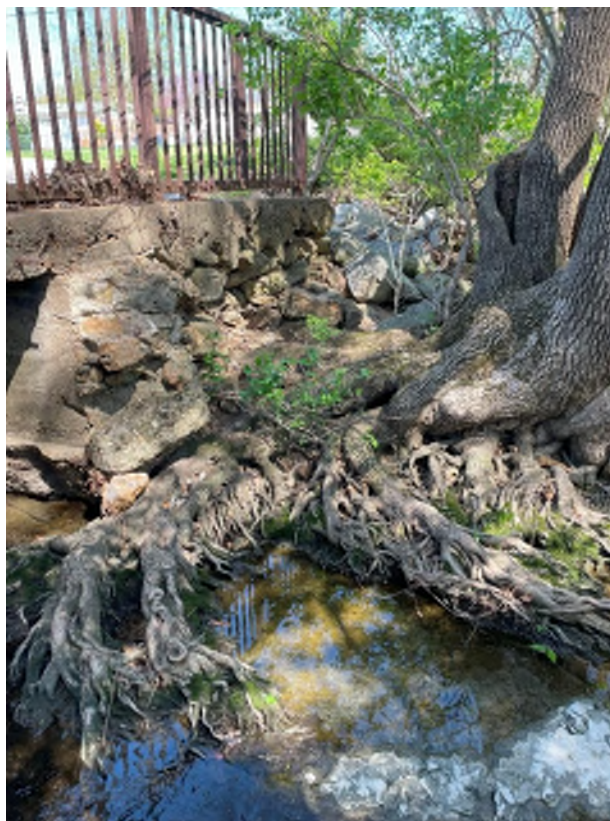
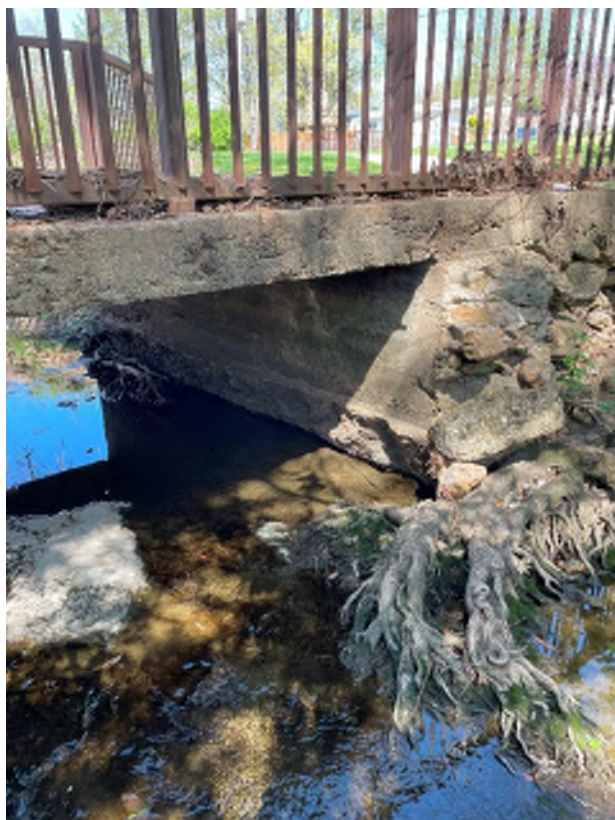
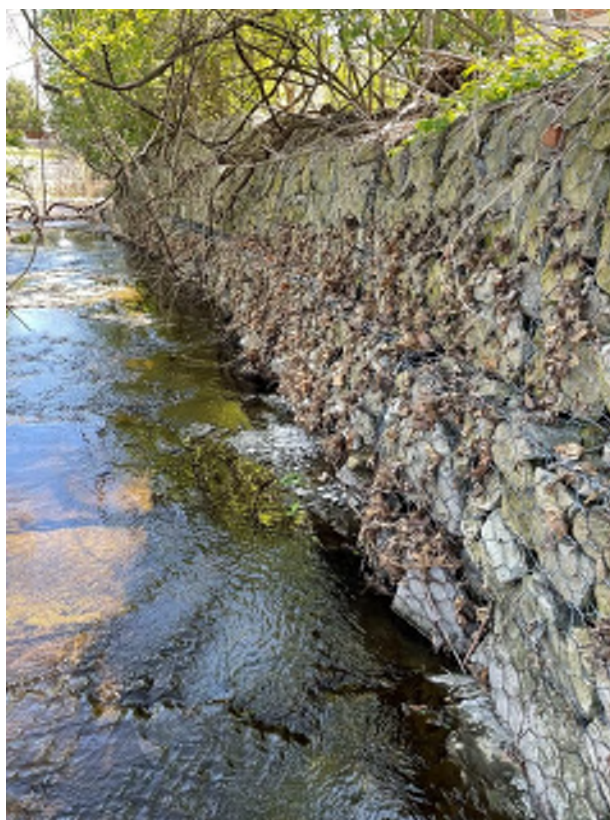
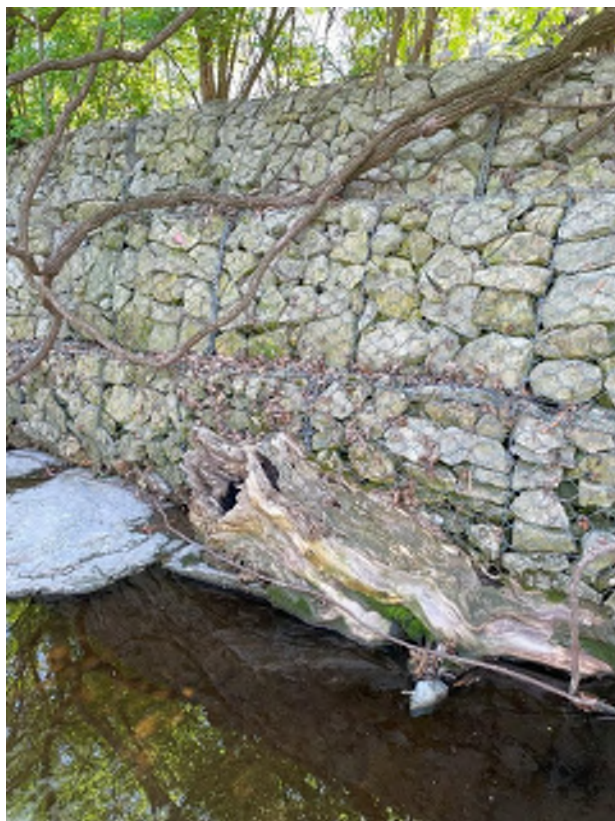
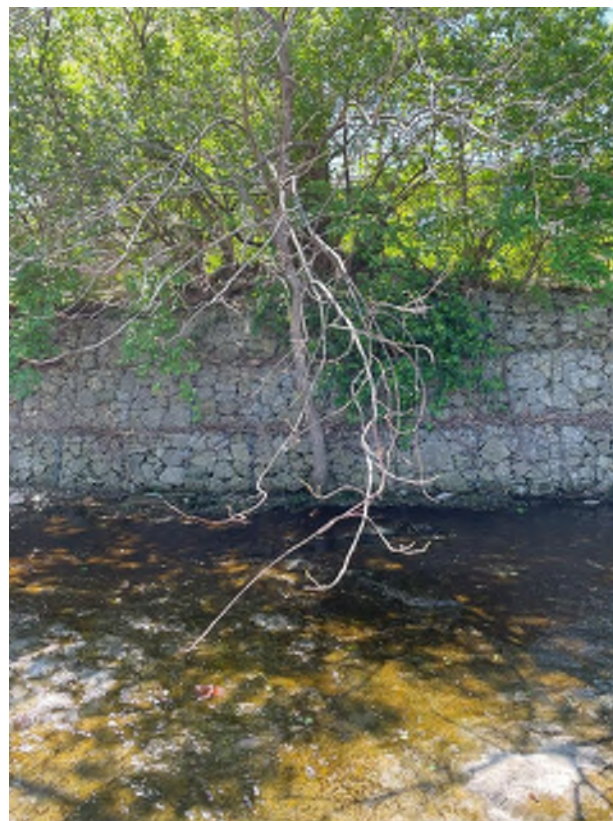
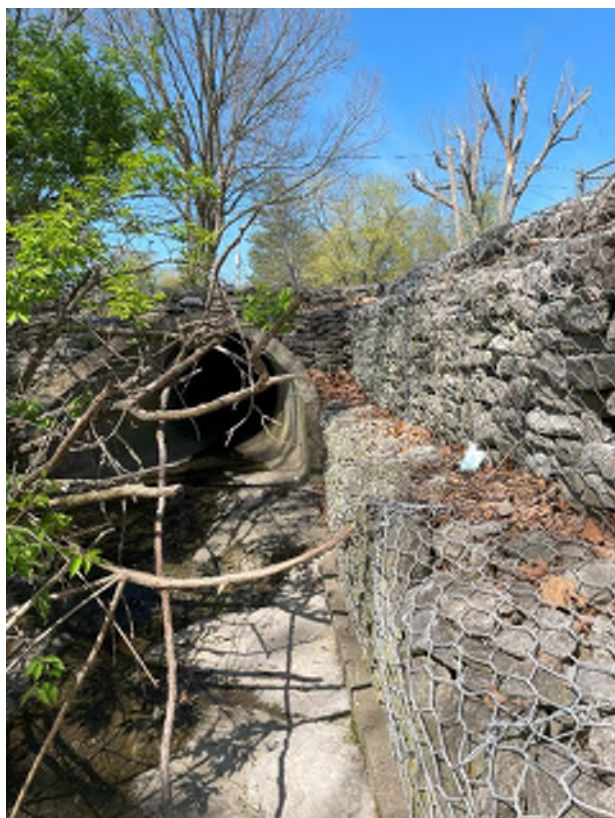
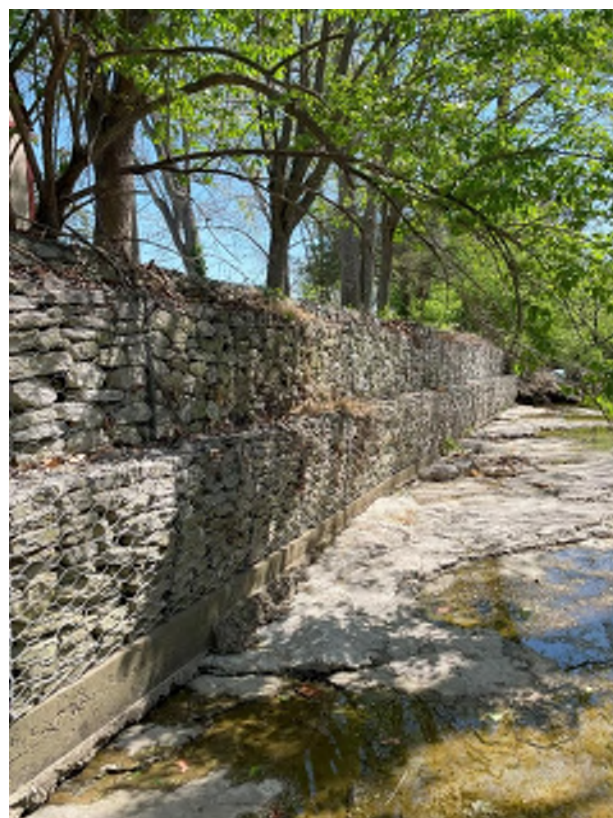
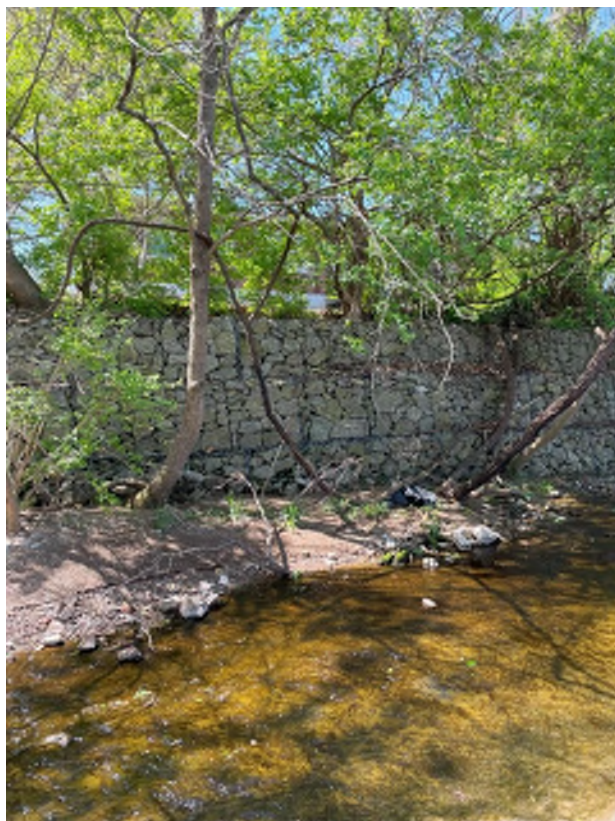
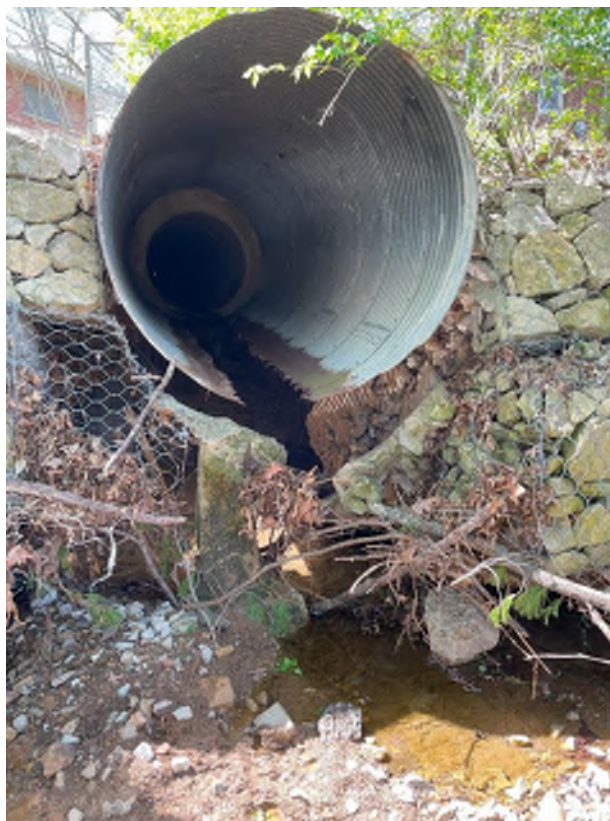
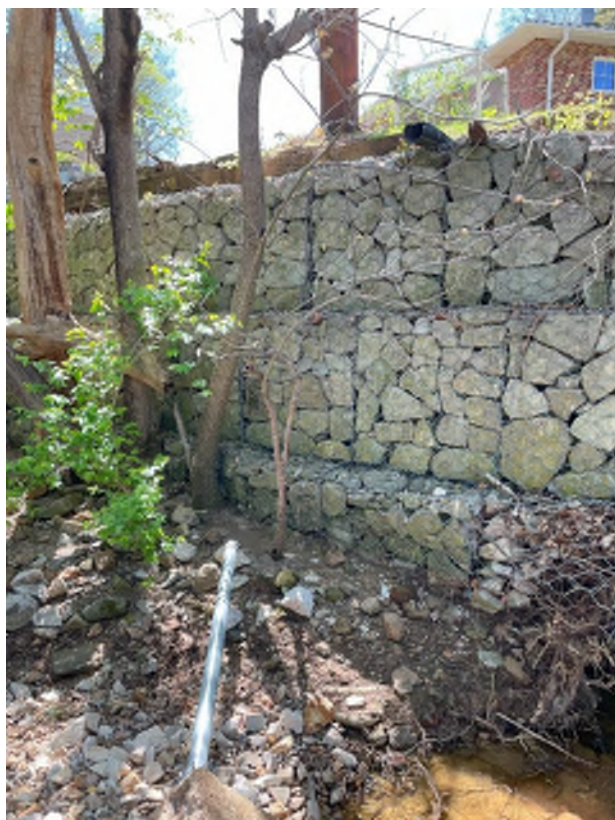
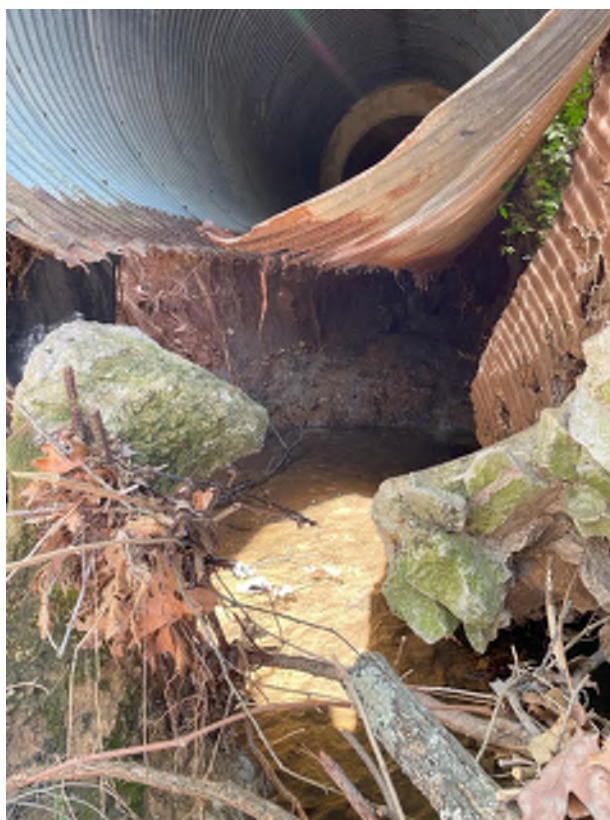
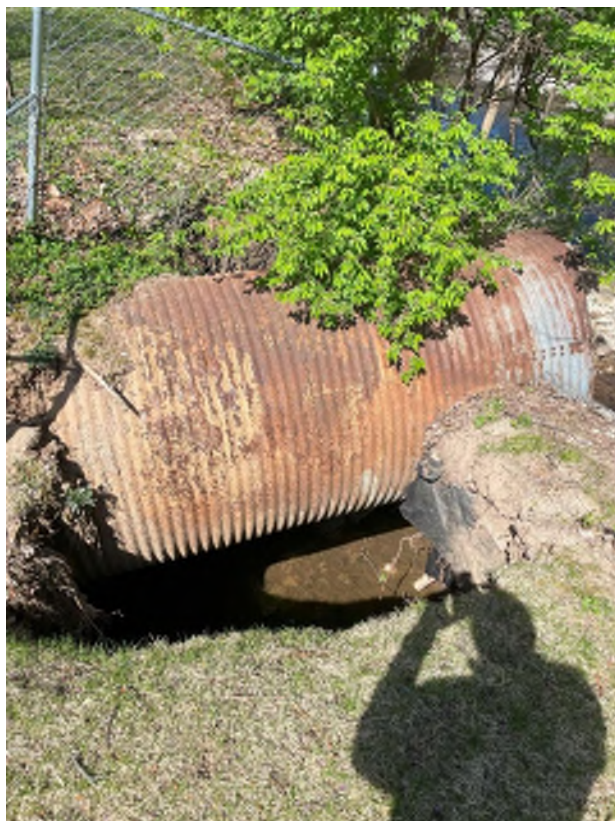
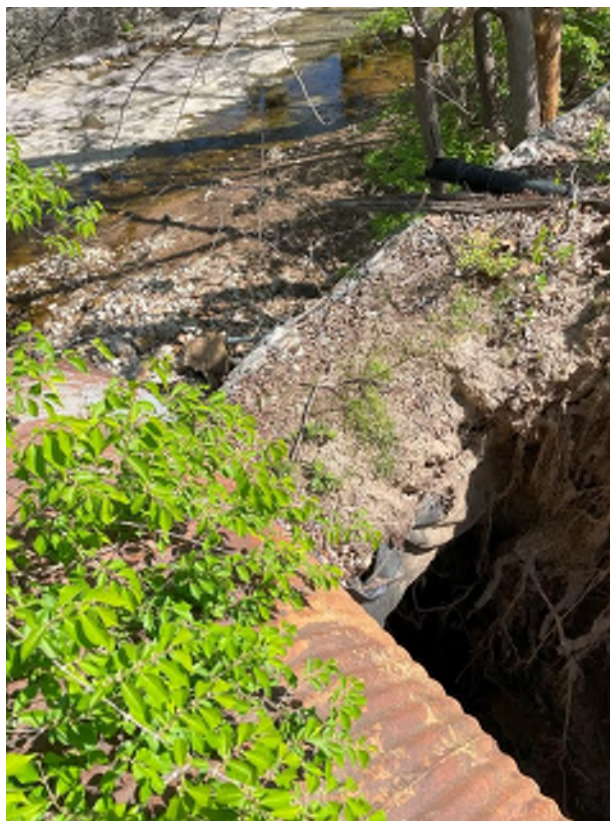
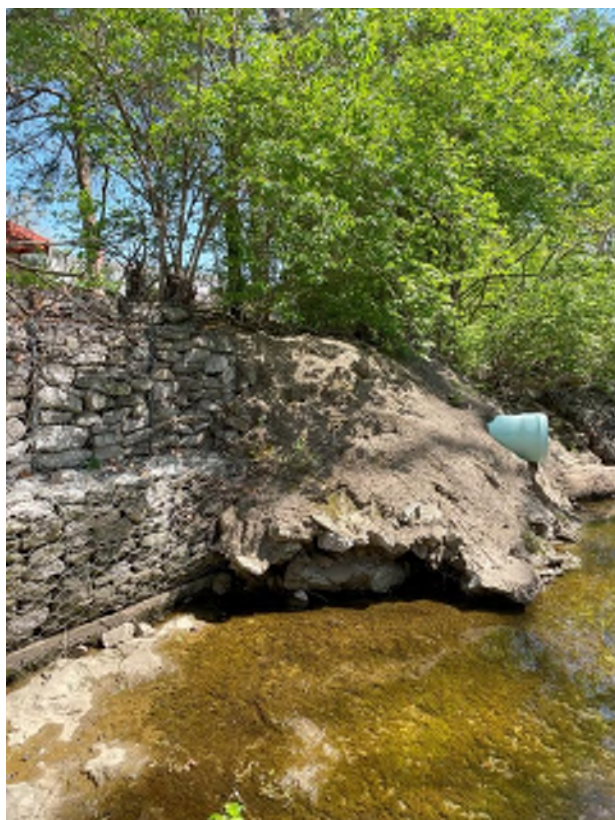
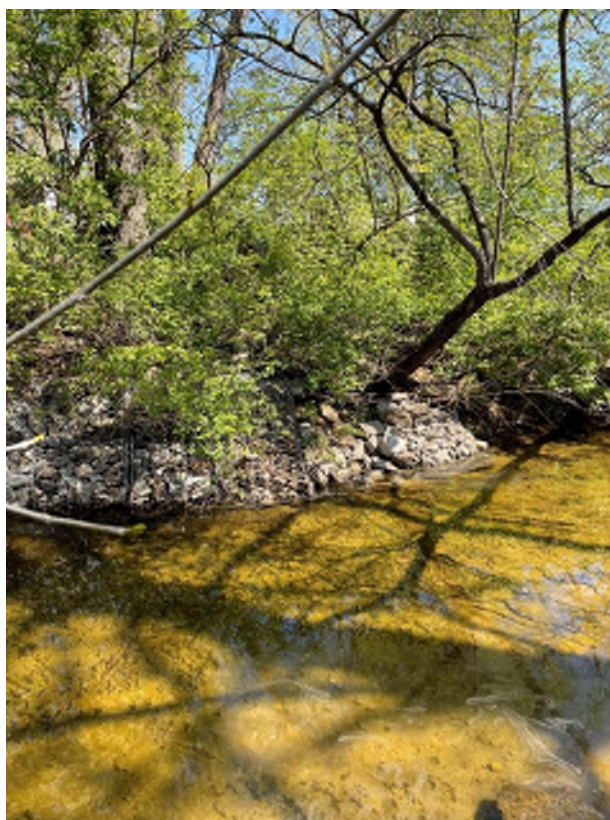
Figure 6.c.ii-2 9600 Block Yorkshire Estates Drive

An inspection was conducted beginning at 9648 Yorkshire Estates Drive, where gabion walls were identified along the south side of the creek. The base of these structures is exhibiting significant corrosion, resulting in the failure of the gabion basket foundations. Additionally, several sections of the gabions are bulging, which appear to be attributable to the presence of nearby trees. In at least one location, tree roots have penetrated the gabion structure, further compromising its integrity.

Progressing downstream within the channel, an outlet pipe labeled 26L1-213D was located. The gabions in this vicinity are in generally good condition and will require only routine maintenance. However, another outlet pipe, labeled 26L1-053D, was found to be in poor condition. A substantial sinkhole, approximately eight feet in depth, was observed at this location. This sinkhole is contributing to increased erosion in the area. The Corrugated Metal Pipe (CMP) connected to the Reinforced Concrete Pipe (RCP) has deteriorated due to erosion and will need to be replaced in conjunction with the sinkhole repair to mitigate future reoccurrence.

Further along the south side of the creek, additional gabion walls were noted to exhibit similar deficiencies as those upstream, primarily involving failure of the lower layers. In contrast, gabion walls along the north side of the creek were observed to be in stable condition.

On the north side, a third outlet pipe, identified as 26L1-016D, was found with grouted riprap installed around the outlet. The riprap is experiencing undermining and will require replacement to ensure long-term stability and prevent potential failure.

At 9628 Yorkshire Estates Drive, a block retaining wall located in the backyard is in poor condition and must be removed. The existing wall has been extended by the property owners using additional blocks, which are also failing. An adjacent gabion wall on the same property is leaning and will require replacement. A tree positioned directly atop this wall is exacerbating the structural instability.

Further downstream, additional gabion structures were found in substandard conditions, with numerous sections missing or exhibiting failure of the bottom layer.

Inspections of properties located at 9616 and 9620 Yorkshire Estates Drive revealed that the residences are situated at a lower elevation relative to the top of the box culvert labeled 26L1-037D. A hydraulic analysis will be necessary to determine whether the existing culvert has adequate capacity to convey the 100-year storm event. A potential mitigation measure includes the installation of a 220-foot-long, four-foot-high floodwall to protect the residential structures from inundation. Additionally, where a concrete swale connects at a bend in the system, signs of undermining were observed, and corrective maintenance will be required at that location.

Approximately 870 linear feet of stream bank and existing gabions should be removed and re-graded using geogrid reinforcement and rolled erosion control products (RECP). The toe of the slope within this reach generally consists of exposed bedrock, which contributes to inherent slope stability; however, in segments where bedrock is absent, continued erosive degradation has been observed. These locations will require regrading to stable slope geometries and reinforcement through the establishment of vegetative cover.

The existing eroded CMP outlet structures along the creek are to be replaced with new RCP sections, with each replacement sized according to the corresponding existing CMP dimensions. In conjunction with the pipe replacement, all associated erosion at each outlet location must be remediated to ensure structural stability and long-term functionality of the new RCP installations.

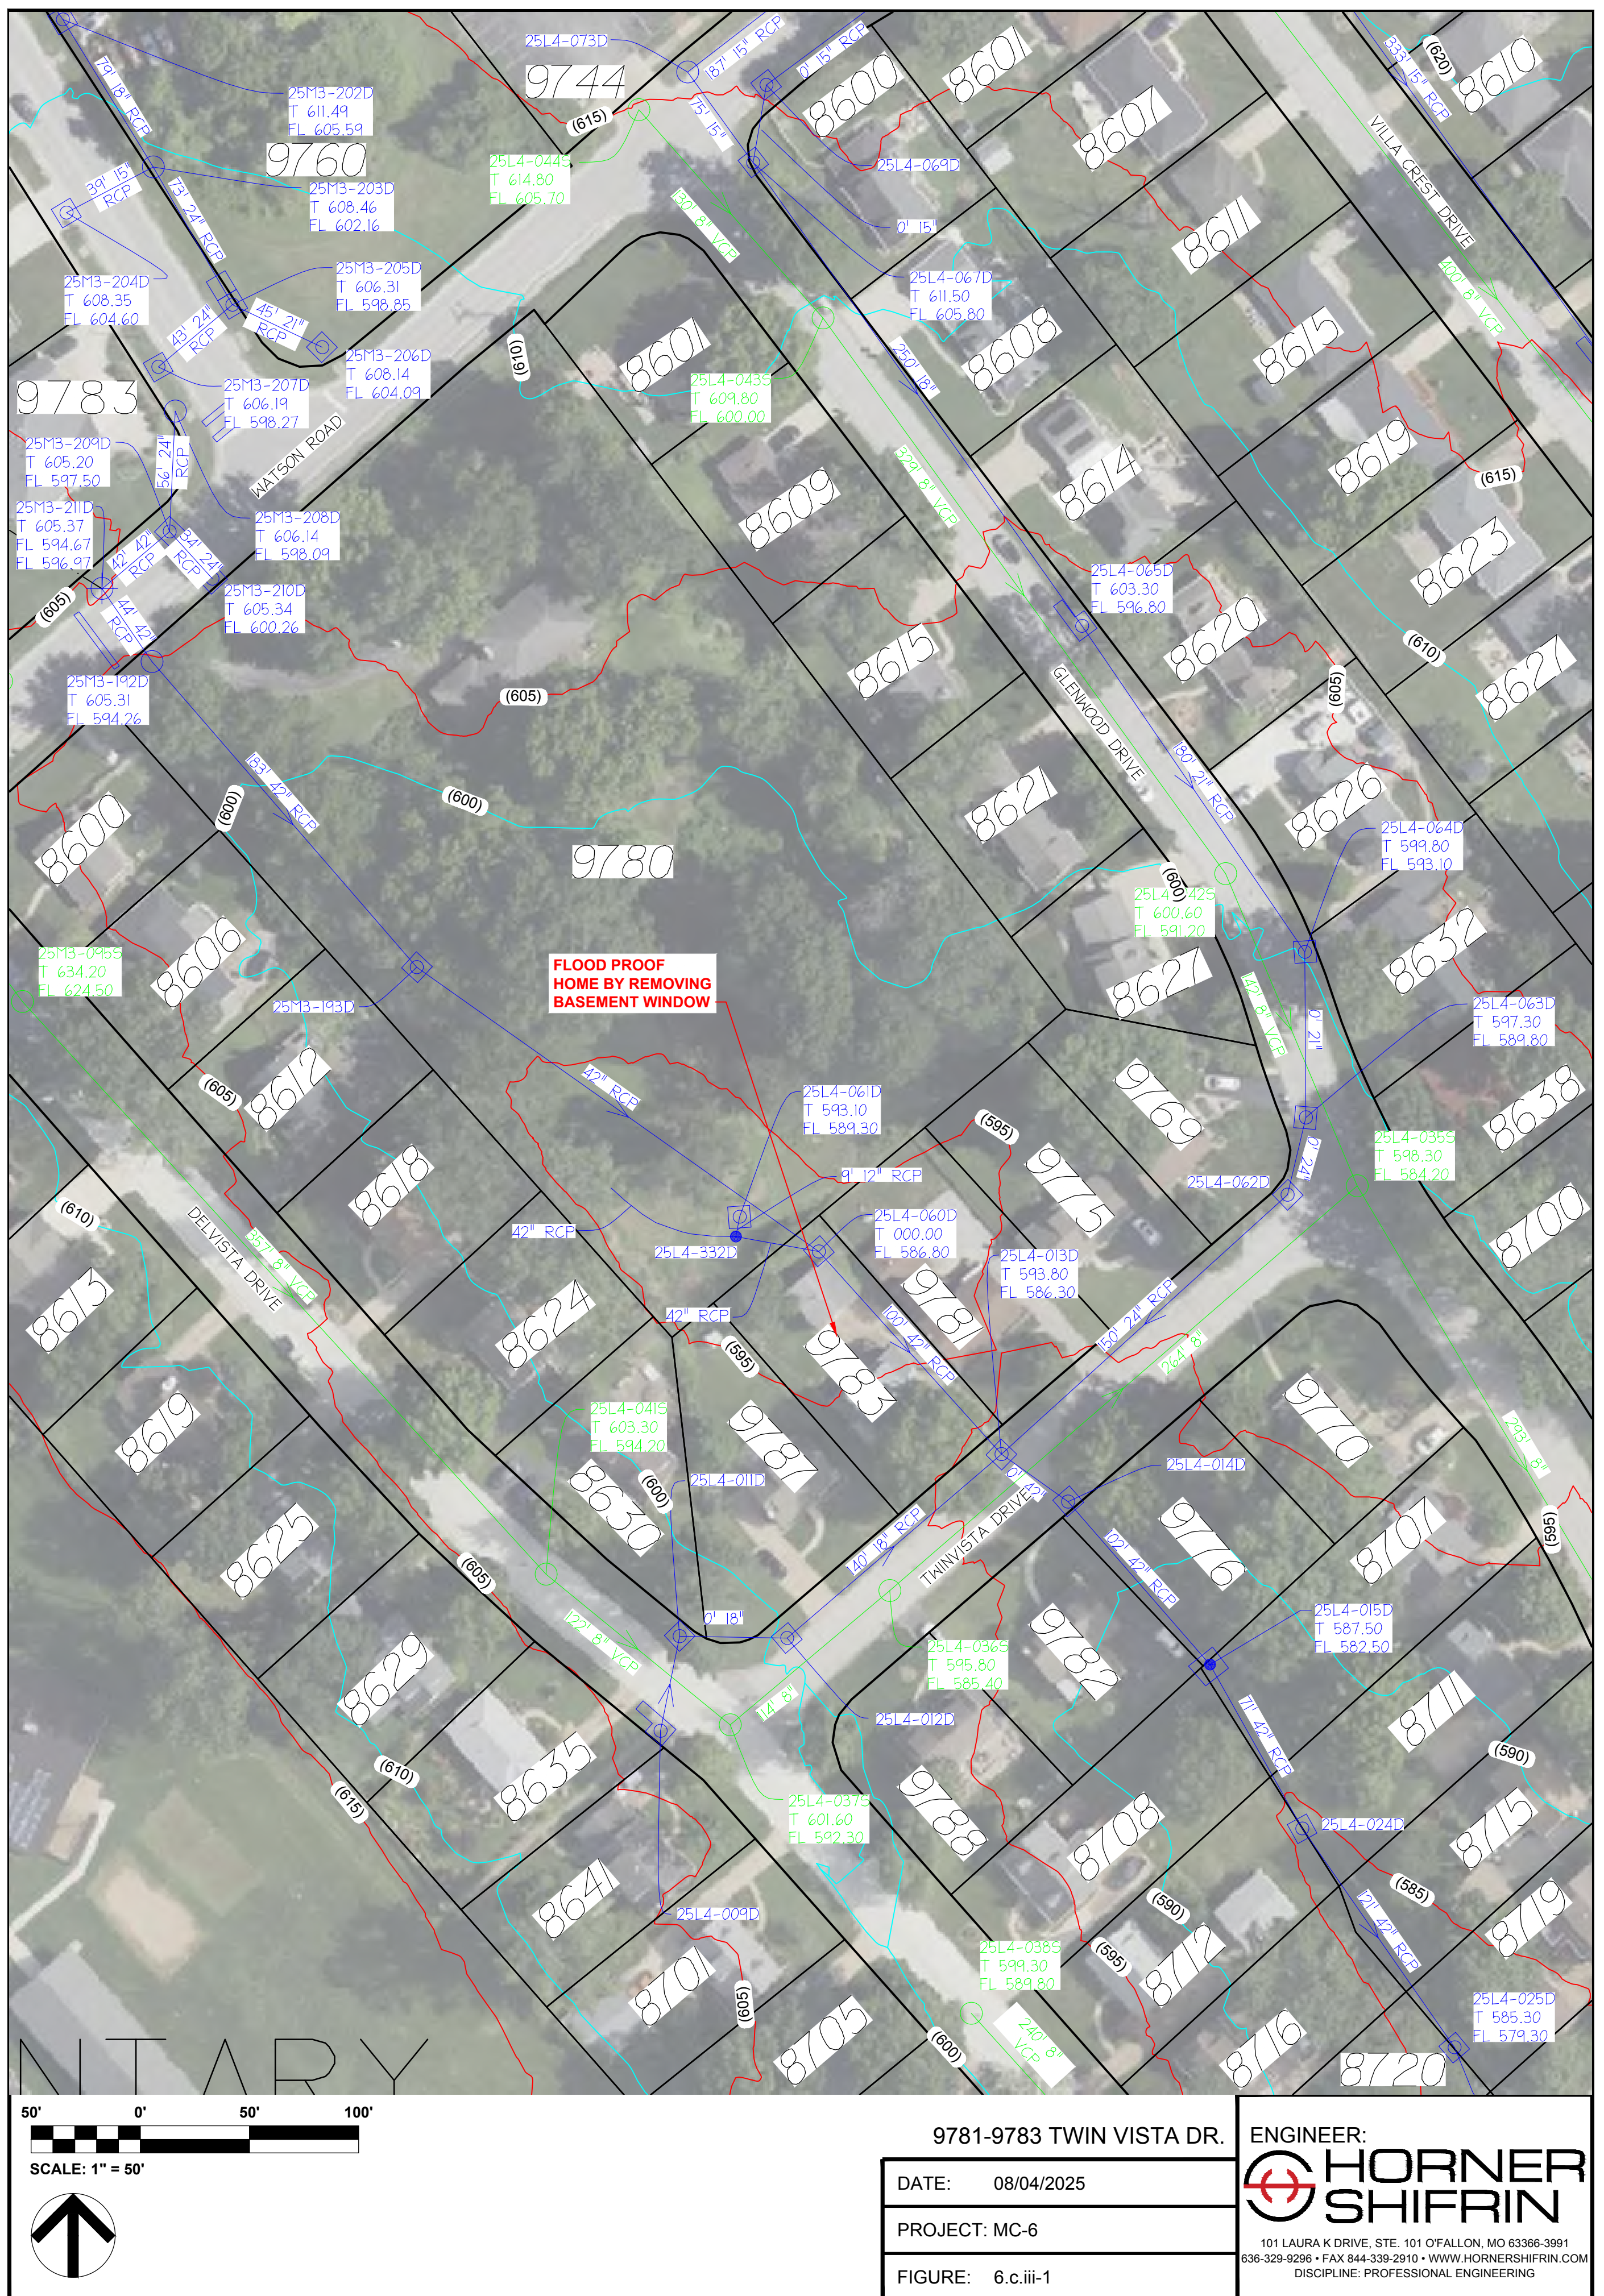
Figure 6.c.iii-2 9781-9783 Twin Vista Drive

Structural flooding is observed between 9781 and 9783 Twin Vista Drive as a result of hydraulic surcharge from area inlets 25L4-060D and 25L4-061D. The absence of an overflow conveyance system prevents the excess runoff from being redirected downstream without encountering structures. Furthermore, the existing 42-inch storm sewer line located between the two properties lacks adequate capacity, worsening the localized flooding conditions during storm events.

The most cost-effective solution to the issue involves implementing comprehensive floodproofing measures for the adjacent garage and residence. This includes sealing or eliminating all low-elevation openings that could permit water intrusion and reinforcing or modifying the building foundations to enhance their resistance to hydrostatic and hydrodynamic flood forces. The concrete to the rear of the structure should also be removed and replaced to provide positive drainage away from the structure. This solution prioritizes floodproofing the affected structure to prevent water intrusion while the area inlet's capacity is exceeded. The existing 42" line, line 25L4-060D, still lacks the capacity to drain the 100-year storm due to the reduced slope through this section. The estimated probable project cost is approximately \$56,400.

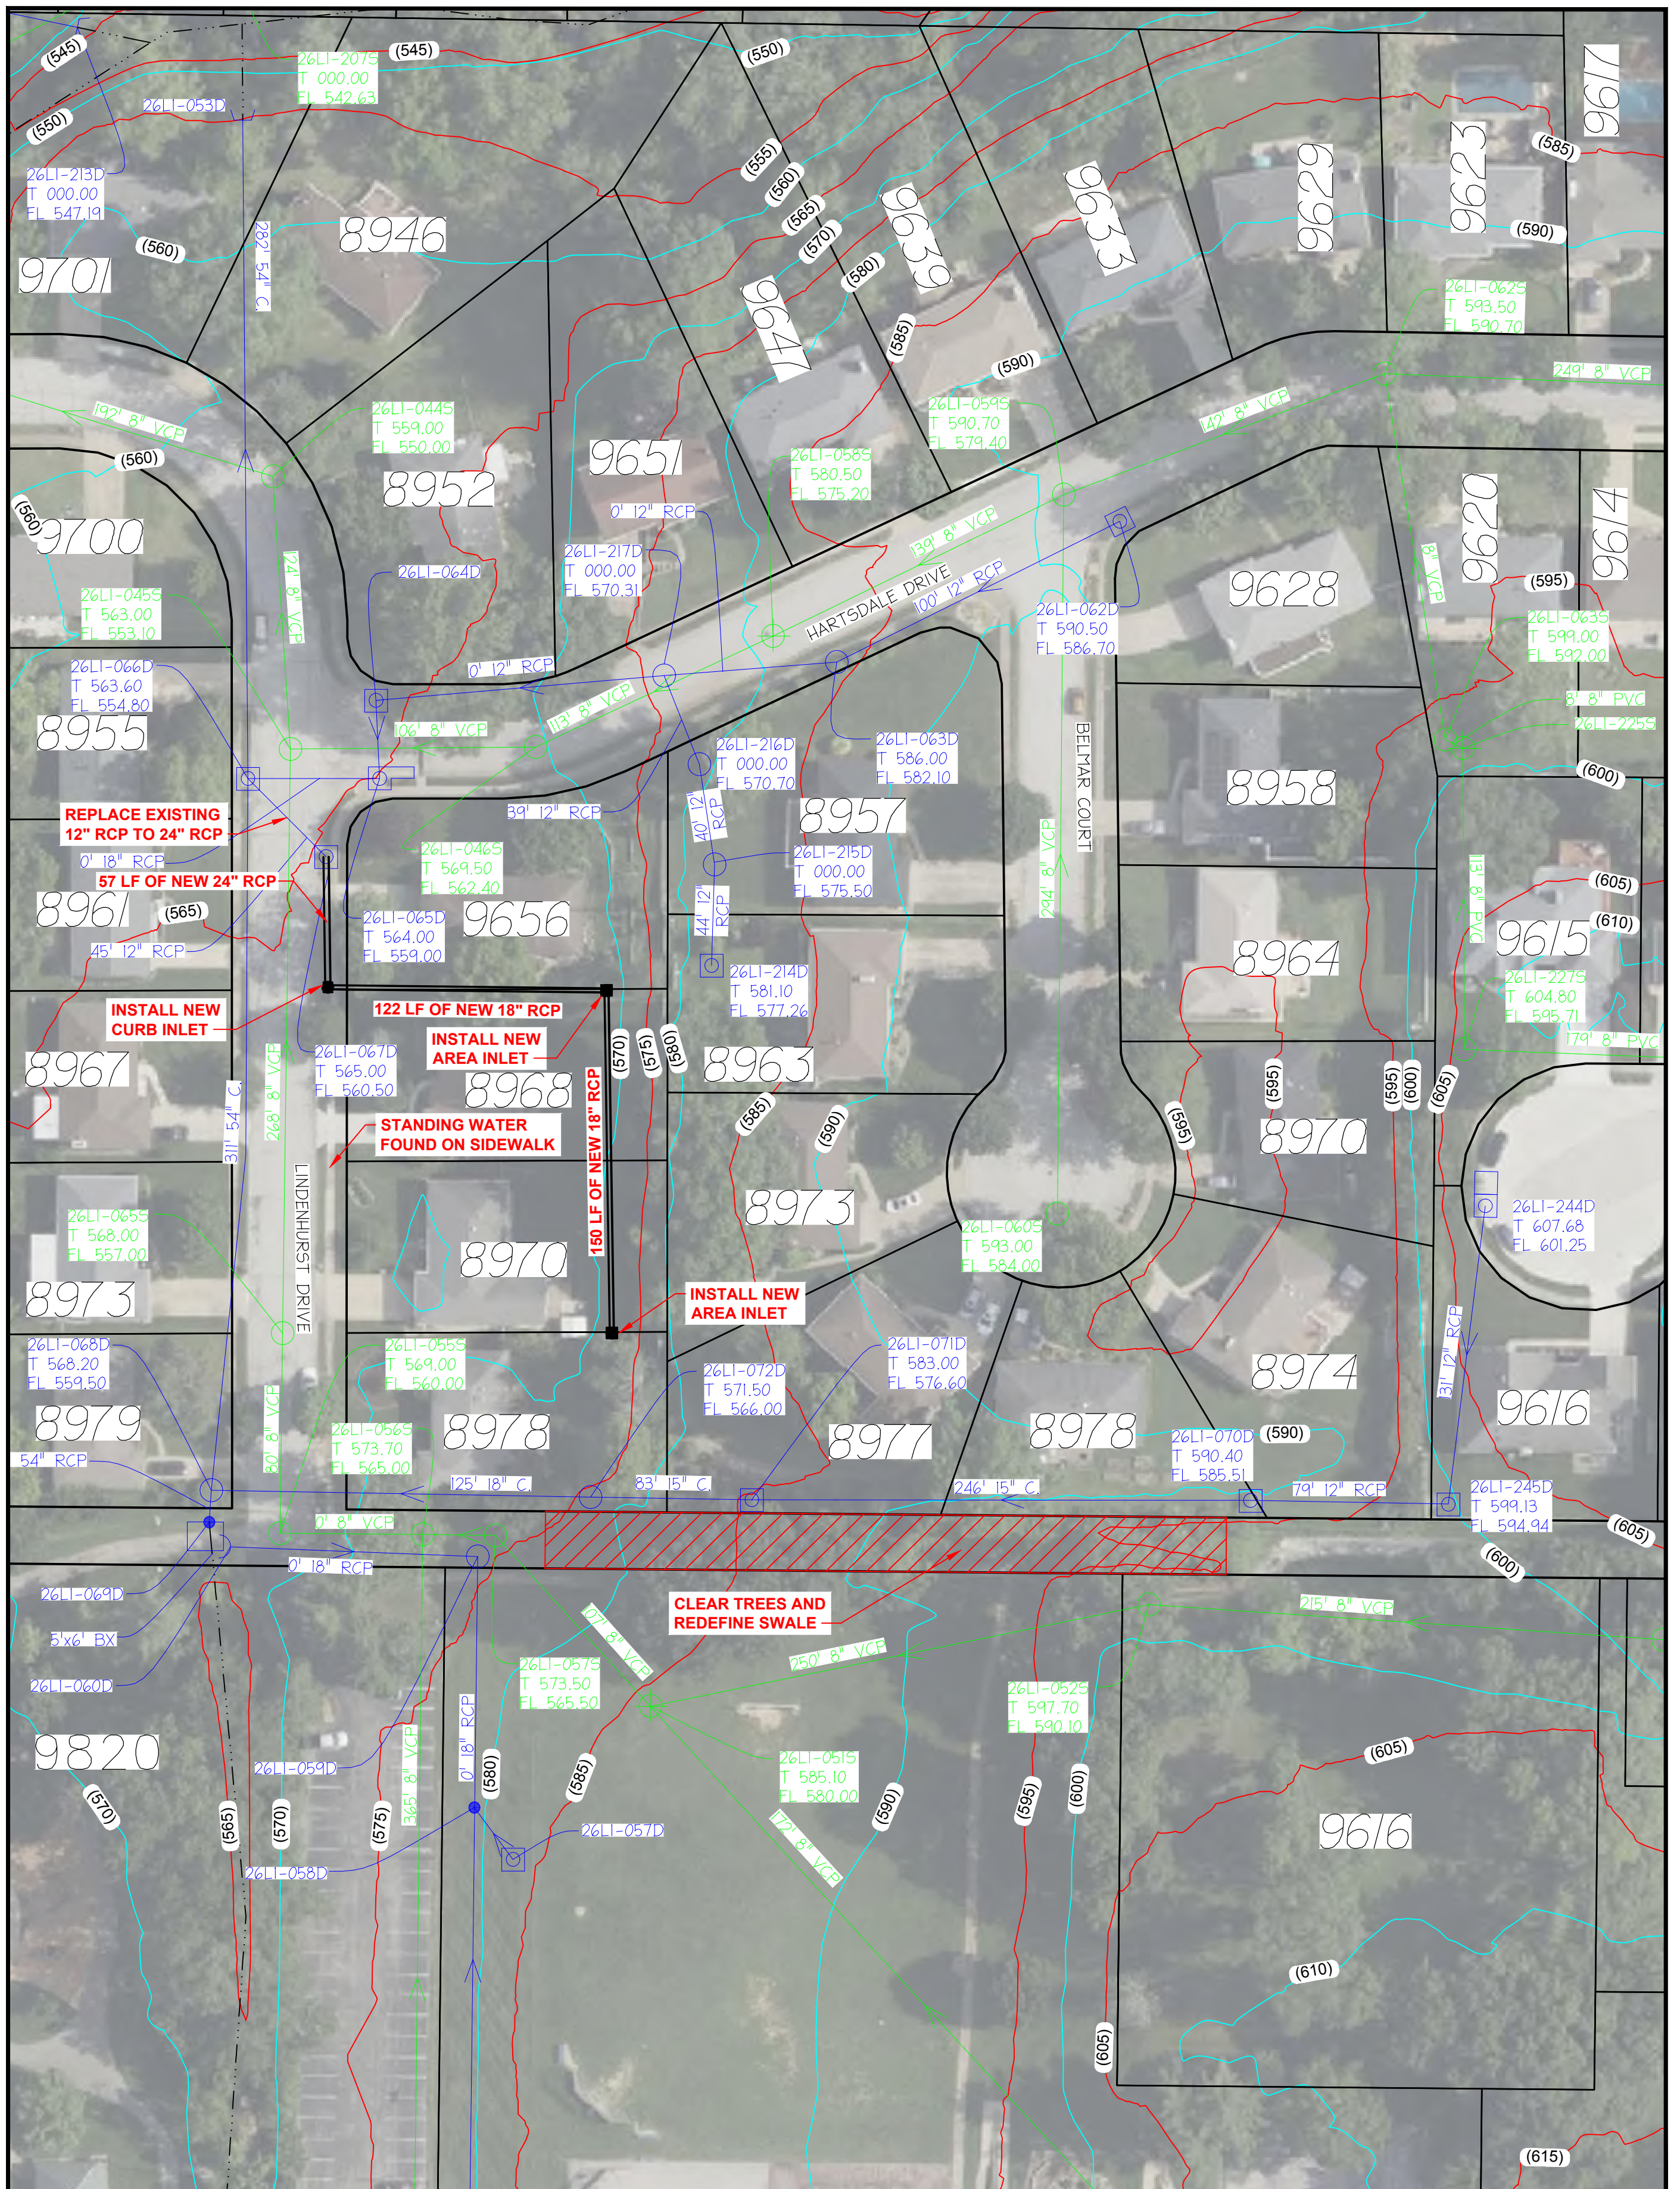
| FIGURE: | 6.c.iv-1 | |

A site inspection of the properties located between 8966 and 8978 Lindenhurst Drive revealed multiple drainage and erosion control deficiencies. Rear yard flooding and slope instability are evident, likely due to inadequate stormwater conveyance and lack of proper grading. At 9656 Lindenhurst Drive, the property owner has implemented provisional mitigation measures, including the placement of sandbags along the east basement window well and the excavation of a narrow, non-engineered drainage channel to redirect surface runoff. At 8968 Belmar Court, a structurally insufficient retaining wall appears to be contributing to progressive erosion and potential slope failure. Furthermore, standing water was observed on the sidewalk in front of 8968 Lindenhurst Drive, suggesting poor surface drainage and the need for evaluation of curb/gutter function and pavement grading in that location. These conditions warrant further hydrologic assessment and may require engineered solutions to prevent continued infrastructure degradation and property damage.

The property at 8978 Belmar Court is experiencing localized flooding attributed to a recent building addition on the school property directly to the south. While a culvert discharges runoff toward an existing drainage ditch along Richter Lane, the ditch lacks clear definition and is heavily vegetated, impeding effective stormwater conveyance. To mitigate overflow onto the adjacent roadway and into area inlet 26L1-070D, it is recommended that the swale be cleared and regraded to reestablish proper flow paths. Given the increased runoff from the new development, the existing inlet (26L1-070D) is insufficient to manage a 15-year design storm and may require hydraulic upgrades or additional infrastructure to meet capacity needs. See below for the recommended solution to each issue.

Component 2 – A system of existing drainage structures, including area inlets designated as 26L1-070D and 26L1-071D, along with an unlabeled CMP end section, is situated south of the property located at 8978 Lindenhurst Drive. These structures currently discharge to junction box 26L1-068D. It is recommended that site grading be revised in the vicinity of the inlets to optimize surface runoff capture and mitigate excessive

Component 3 – Two 100-foot lengths of four-foot-high block retaining walls terraced behind 8963 Belmar Court. Geotechnical investigation is needed prior to foundation design and wall drainage needs, to be provided with final design.

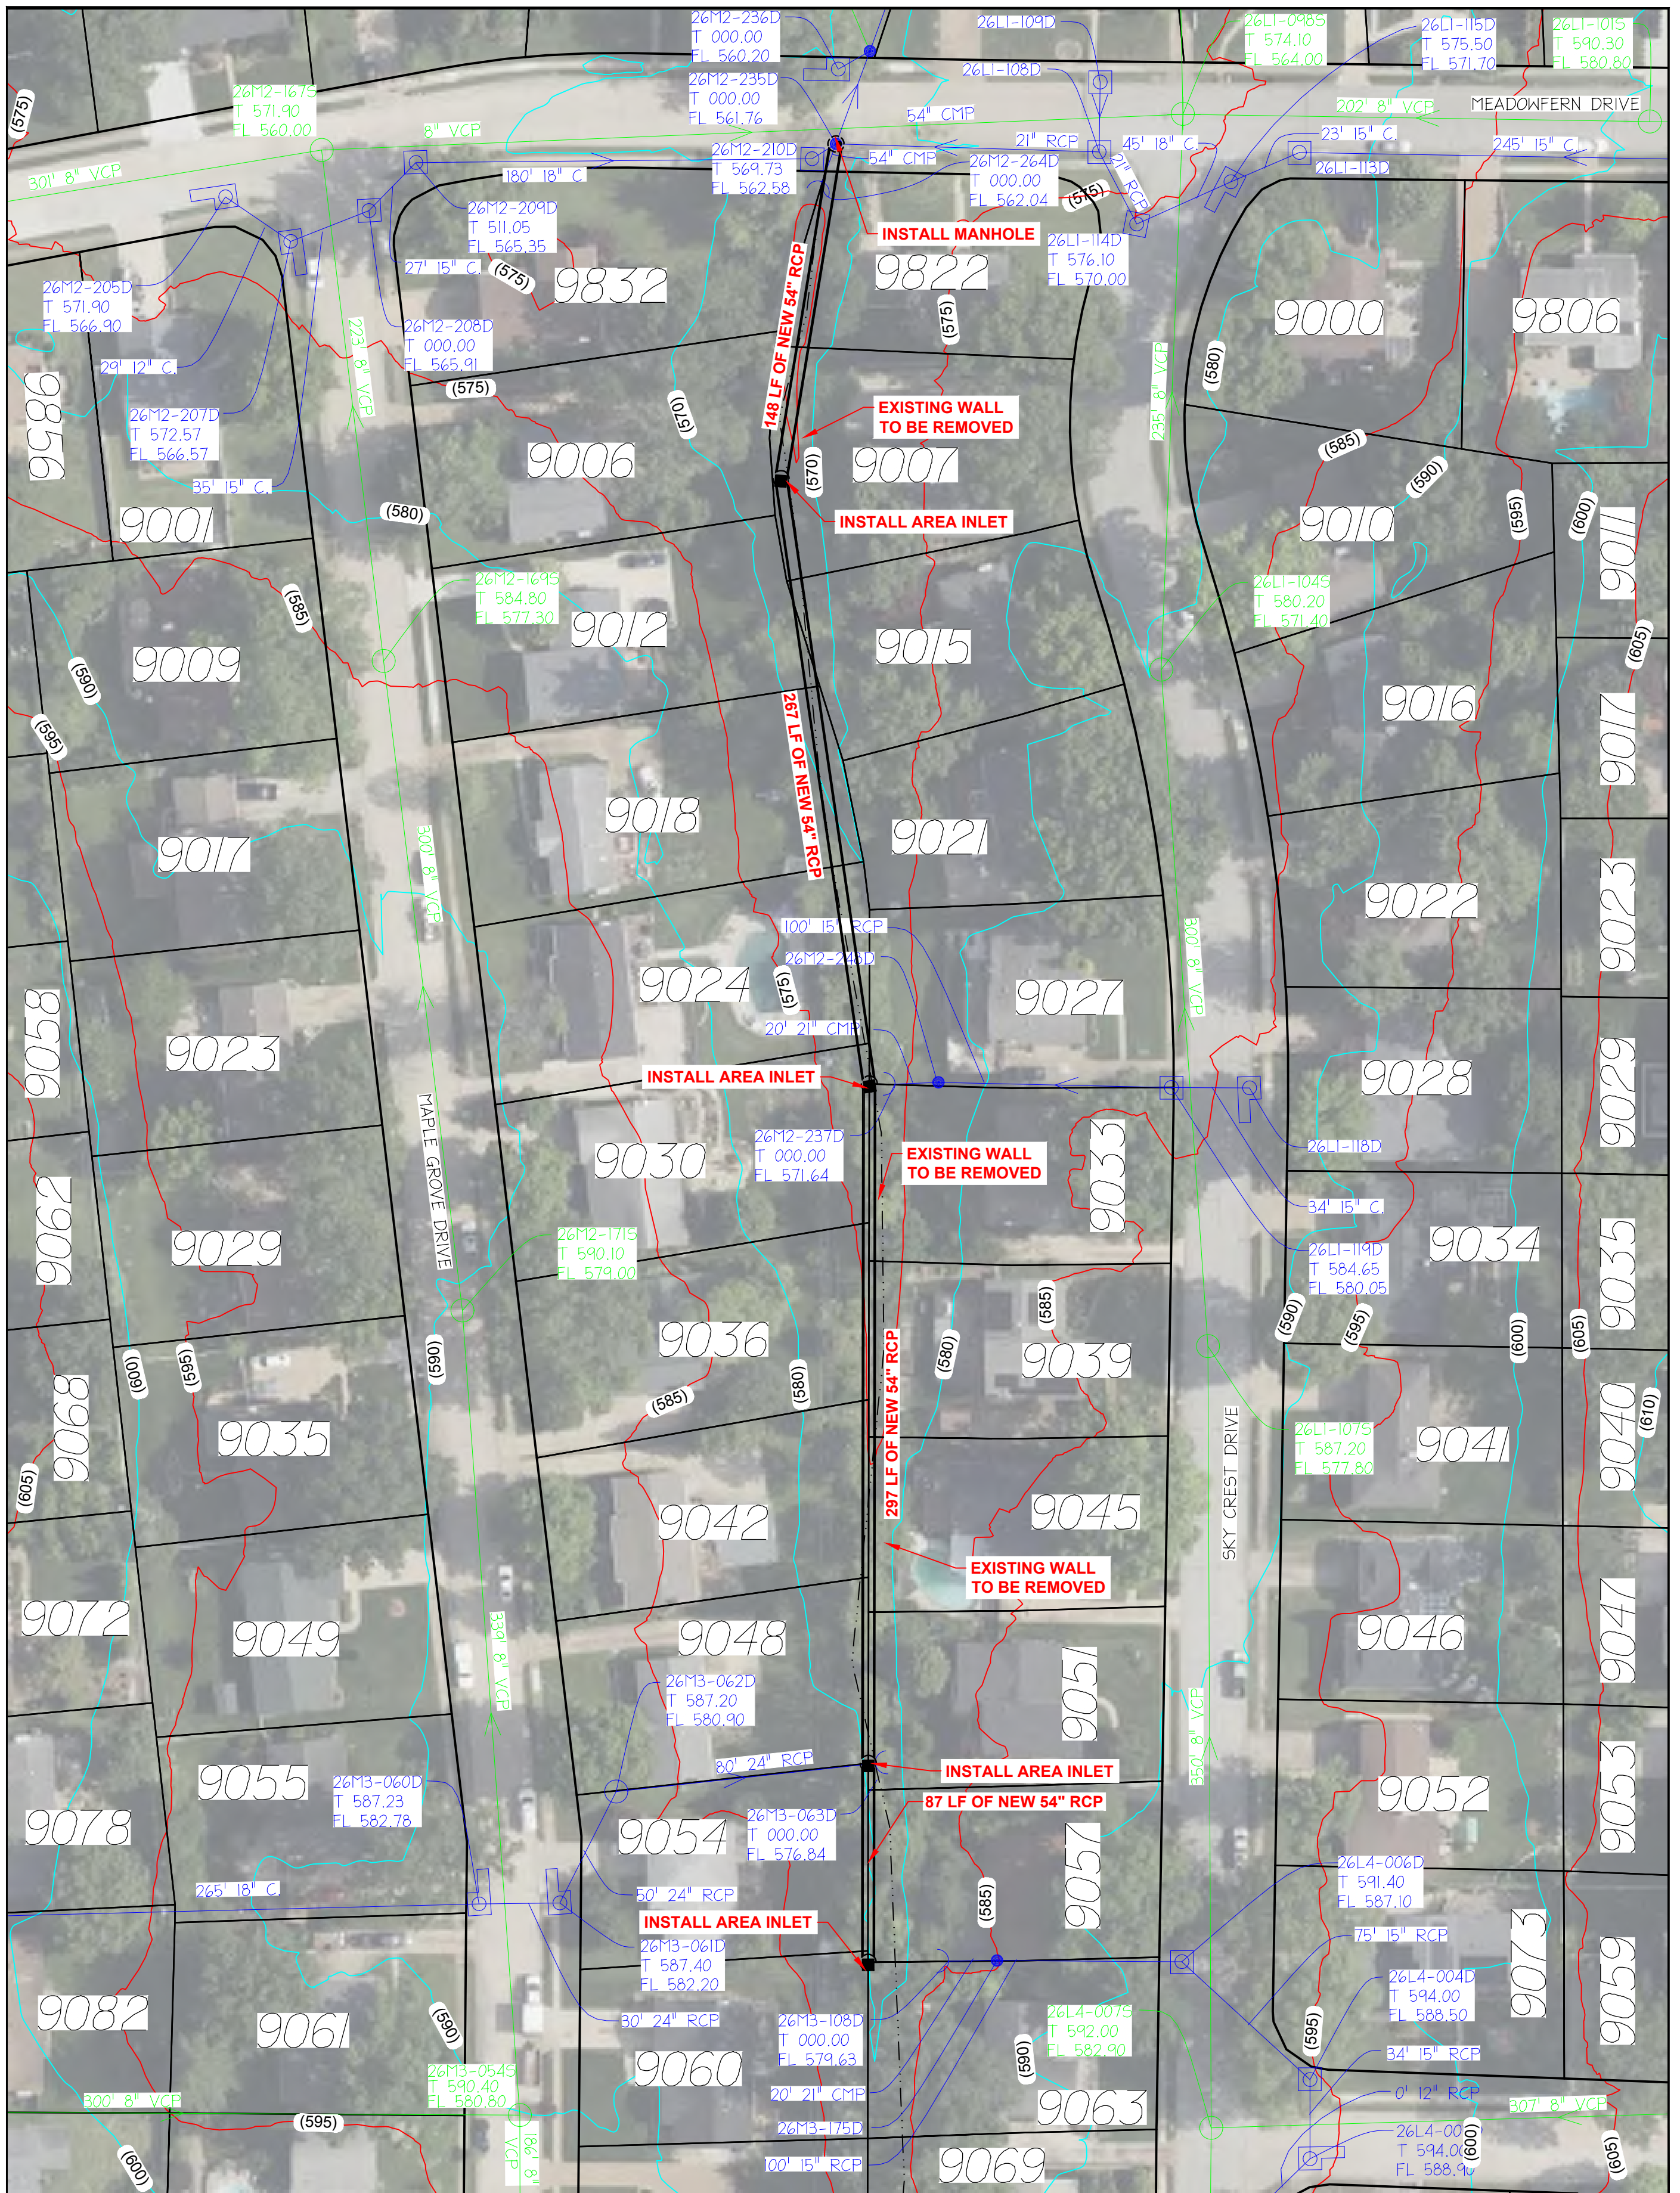
Figure 6.c.v-2 9000 Block Maple Grove/Sky Crest

The segment of the open channel located between Sky Crest Drive and Maple Grove Drive, upstream of Meadowfern Drive, exhibits significant erosion and degradation. This channel does not follow a naturally occurring alignment, and the existing longitudinal slope of approximately 2.6% generates flow velocities in the range of 15 to 20 feet per second, which are sufficient to cause erosive conditions. Active signs of erosion, including channel incision and downcutting, are present throughout the reach. In addition, structural failures have been observed along the channel banks, where timber retaining walls are deteriorating and brick masonry walls are also showing signs of instability. Certain low-lying sections of the channel contain ponded water with depths up to one foot, indicating poor drainage or grade control issues. The presence of overhead utility infrastructure, specifically power poles situated adjacent to the channel, presents additional constraints to performing maintenance or reconstruction activities without first relocating the utility poles.

This configuration ensures effective integration of the proposed infrastructure with the existing stormwater network, thereby improving flow capacity and reducing erosion in the rear yards. Alternative 1 from the previous report is the recommended course of action. The estimated probable project cost is approximately \$600,300.
