STORMWATER REPORT

CRESTWOOD STORMWATER

MASTER PLAN

CRESTWOOD, MISSOURI 63126

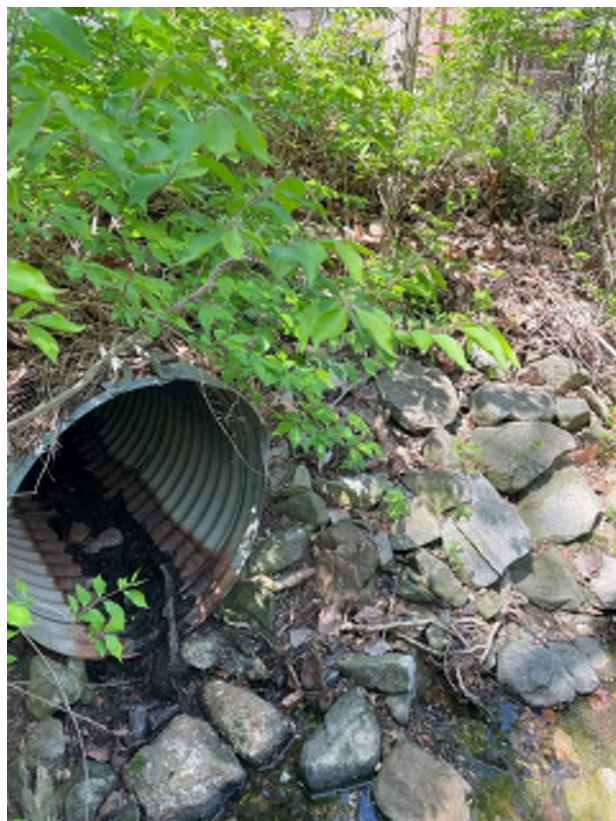
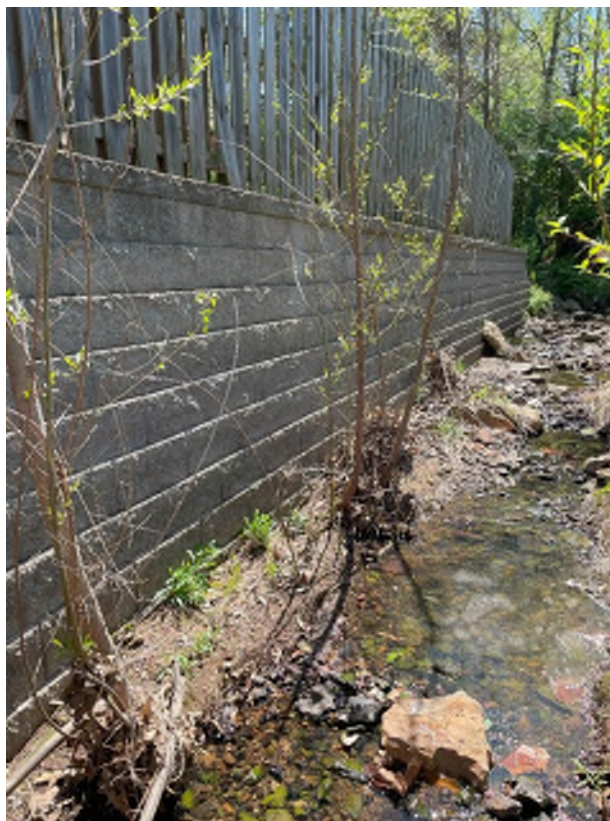
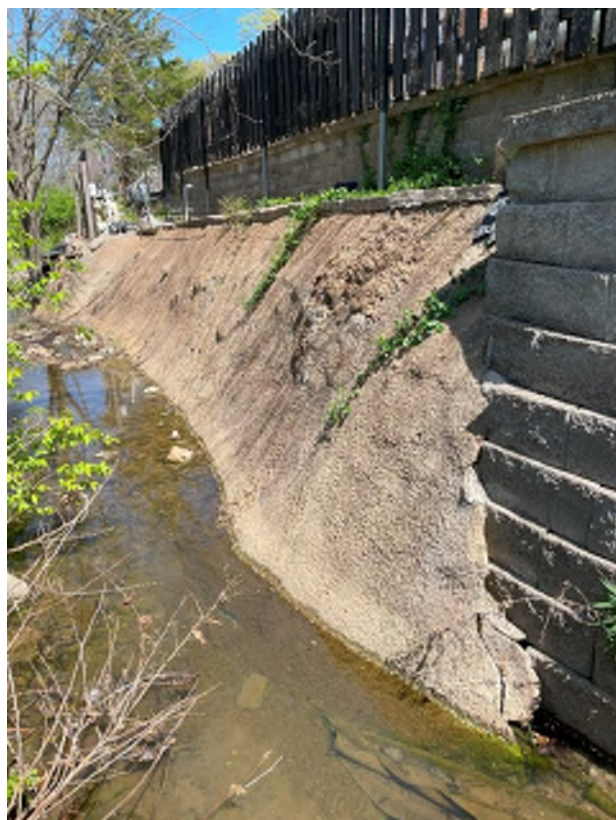
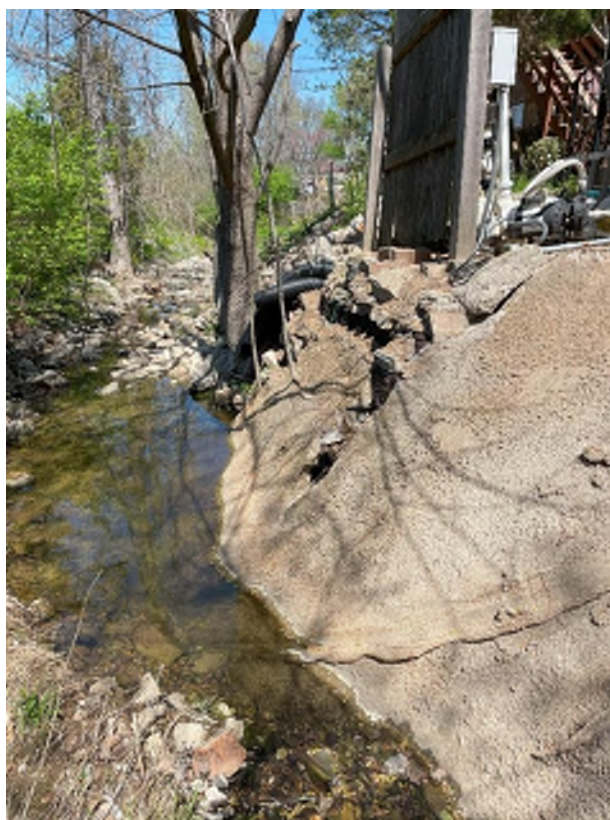
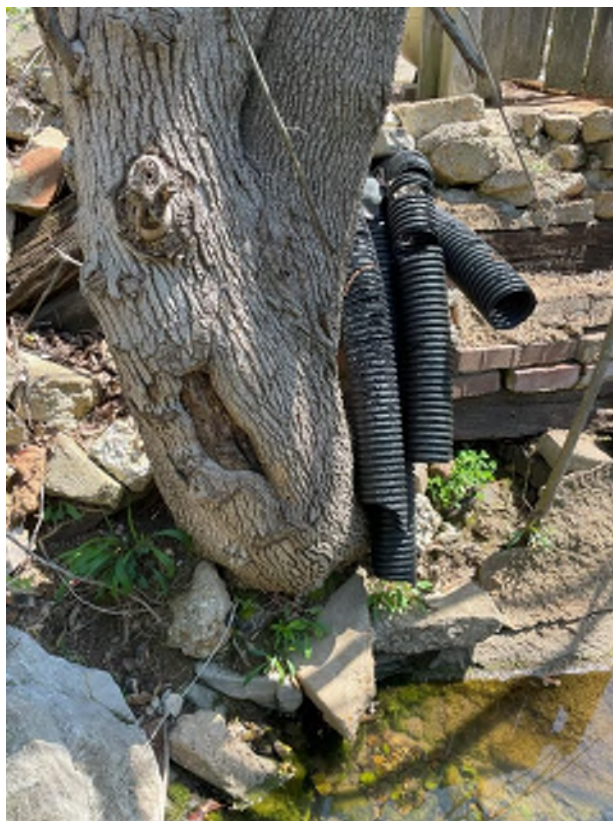
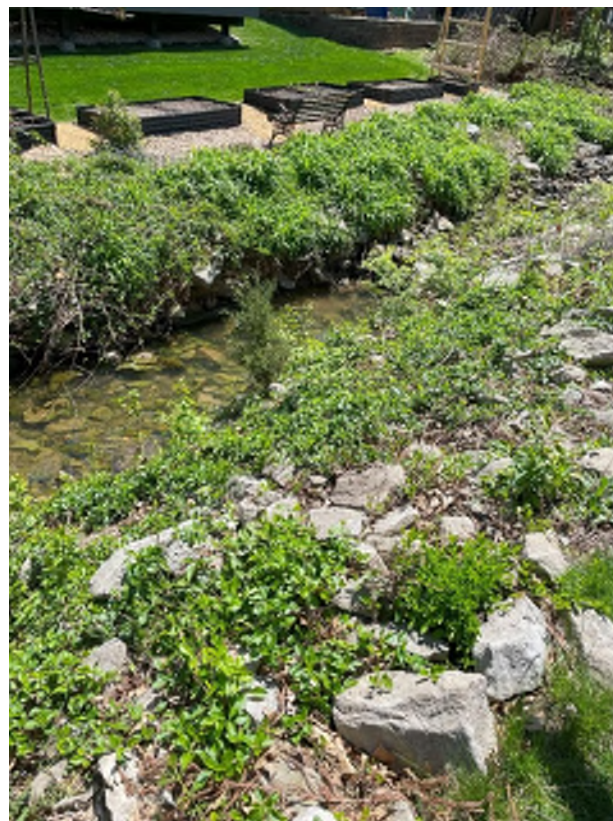
The segment of the open channel located between Sky Crest Drive and Maple Grove Drive, upstream of Meadowfern Drive, exhibits significant erosion and degradation. This channel does not follow a naturally occurring alignment, and the existing longitudinal slope of approximately 2.6% generates flow velocities in the range of 15 to 20 feet per second, which are sufficient to cause erosive conditions. Active signs of erosion, including channel incision and downcutting, are present throughout the reach. In addition, structural failures have been observed along the channel banks, where timber retaining walls are deteriorating and brick masonry walls are also showing signs of instability. Certain low-lying sections of the channel contain ponded water with depths up to one foot, indicating poor drainage or grade control issues. The presence of overhead utility infrastructure, specifically power poles situated adjacent to the channel, presents additional constraints to performing maintenance or reconstruction activities without first relocating the utility poles.

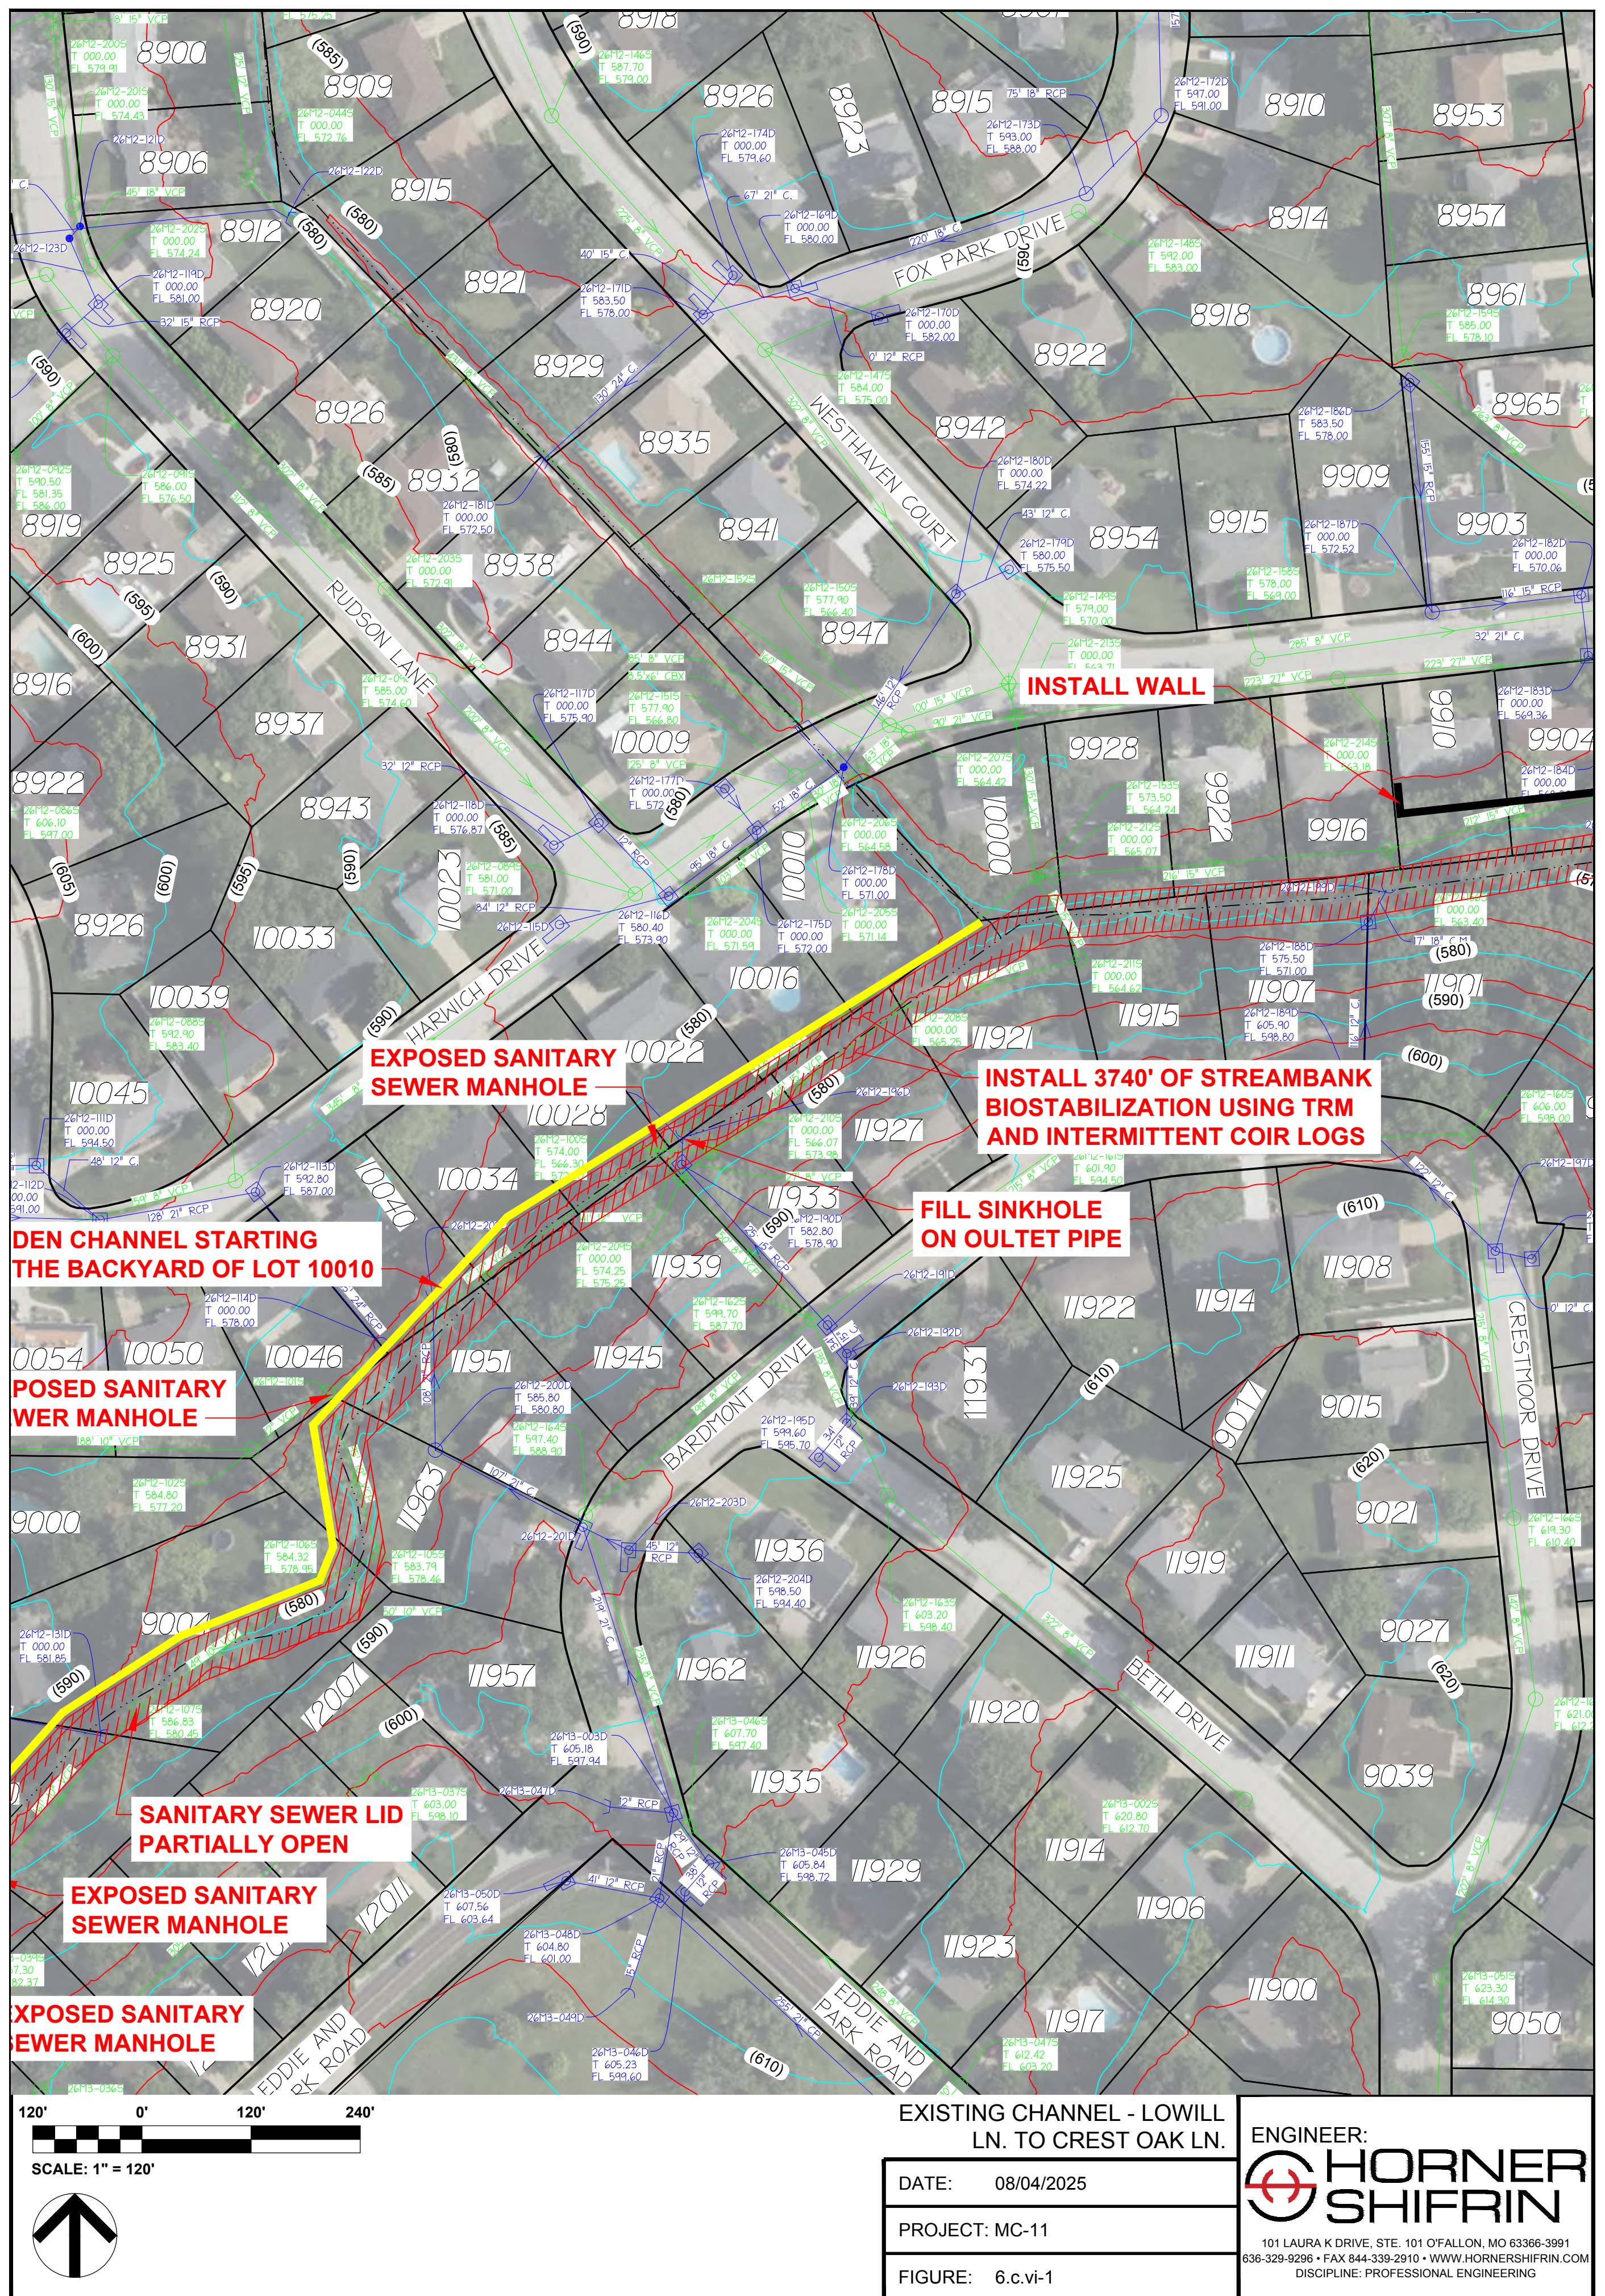
Figure 6.c.vi-2 Lowill Lane to Crest Oak Lane

Residents have reported stream bank erosion in the backyards of homes behind 9010 Lowill Lane and along a reach between 9004 Lowill Lane and 9904 Harwich Drive for both sides of Mulberry Creek. In addition to the erosion of this channel section, residents at 9904 and 9910 Harwich Drive and 10028 Harwich Drive have reported structural flooding. A larger cross-section and reduced longitudinal slope are needed to promote resiliency of the channel section. Without these alterations, the channel will continue to erode until these conditions stabilize naturally.

Going upstream of the channel, the north bank of the channel has grouted riprap in some places due to previously observed erosion. On the south bank, there is no grouted riprap and the bank is fully vegetated. The slopes seem to be in good condition and no erosion problems were found.

Upon reaching the vicinity of 10010 Harwich Drive, the channel exhibits a noticeable reduction in width. Several stormwater outlet pipes and sanitary sewer manholes are situated within the channel. Both banks are undergoing active erosion and vertical incision (downcutting) of the channel bed. Multiple pedestrian and vehicular bridges span the channel, with accumulated debris observed—likely due to elevated water surface elevations during high-intensity storm events. At 10050 Harwich Drive, a section of the channel is reinforced with gabion retaining walls, which appear to be structurally sound and functioning as intended.

Further downstream, at 9010 Lowill Lane, the proximity of the residential structure to the channel poses a risk, especially considering the insufficient channel depth to effectively convey peak stormwater flows. From 9010 to 9028 Lowill Lane, the channel continues to constrict in width. Multiple sanitary sewer manholes are located within the channel bed. Of particular concern is the manhole at 9004 Lowill Lane, which has a partially dislodged lid, presenting a potential public safety and contamination hazard. Additionally, two other manholes in this reach are fully exposed, likely a result of high stormwater velocity and erosive flow conditions.

At 9034 Lowill Lane, two distinct discharge points converge into a single outfall. A riprap energy dissipation basin is located at this confluence and is currently functioning effectively. However, based on field assessments, routine maintenance of the stilling basin is recommended to ensure continued performance and to prevent sediment accumulation and structural degradation.

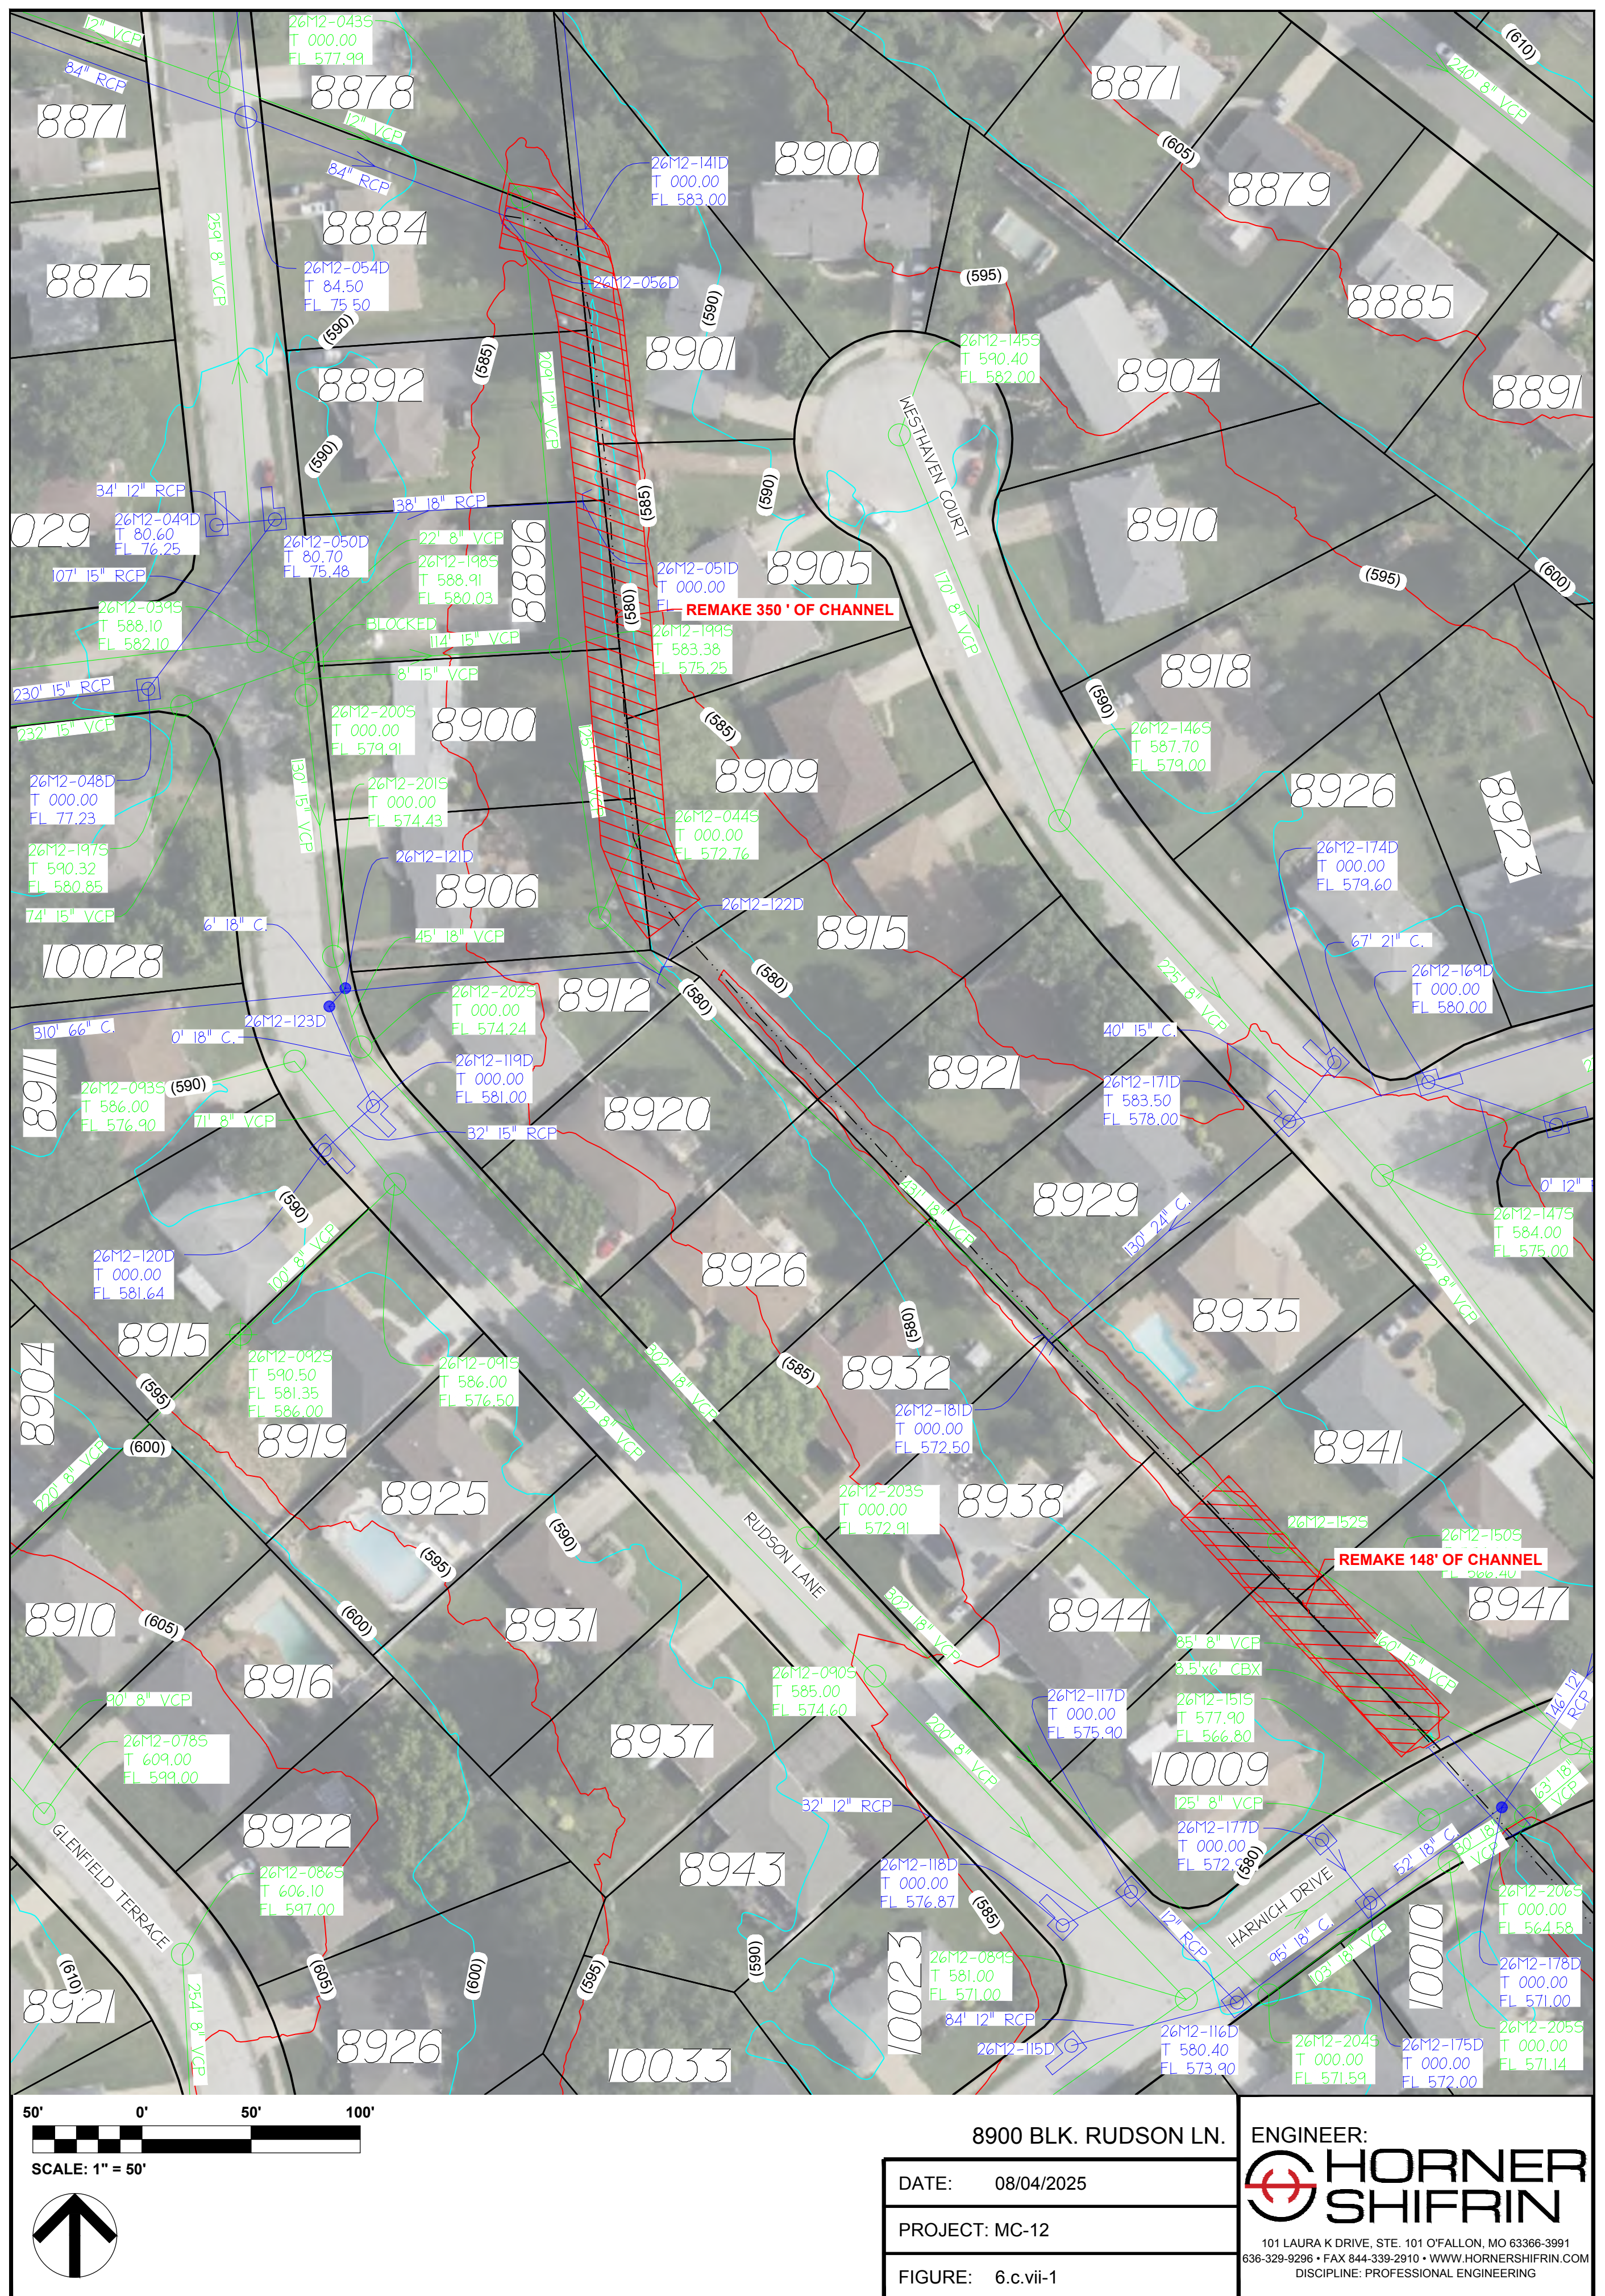
Figure 6.c.vii-2 8900 Block Rudson Lane

The existing concrete-lined drainage channel located behind residential properties at 8884 through 8906 Rudson Lane and 8944 through 10009 Rudson Lane is exhibiting significant structural deterioration. Hydraulic analysis indicates that, under a 15-year design storm event, flow velocities within the channel exceed 20 feet per second. These velocities result from the current geometric configuration of the channel, which consists of an 8-foot bottom width, side slopes varying between 2:1 (horizontal to vertical) and 3:1, and a longitudinal slope of approximately 1.9 percent. The existing conditions contribute to high erosive forces and are a primary factor in the ongoing degradation of the channel infrastructure.

Based on field investigations and site assessments, full replacement of the existing drainage channel is determined to be the most appropriate and effective corrective measure. Portions of the channel have previously undergone replacement; however, the remaining sections exhibit significant structural degradation and are no longer considered serviceable. The proposed scope of work includes the construction of a new 990-foot-long cast-in-place concrete trapezoidal channel, designed with an eight-foot-wide bottom, 3:1 (horizontal to vertical) side slopes, and a longitudinal slope of 1.9 percent to match the existing geometry and maintain positive drainage. Additionally, continuous safety railings are to be installed along both sides of the channel to enhance public safety and comply with applicable design standards. The estimated probable project cost is approximately \$624,800.

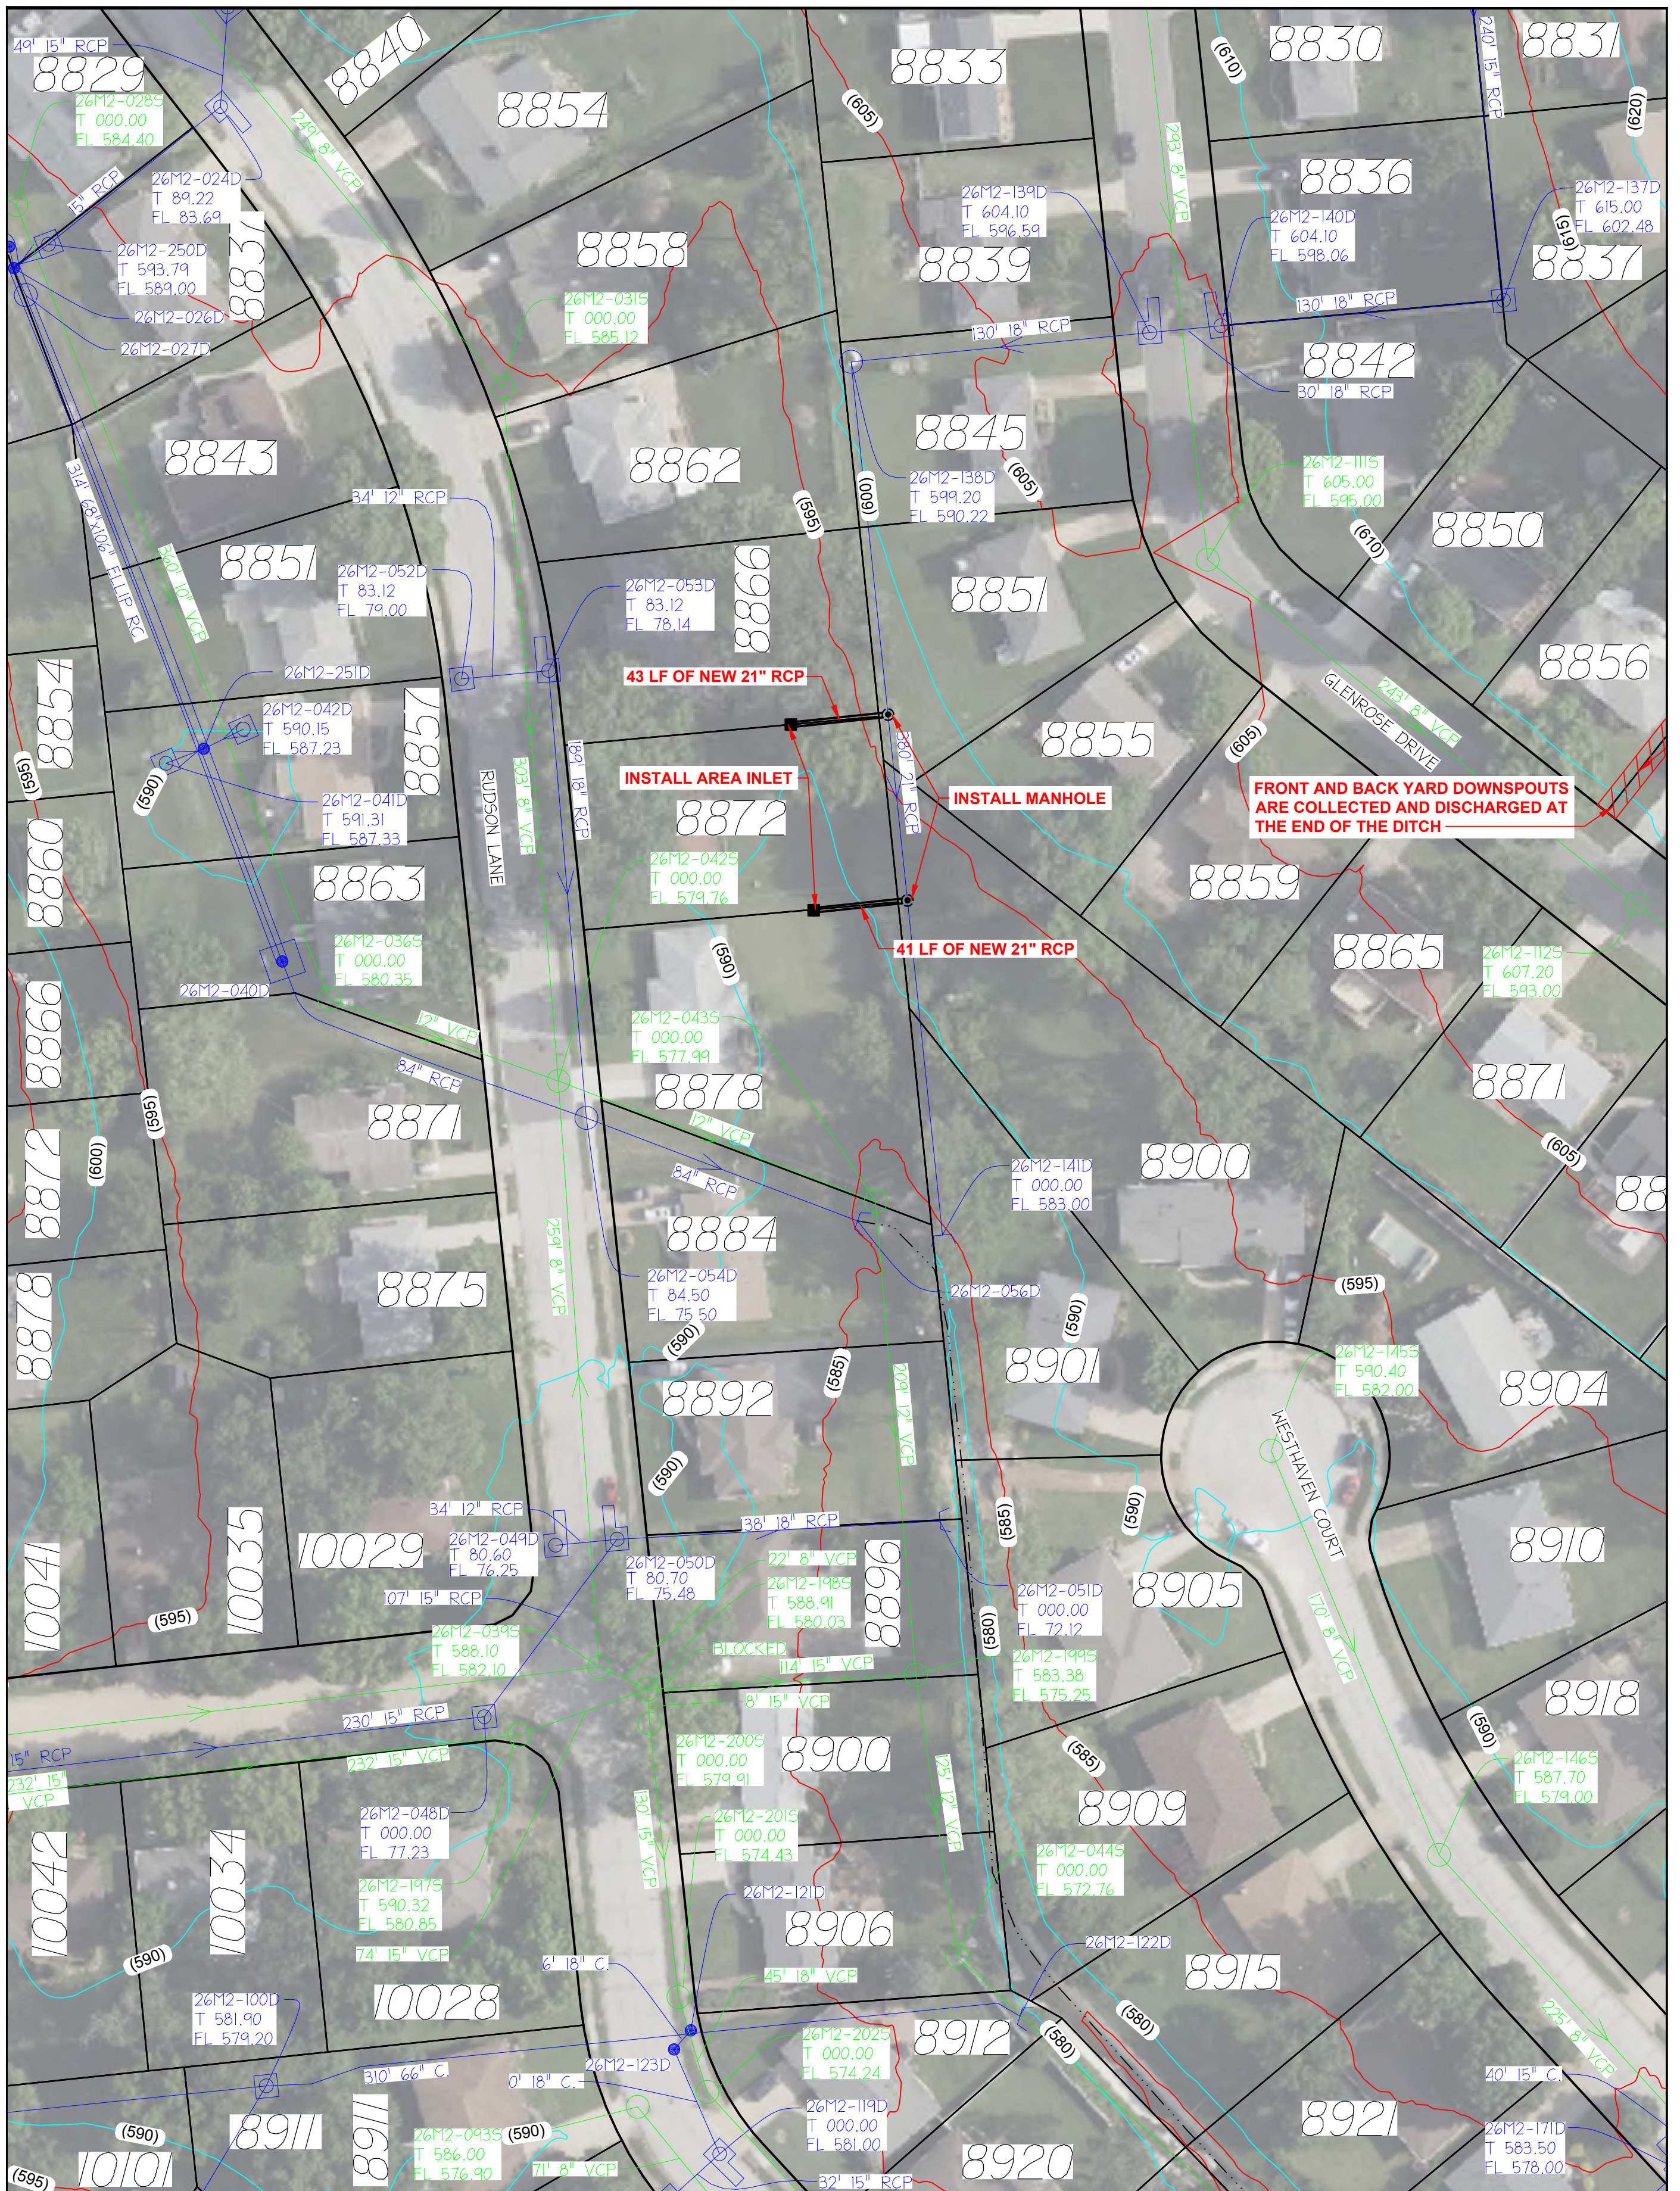
Figure 6.c.viii-2 8866-8878 Rudson Lane

Residents between 8854 and 8872 Rudson Lane have reported recurring stormwater ponding, with an average depth of approximately six inches. This condition is attributed to inadequate surface grading, which prevents positive drainage and contributes to water accumulation following precipitation events.

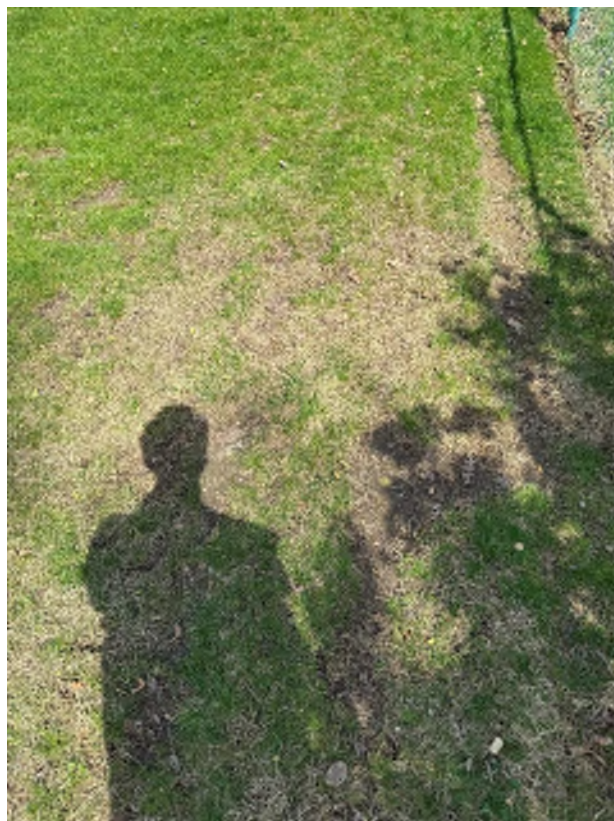
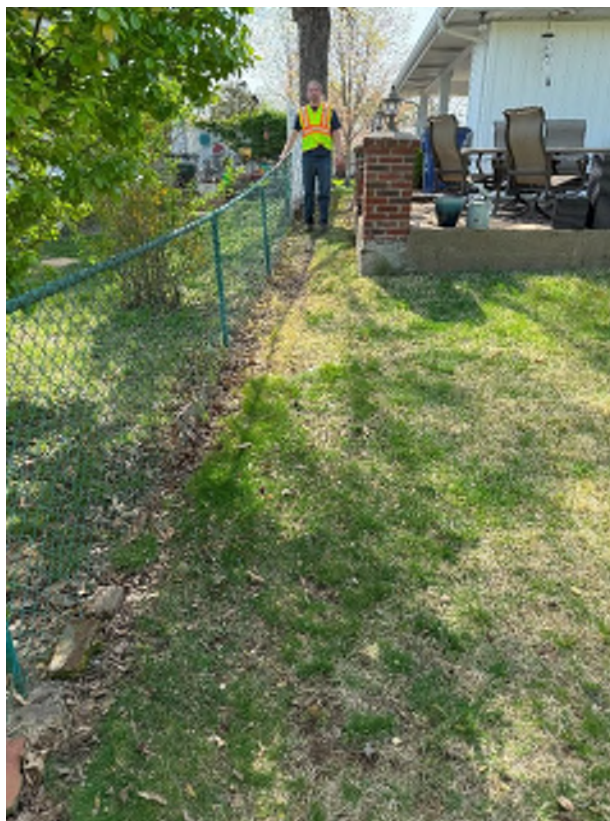
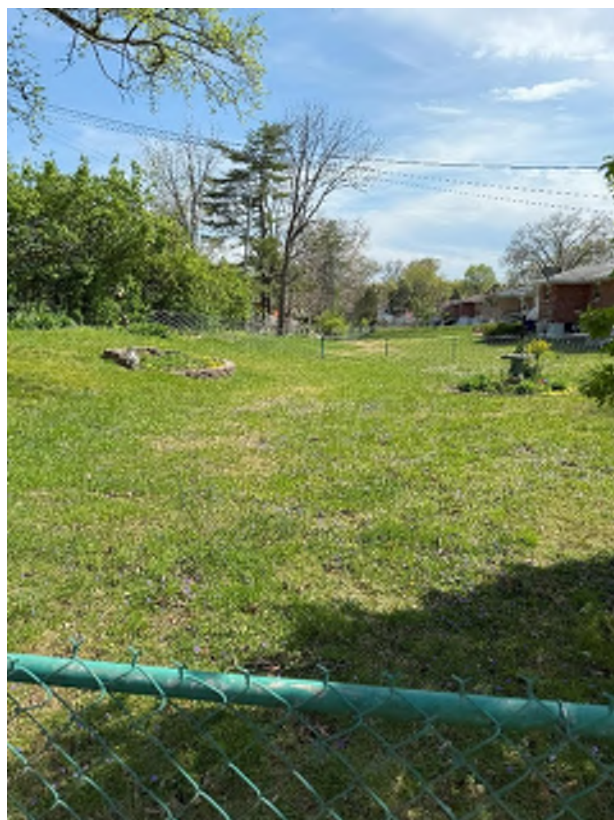
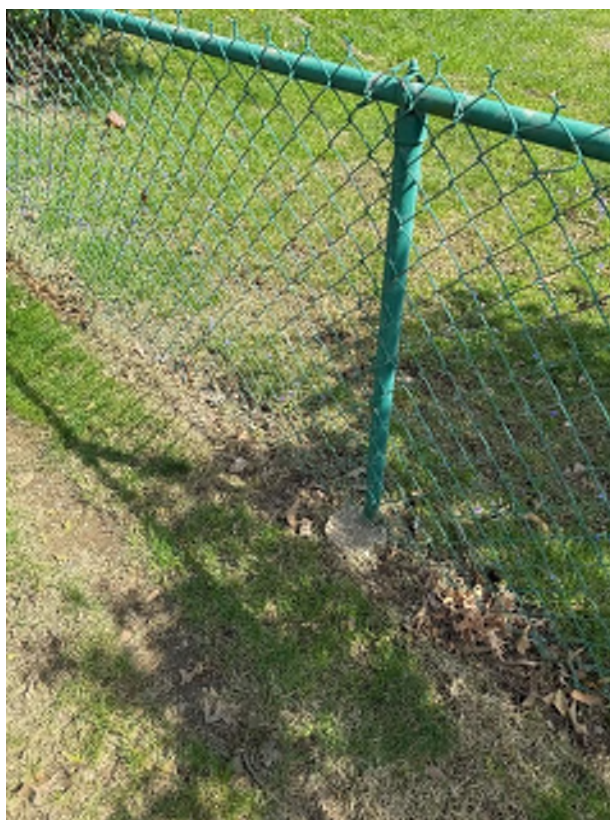
ix. MC-14 10069-10075 Barberton Drive

Excessive stormwater runoff originating from the field located behind 10069 Barberton Drive has been a consistent issue, with runoff flowing directly into the resident's backyard, causing significant drainage concerns. The property owner has formally reported that the source of the water contributing to the problem includes runoff from the church situated to the north of the property in addition to stormwater from three residential properties located along Manda Lane. The homes on Manda Lane, which are in close proximity to 10069 Barberton Drive, have interconnected downspouts, all of which channel their stormwater runoff into a shared drainage path. This collective drainage system results in increased volume and velocity of the runoff that ultimately discharges onto the backyard of 10069 Barberton Drive, exacerbating the flooding and erosion issues experienced by the resident. The cumulative effect of these multiple contributing sources highlights the need for a comprehensive evaluation and potential redesign of the stormwater management infrastructure in this area to mitigate further impact on the property.

The proposed stormwater infrastructure will include the placement of approximately 140 linear feet of 18-inch diameter RCP, which will connect the new area inlet to the existing curb inlet identified as 26M2-061D on Barberton Drive. This connection is essential to ensure that runoff collected from the upstream catchment area is efficiently conveyed to the municipal storm drainage network. Furthermore, the existing curb inlet (26M2-060D) will need to be replaced due to the connection of the proposed 18-inch RCP. During engineering design, the hydraulic capacity for the existing 18-inch RCP beneath Barberton Drive will be checked. The upsizing of the existing 18-inch RCP may be necessary if the hydraulic capacity does not meet the requirements. The estimated probable project cost is approximately \$59,100.

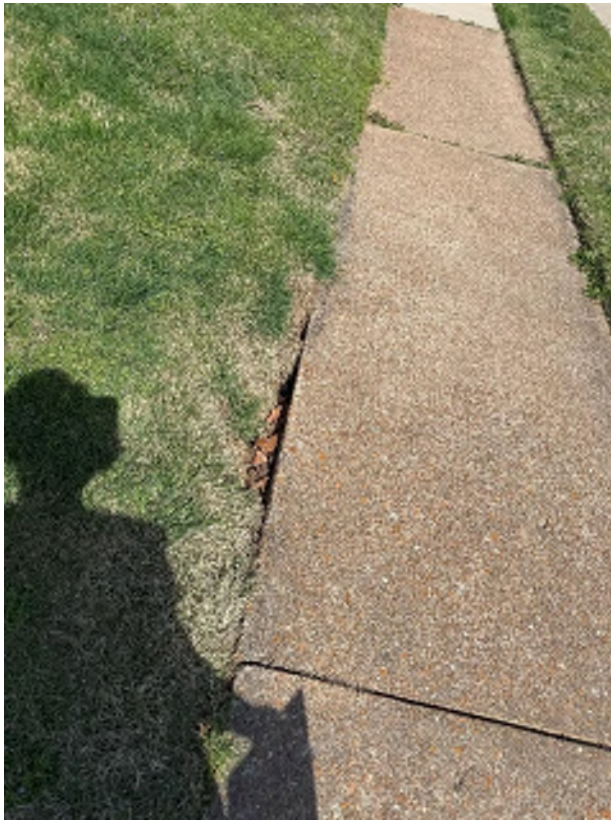
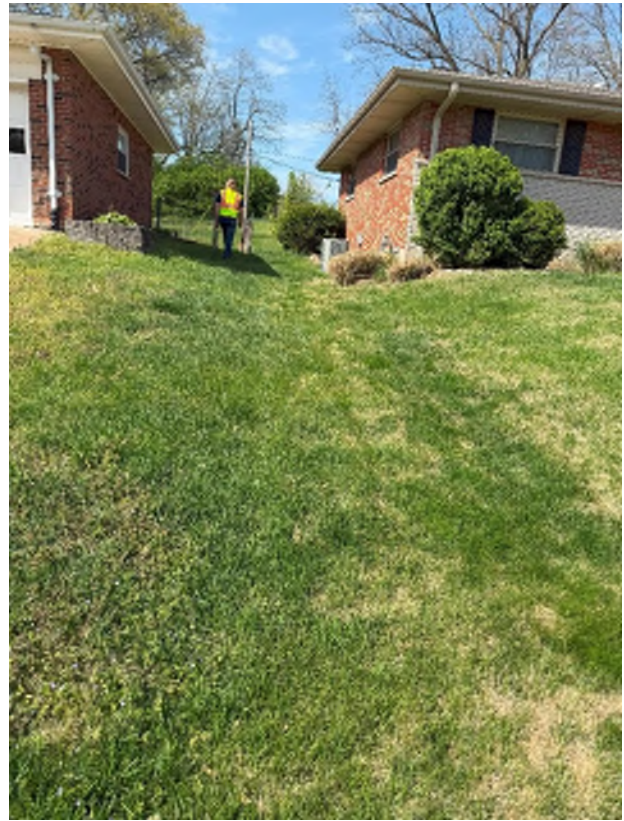
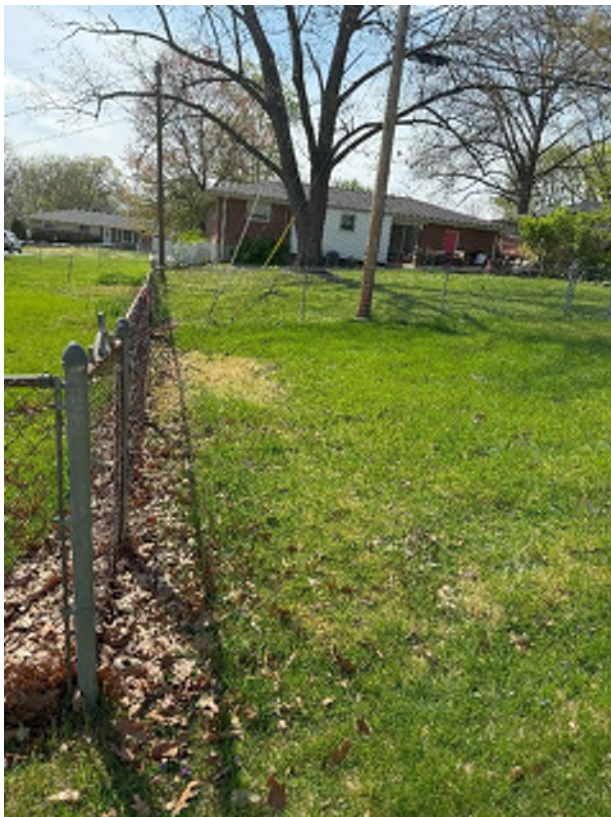
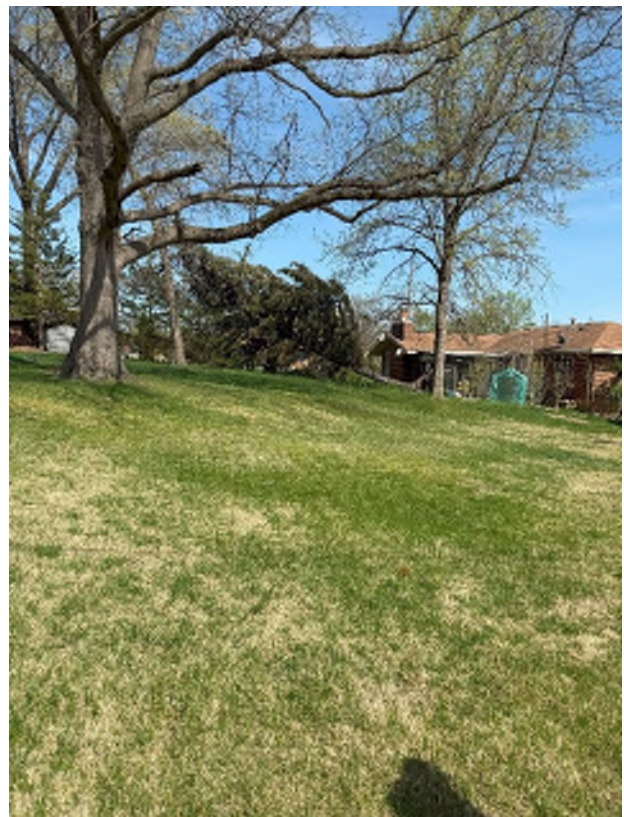
x. MC-15 8901 Manda Lane

This project, in the original CDM report, was not identified as completed by MSD or the City. Therefore, a site visit was completed by Horner & Shifrin, and it appears the stormwater concerns have been repaired by adding two storm sewer inlets. The project has been left in the Addendum such that conformation can be received that this project has been completed and the new inlets have sufficient capacity. Additionally, the project has been ranked with a 0.00 benefit/cost ratio since no work is proposed.
