STORMWATER REPORT

CRESTWOOD STORMWATER

MASTER PLAN

CRESTWOOD, MISSOURI 63126

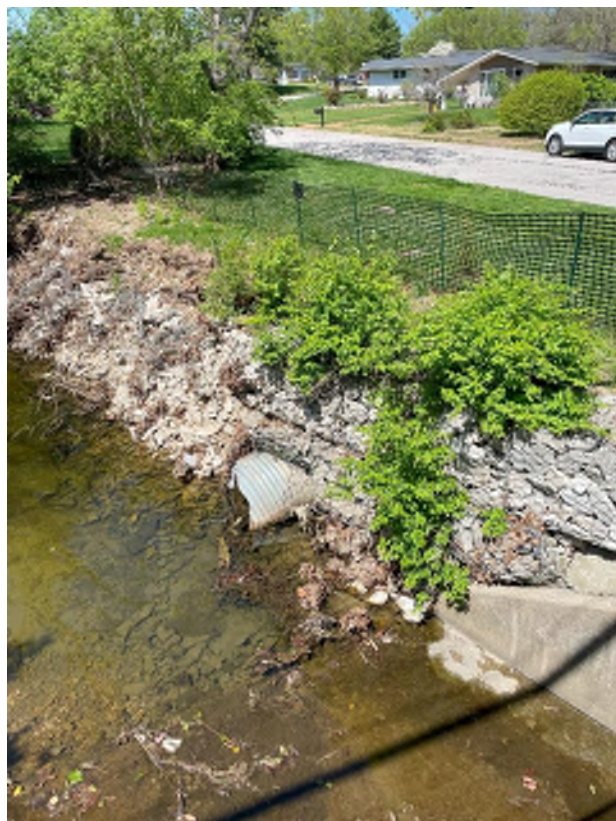
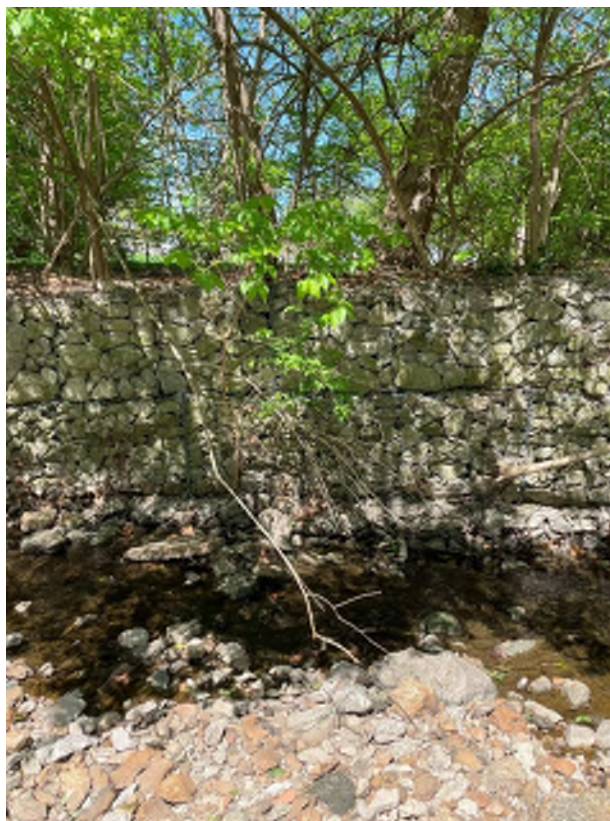
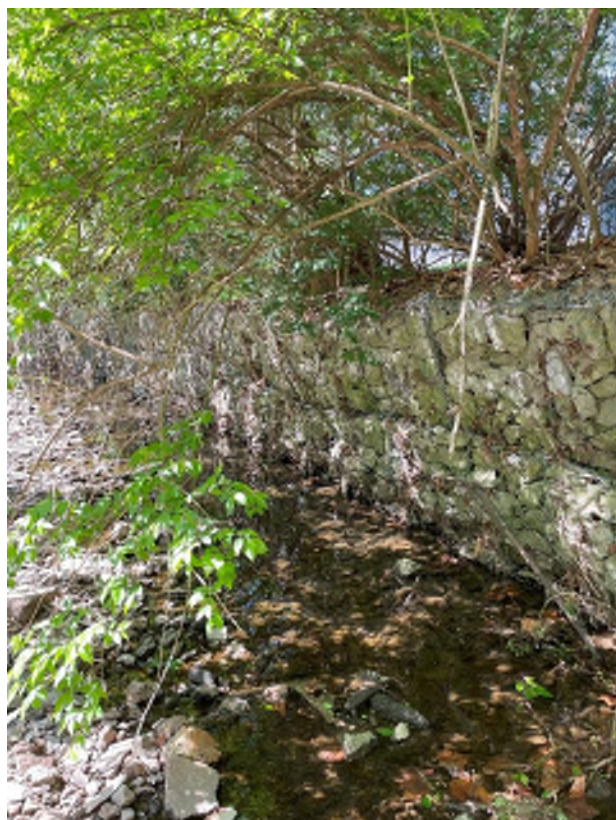
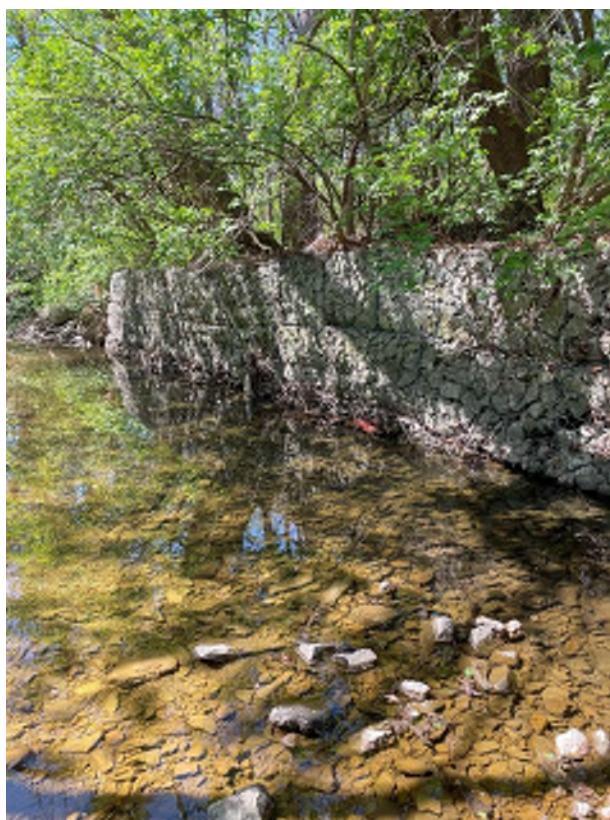
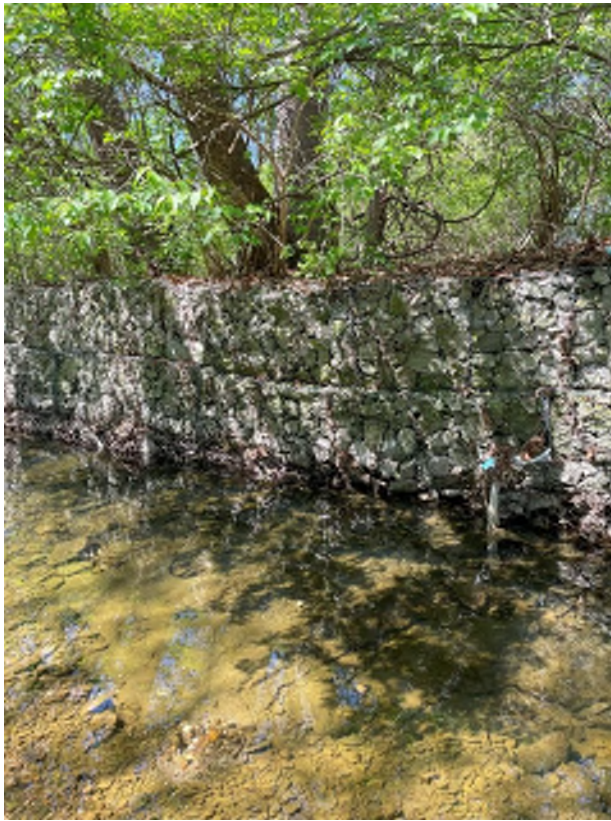
xi. MC-16 8841 Cornish Drive

At the rear property line of 8841 Cornish Drive, a gabion retaining wall is installed along the north-facing slope adjacent to the creek. Structural distress has been observed in sections of the wall, primarily due to hydrodynamic forces from increased stormwater flow and root intrusion from nearby vegetation, which are exerting lateral pressure and causing displacement toward the watercourse. Additionally, failure at the toe of the structure has been identified, attributed to inadequate embedment and improper installation of the initial gabion course. The recommended corrective action involves full replacement of the existing gabion wall, constructed per recommended engineering standards for toe embedment to enhance structural stability and prevent future undermining. The estimated probable project cost is approximately \$63,400.

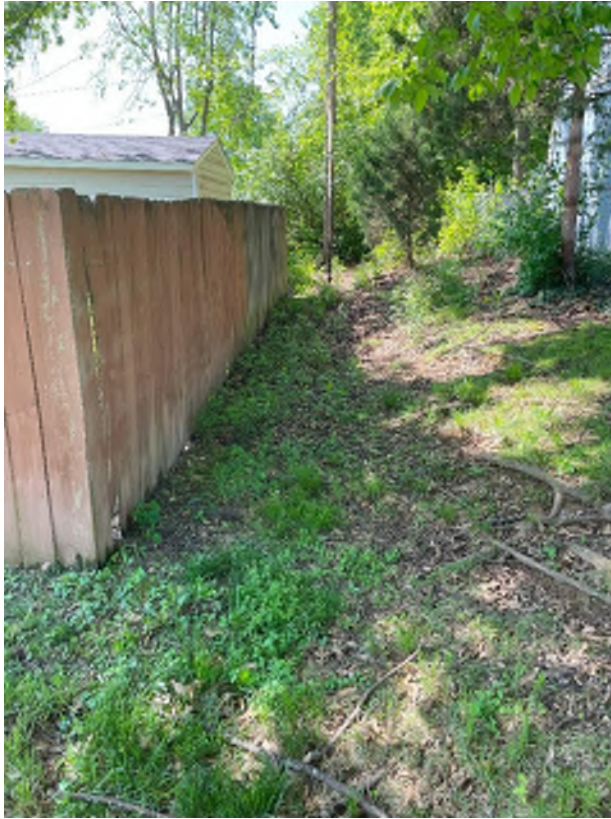
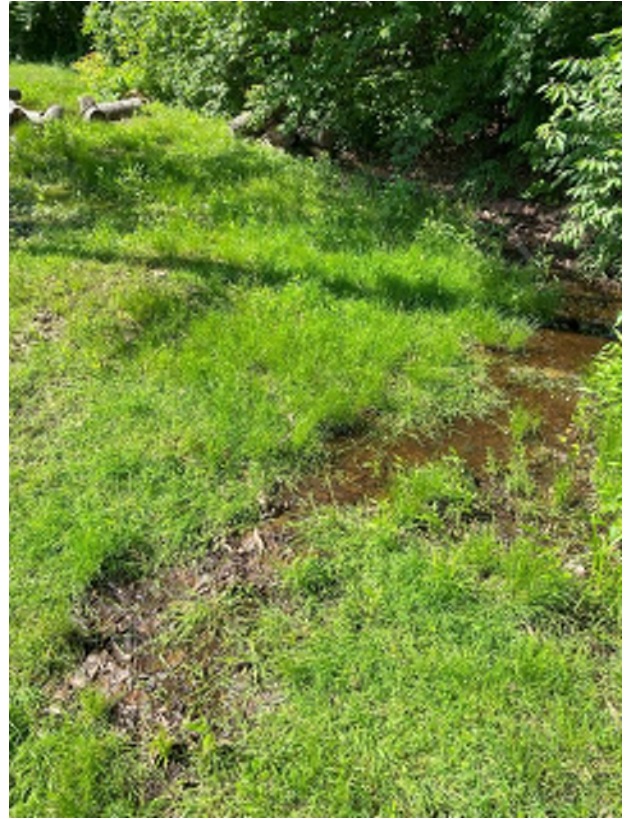
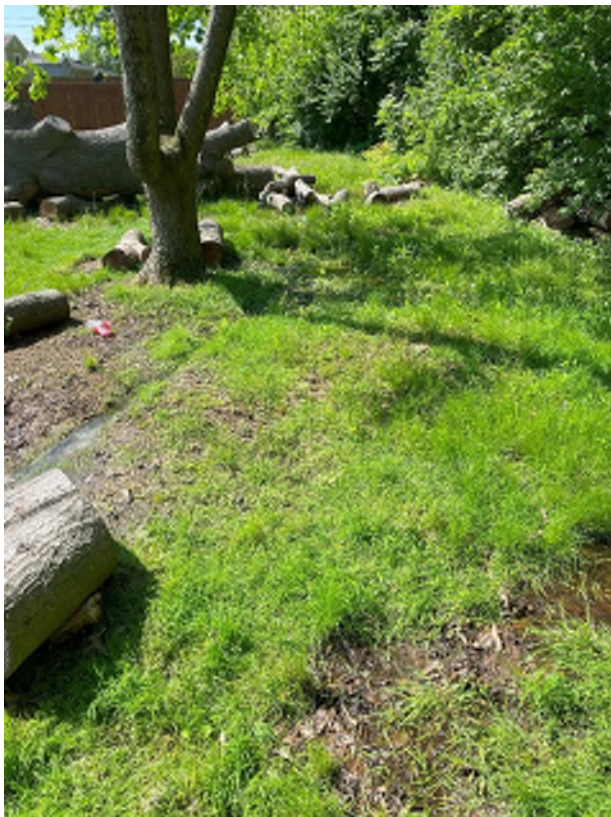
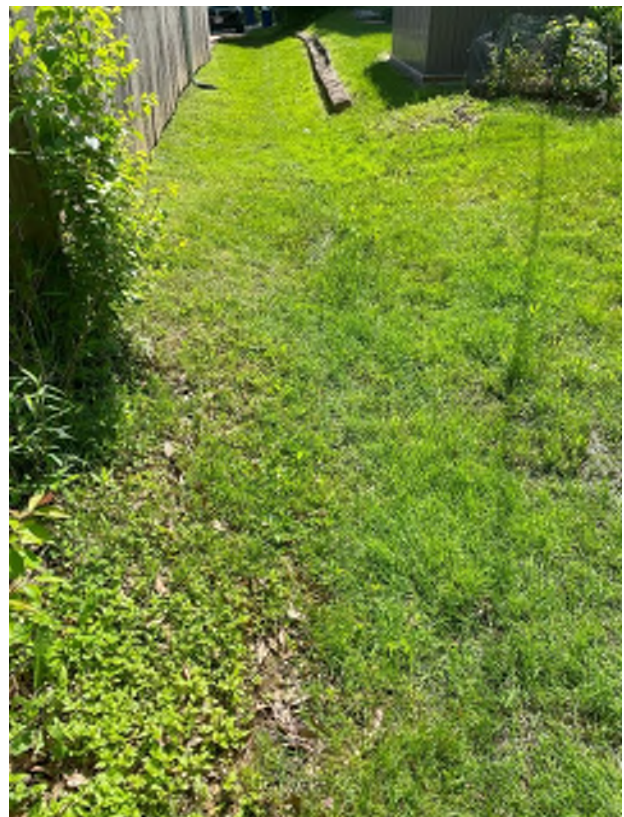
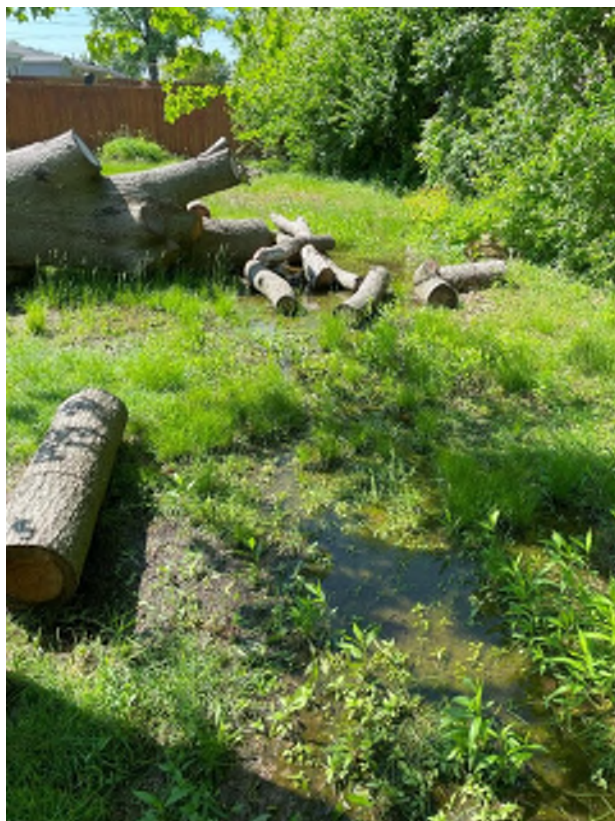
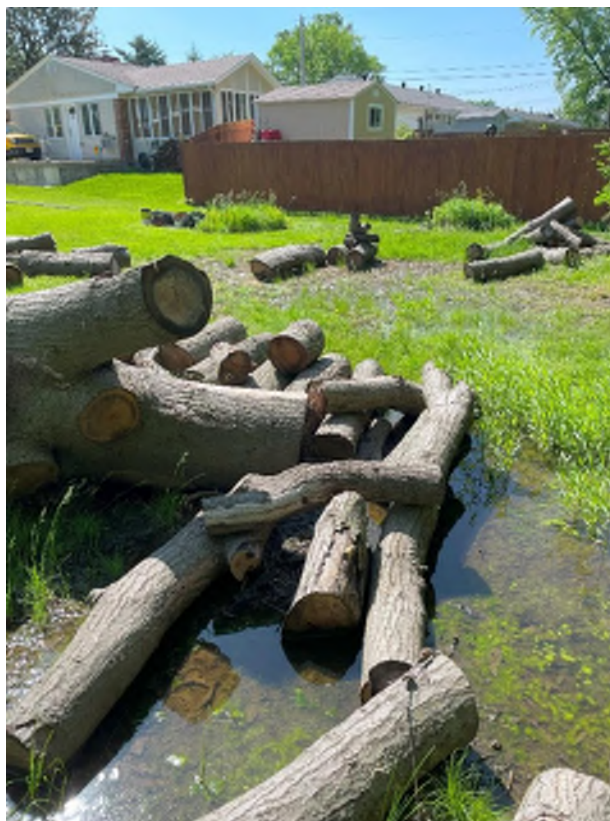
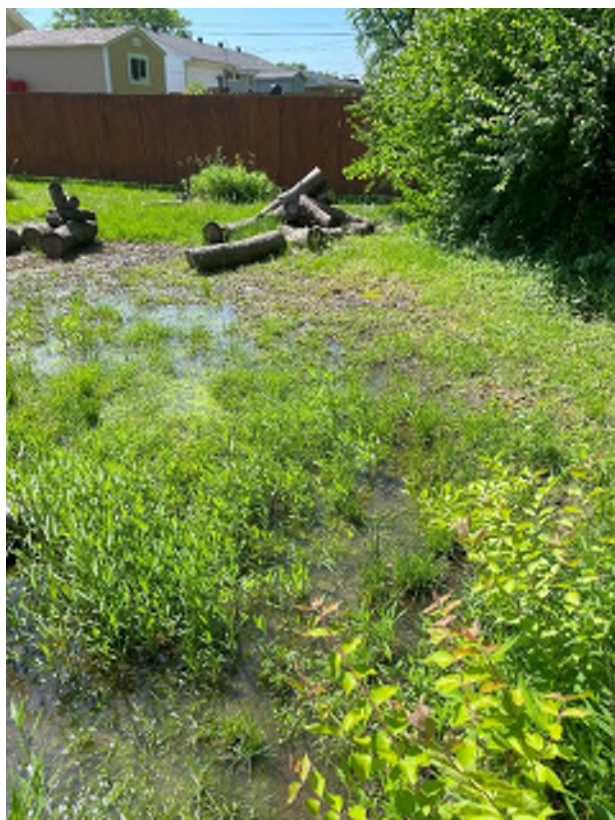
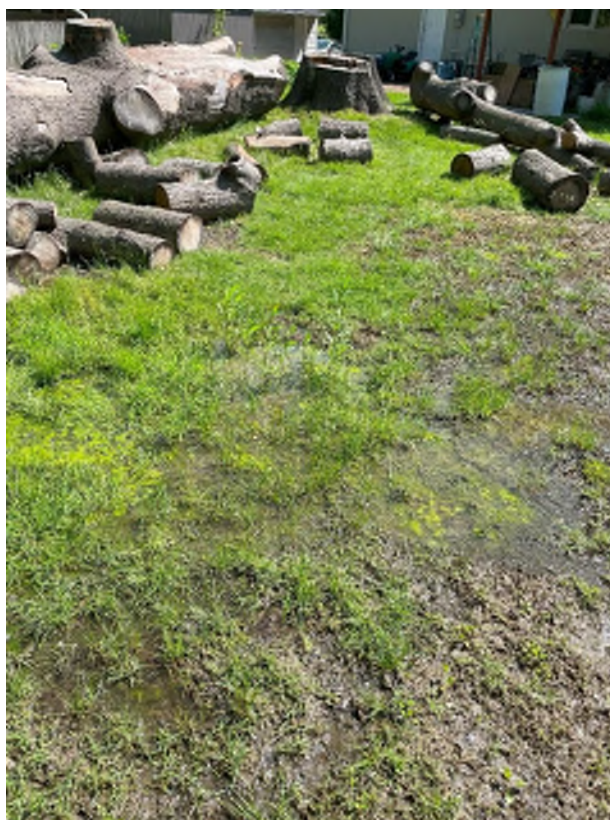
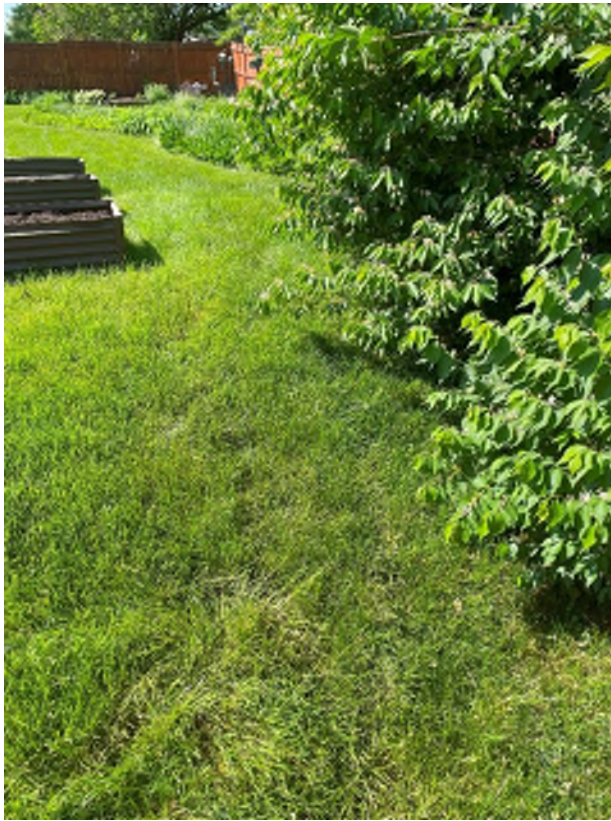
xii. MC-17 8701-8715 Gayle Avenue

The properties located at 8701 through 8715 Gayle Avenue were inspected following reported issues. No deficiencies related to stormwater drainage were observed at 8701 and 8715. However, significant drainage concerns were identified at the rear yard of 8709. The backyard area of this lot exhibits multiple locations of standing water, indicative of poor surface drainage and the absence of a defined outfall or positive drainage path for stormwater runoff. Additionally, the accumulation of tree logs and other vegetative debris along the rear yard further impedes stormwater flow and will require removal as part of remediation.

To supplement the storm sewer system, a 190-foot swale will be constructed along the rear yards of Lots 8701 and 8709 to promote positive drainage and direct surface flow toward the area inlets. Field observations indicate the presence of an existing swale; however, it lacks adequate slope to convey stormwater effectively, resulting in ponding conditions. The proposed improvements are designed to mitigate these issues by enhancing both surface and subsurface drainage.

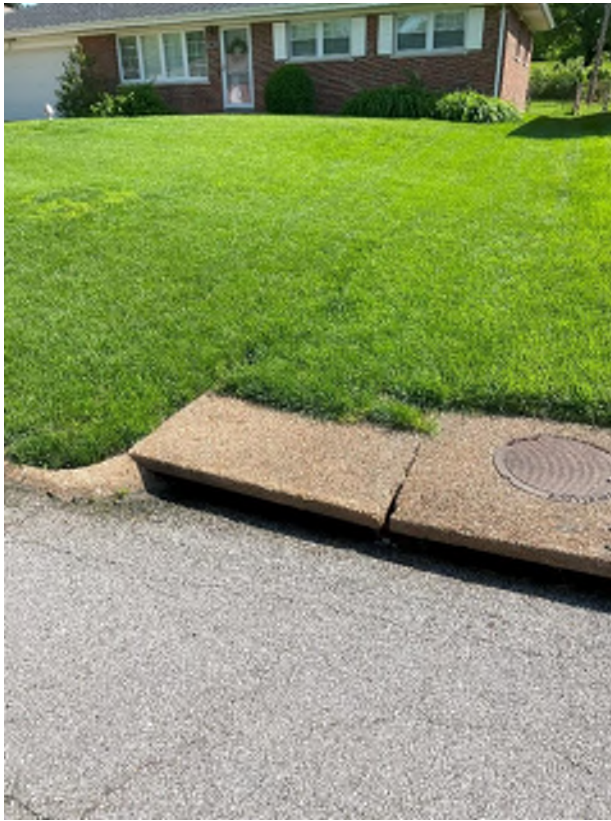
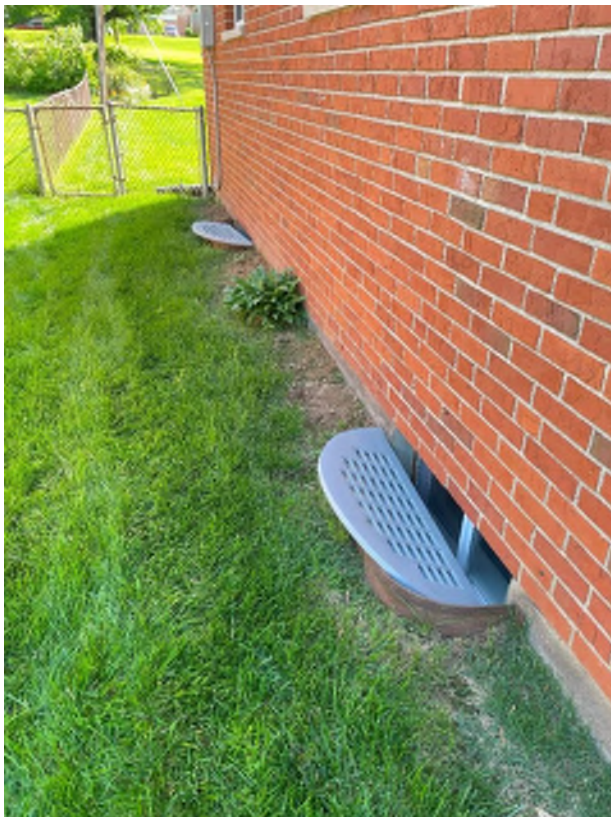
xiii. MC-18 8718-8722 Villa Crest Drive

A shallow swale is situated between the residential properties located at 8718 and 8722 Villa Crest Drive. Based on field observations, the swale lacks sufficient depth to effectively convey stormwater during higher intensity storm events. Both residences have basement windows that are recessed within window wells. Due to the limited depth of the swale, there is a potential risk that during significant rainfall, stormwater may overtop the window wells and enter the basement areas. Additionally, subsurface drainage infrastructure was observed within the swale, consisting of private grate inlets located near the upstream end adjacent to the fence line. These drains are connected via piping and discharge to the existing public roadway at the downstream terminus of the swale.

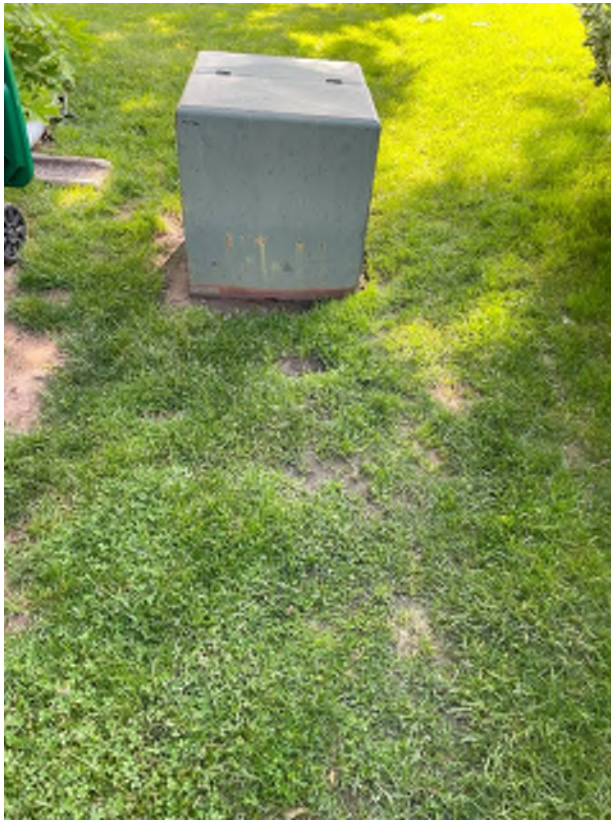
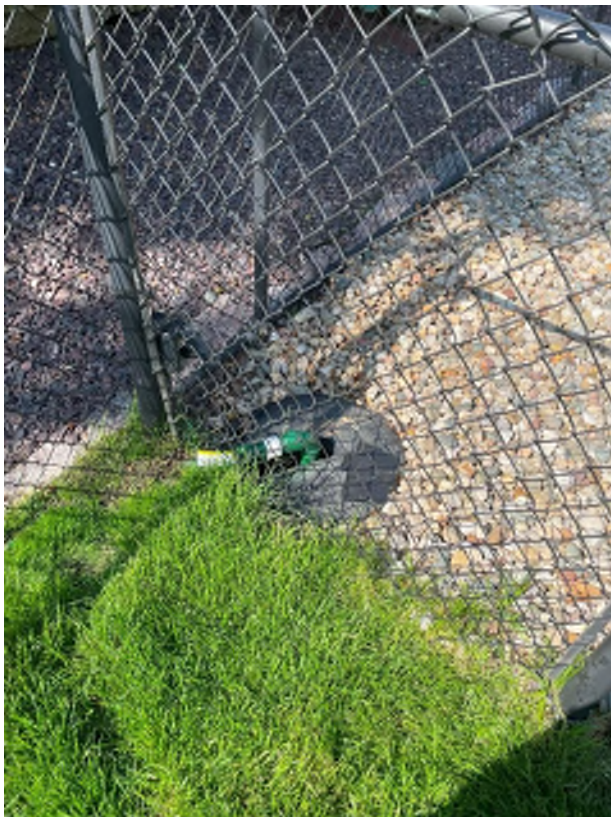
xiv. MC-19 9409 Sappington Greens Lane

The property owner at lot 9411 Sappington Greens Lane is having a flooding issue on the side yard. From the field investigation carried out by Horner & Shifrin, it was noted that there were two external sump pumps located in the side yard. One was found in the back yard of 9411 Sappington Greens Lane and the other was found in the side yard of 9415 Sappington Greens Lane. These sump pumps were probably added due to the flooding issue in the side yard and discharge onto Sappington Greens Lane. The addition of the sump pumps appears to resolve the side yard flooding. MSD or the City will need to check if sump pumps added by the property owner meet their respective requirements. Another issue that was found was an existing transformer located between lots 9407 and 9411 Sappington Greens Lane is in a low point. The homeowner at 9407 Sappington Greens Lane has stated to Horner & Shifrin that water ponding occurs at the transformer. Grading up around the transformer and making a high point around it to direct the stormwater towards the existing area inlet on the west or to drain towards the street will resolve this issue. The estimated probable project cost is approximately \$9,200.

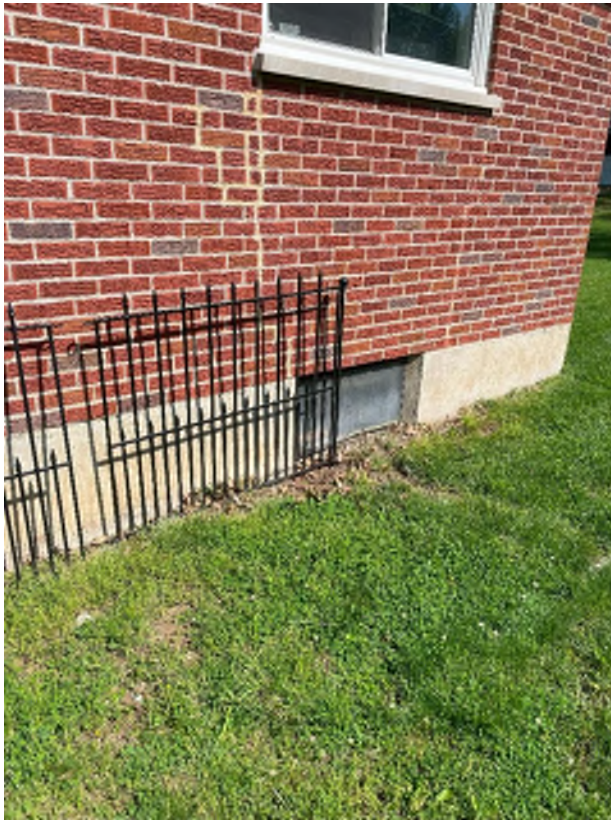
xv. MC-21 8856 Glen Rose Drive

A field investigation was performed at 8856 Glen Rose Drive for stormwater drainage issues in the area. Along the side yard of 8856 and 8862 Glen Rose Drive, a shallow swale was found along with a low point along the swale. The low point is located near a basement window and could cause an issue if a higher storm event occurs. The swale does not have a positive slope to drain towards the roadway. The front and back yard downspouts are collected and are being discharged at the downstream end of the swale towards the roadway.

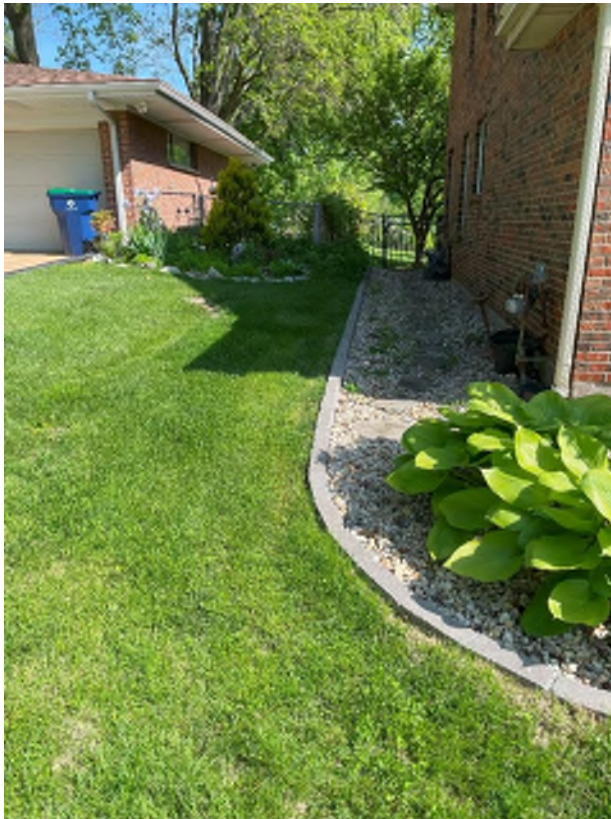
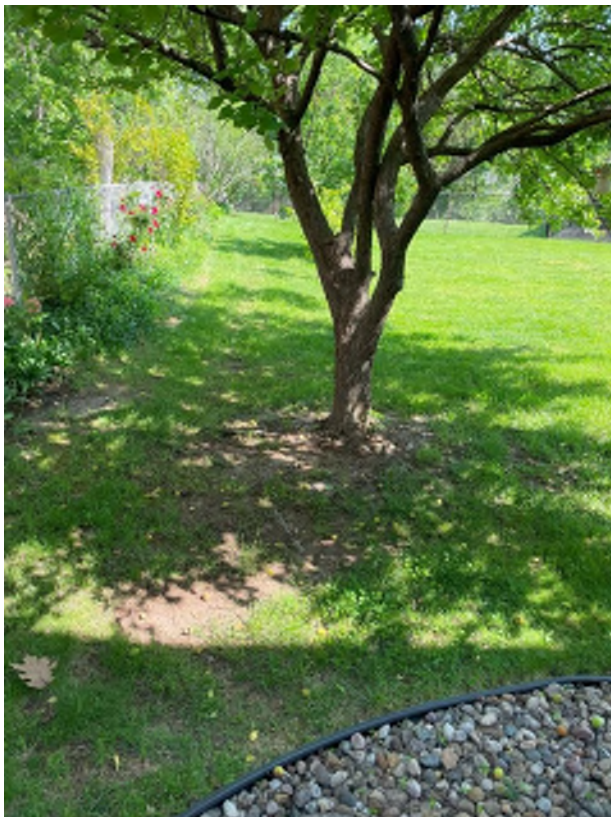
xvi. MC-22 9875 Richter Lane

A swale is located along the side yard of 9875 Richter Lane. The swale is in good condition but does not have a constant slope along the length of the swale. Regrading the swale to have a constant slope will provide better drainage for the front yard and avoid ponding along the swale. The estimated probable project cost is approximately \$6,100.

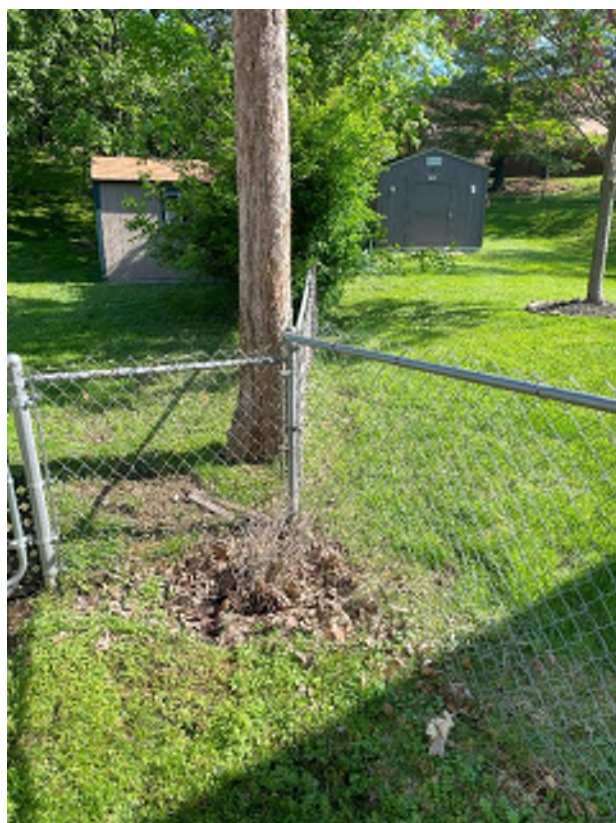
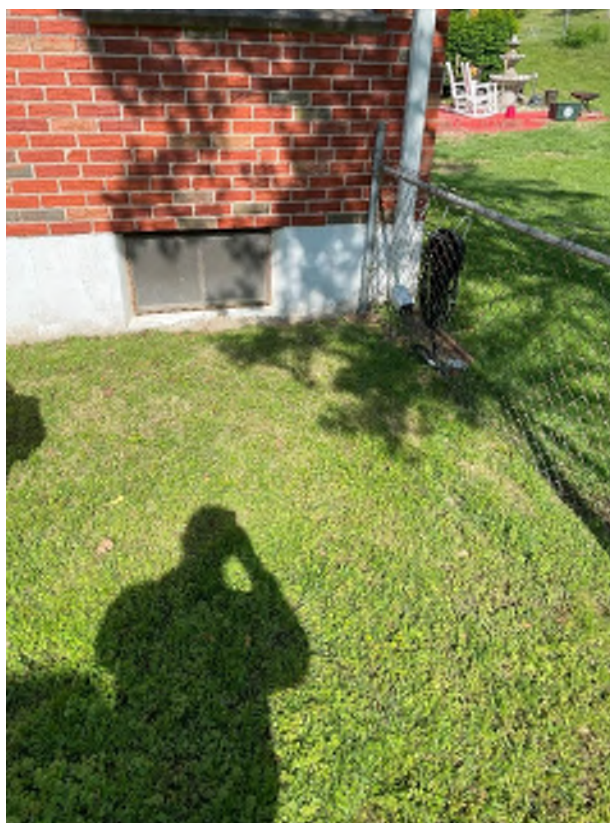
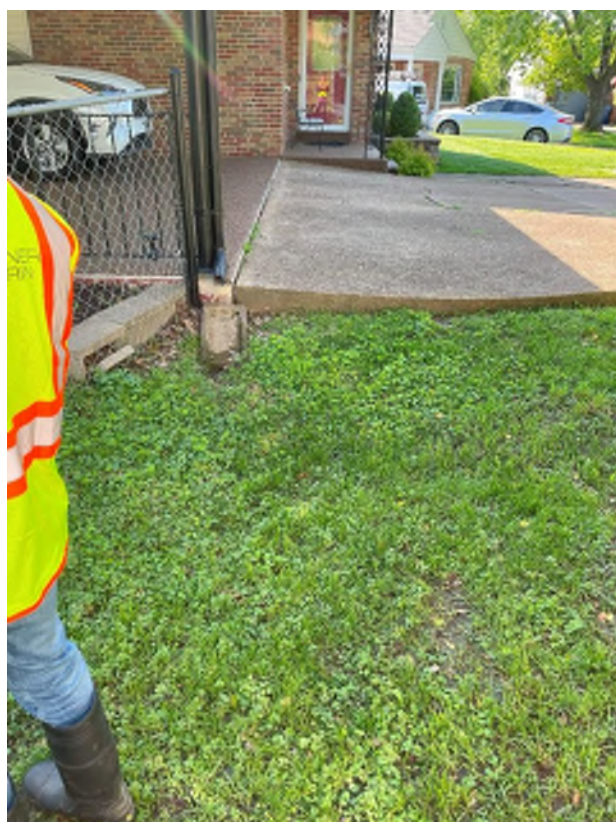
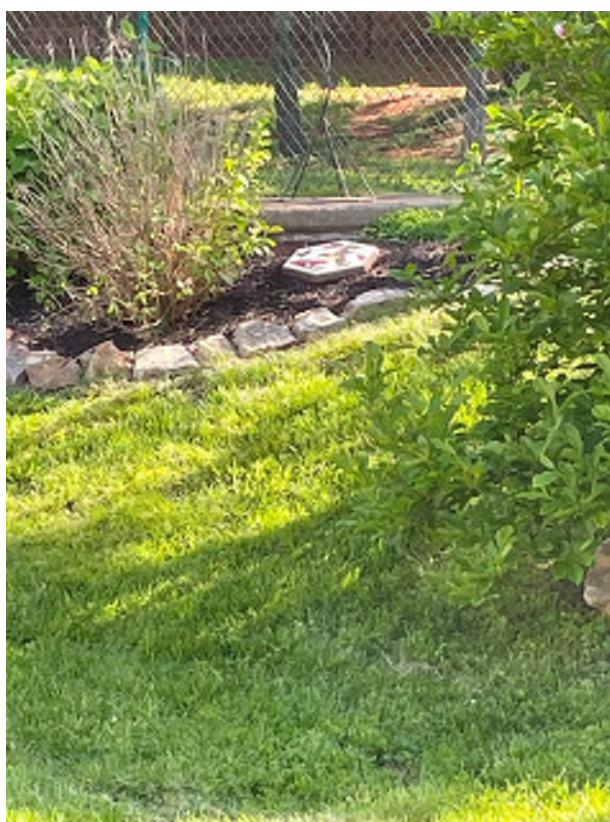
Figure 6.c.xviii-2 9501-9503 Crain Court

Erosion was found in the lots between 9501 and 9503 Crain Court. This is creating a low point where the fence is located on 9501 Crain Court. The downspout for 9503 is discharging at this low point, as well as the downspout for the garage roof of 9501 Crain Court. This is creating ponding in the side yard that could flood the houses.

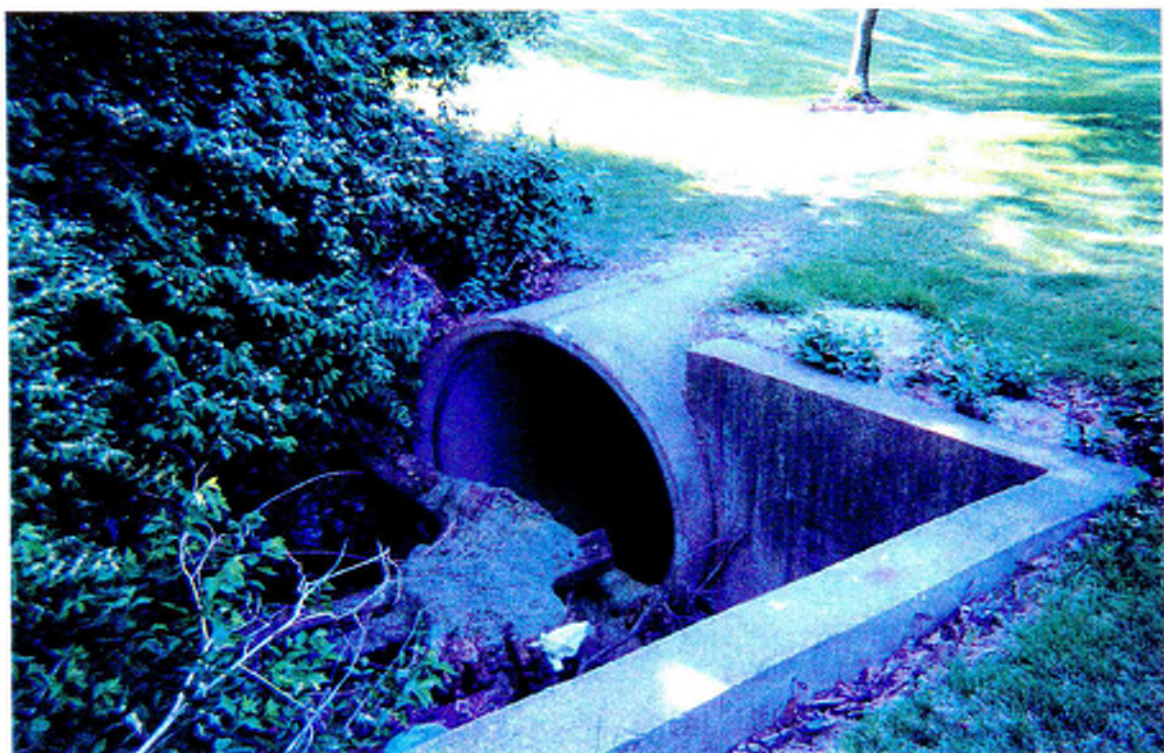
Figure 8-3. 9000 Whitehaven Drive (GC-1)

Residents located between 9047 and 9071 Whitehaven Drive are reporting building flooding along the northwest bank upstream of the existing 8- by 4-foot box culvert, labeled 26K1-006D, under Whitehaven Drive. The box culvert is undersized for the 15-year event, which is the cause of the flooding.

The recommended solution involves increasing the conveyance capacity of the culvert by either replacing the existing culvert with 300 feet of 12- by 4-foot RCB with walls at angles between 30 to 70 degrees, or installing 300 feet of parallel 4- by 4-foot RCB. The recommended solution is to construct the parallel RCB. This solution was selected because the existing RCB is in good structural condition, which makes it cost-effective to install a smaller parallel RCB. The estimated probable project cost of the recommended solution is approximately \$221,000.

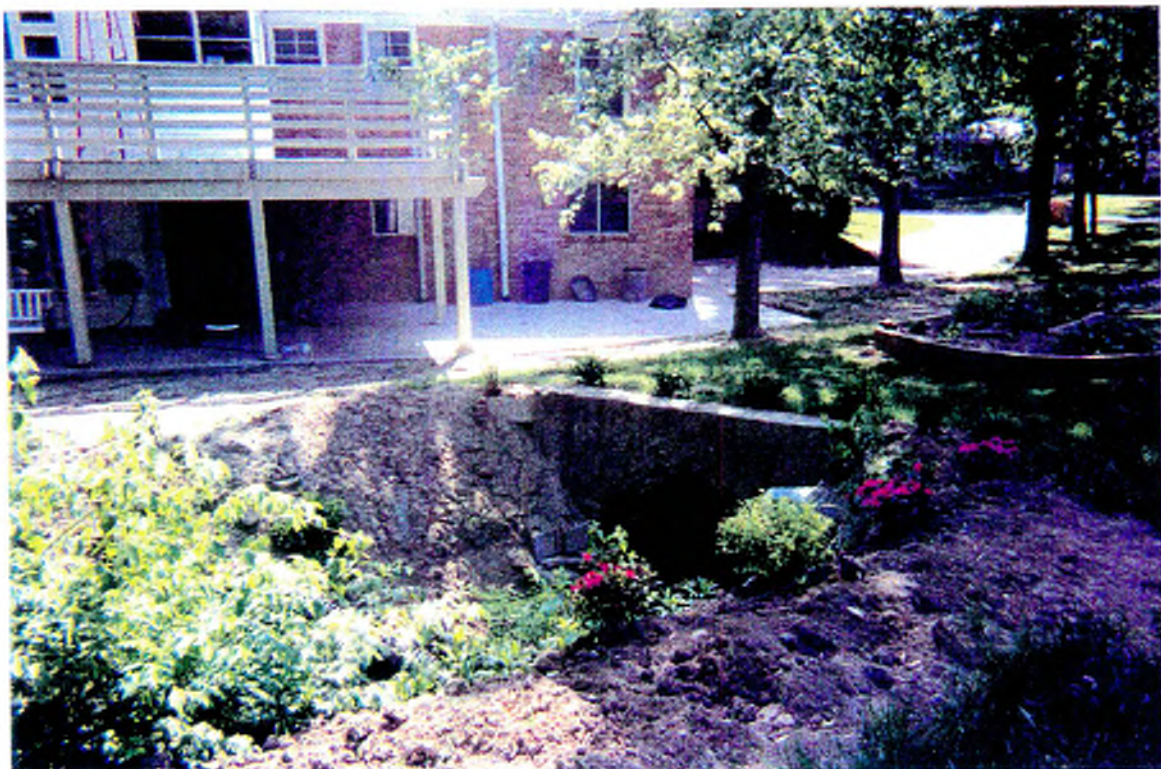
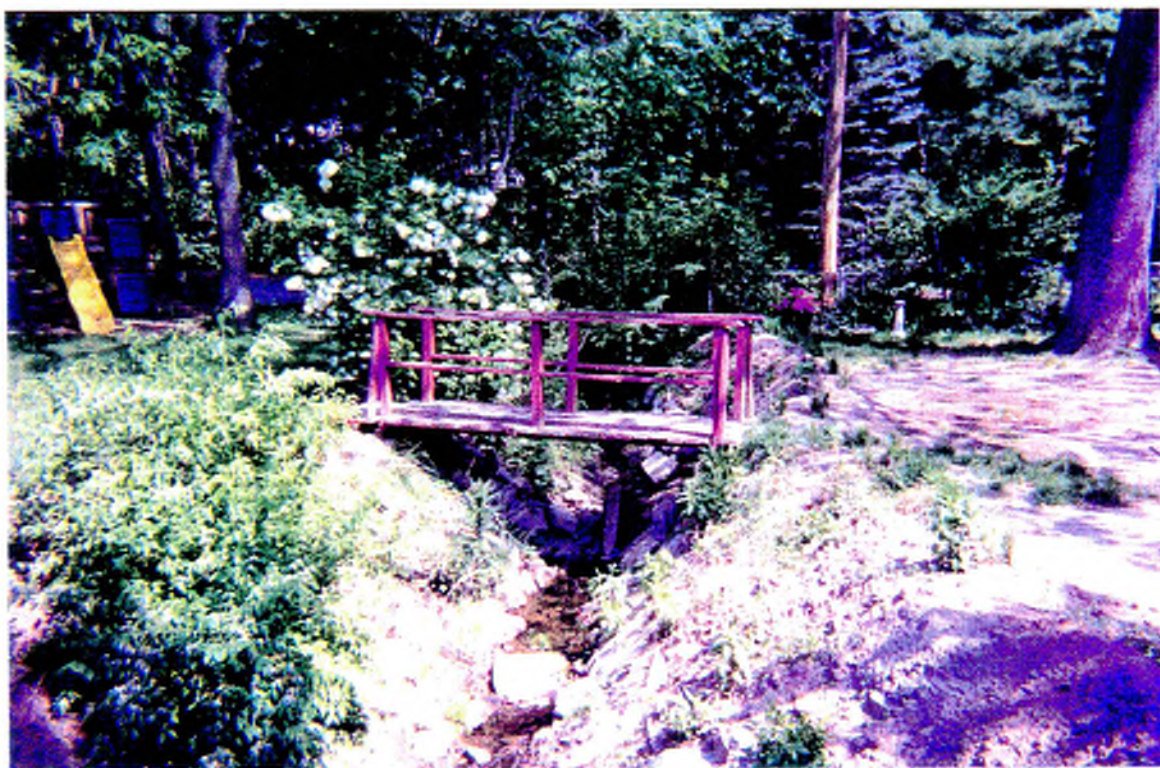
Figure 8-7. 9107 Grant Park Drive (GC-3)

Resident at 9107 Grant Park Drive is reporting flooding in the backyard. An open channel enters an enclosed system behind 9107 Grant Park Drive. The flooding is caused by the lack of adequate headwater depth and no overflow channel at the entrance of the 54-inch RCP, labeled 25K4-052D, which causes flooding of adjacent buildings. Two alternative solutions were evaluated:

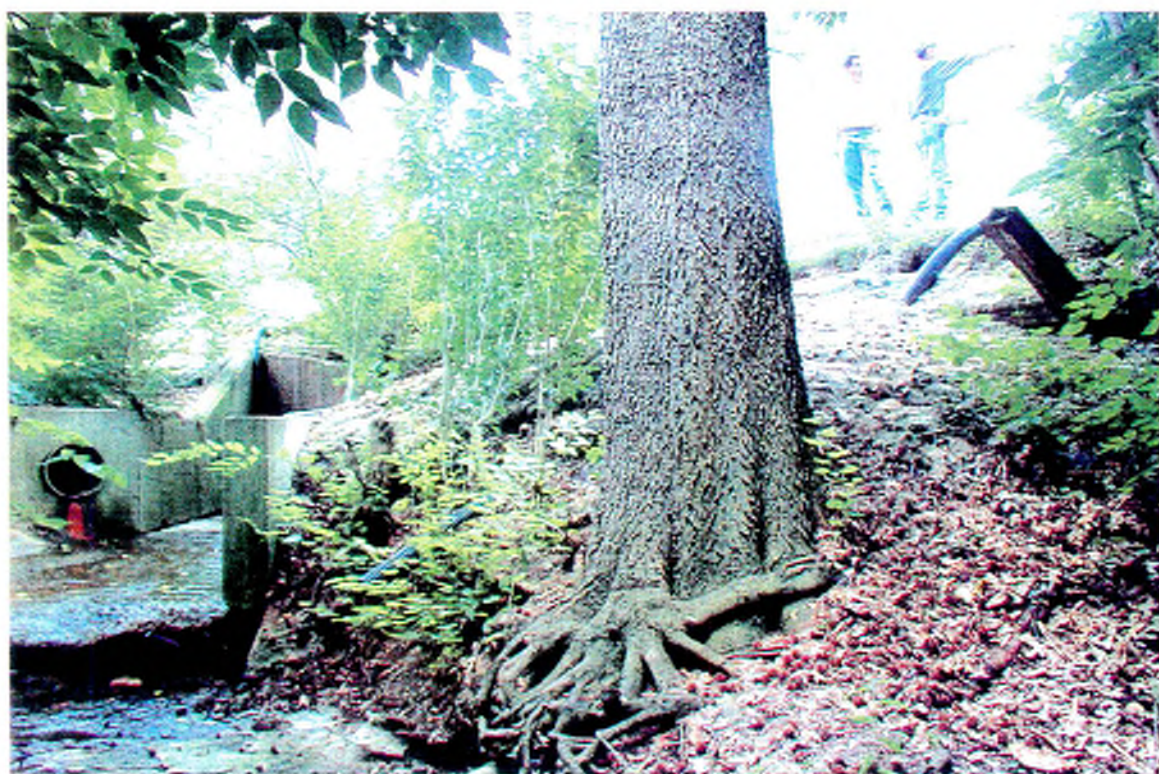
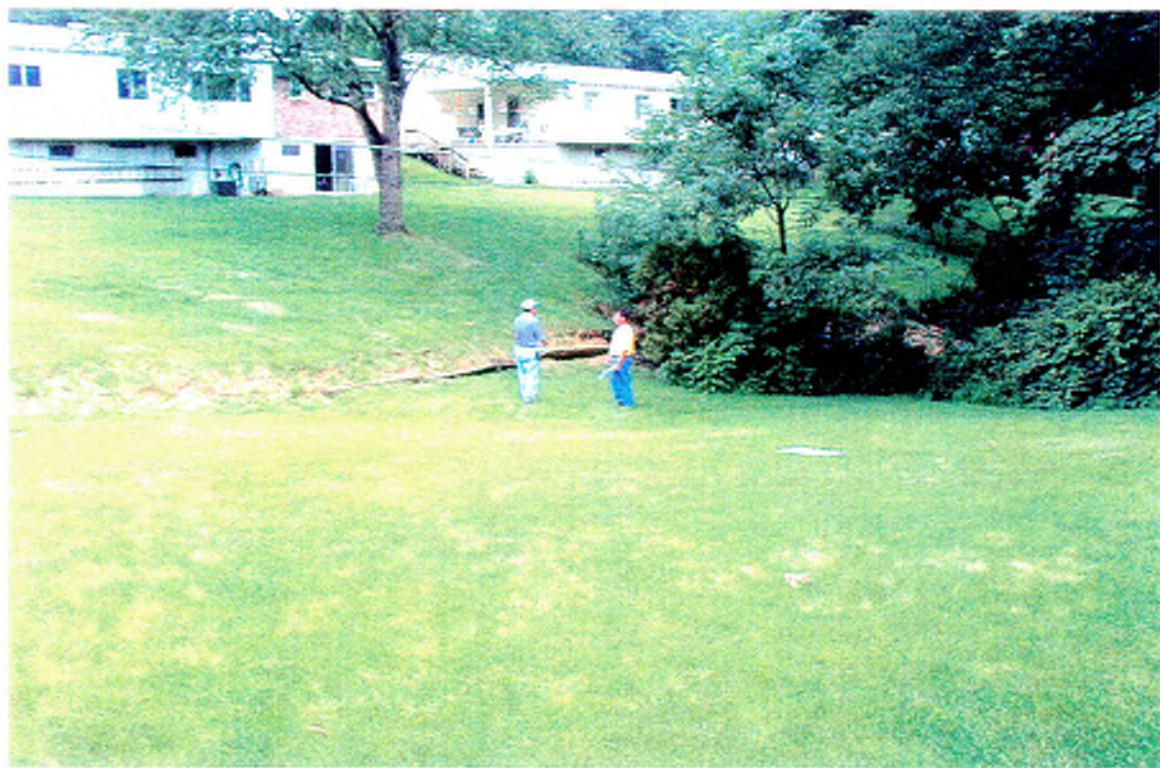
Figure 8-10. 9000 - 9012 Cordoba Lane (GC-4)

Yard drainage is eroding the west creek bank and yards behind homes located from 9006 to 9024 Cordoba Lane. The erosion is affecting the outlet headwall, which is directly behind 9012 Cordoba, and has resulted in a washed out area adjacent to the headwall. The outlet headwall provides structural support for two outfall pipes, labeled 26L2-164D and 26L2-165D. Bank erosion was observed just downstream of structural wall systems behind 9006 Cordoba. Two alternative solutions were evaluated:

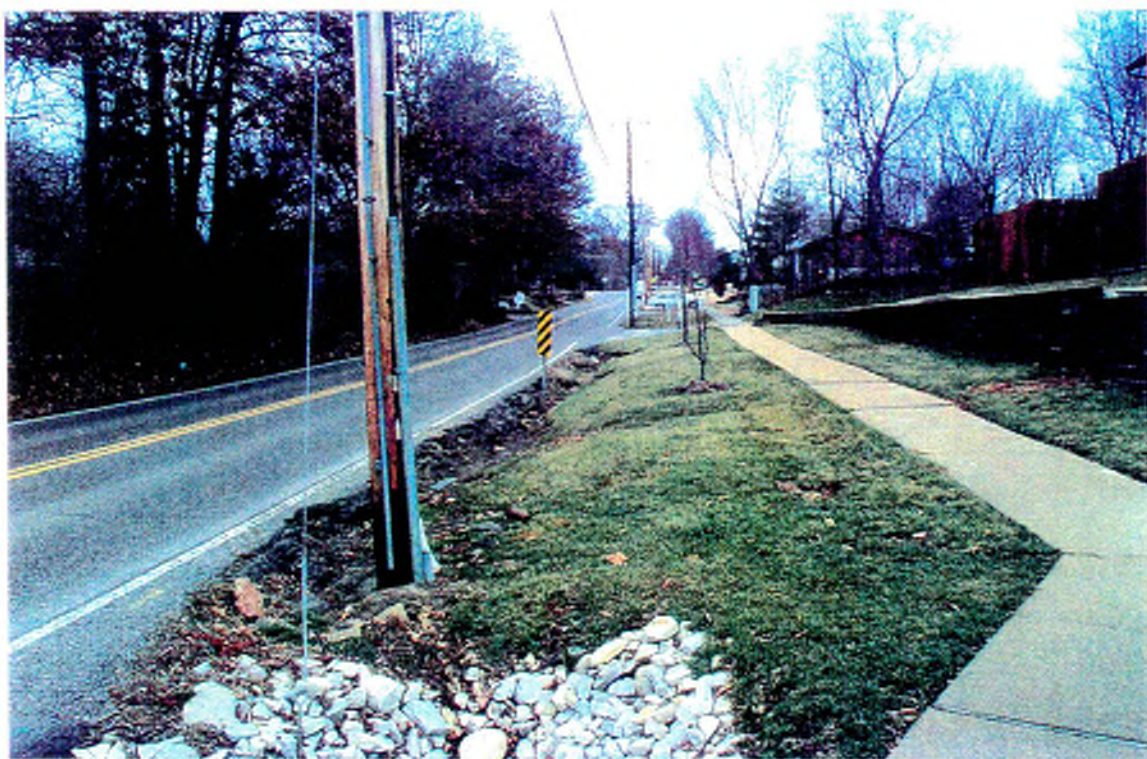
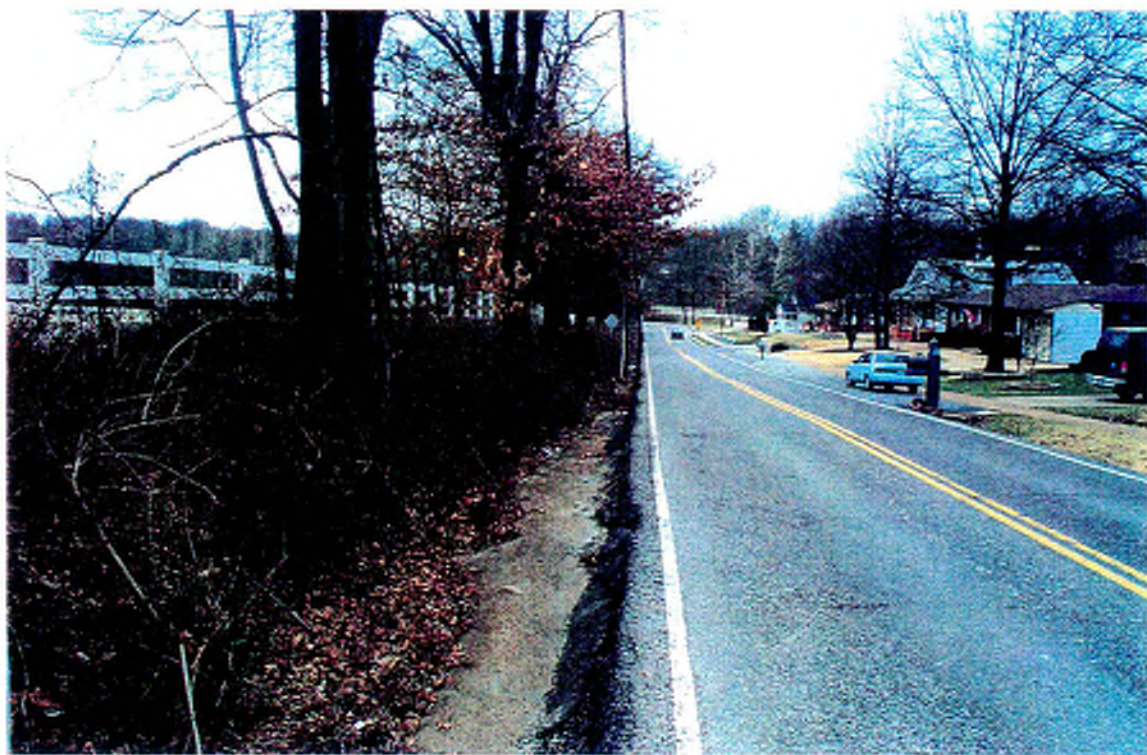
Figure 8-13. Pardee Road (GC-5)

Pardee Road contains inadequate roadside drainage that is causing flooding on the south side of the road between 8951 Pardee Road and Gravois Creek. The recommended improvements include installing 900 feet of s-curb, and 900 feet of RCP that ranges from 12- to 30-inch diameter, and three curb inlets to adequately drain the surface of the road. In addition, the restoration measures will include sod using a RECP for stabilization due to the steep slopes adjacent to the roadway. The estimated probable project cost is approximately \$343,000.

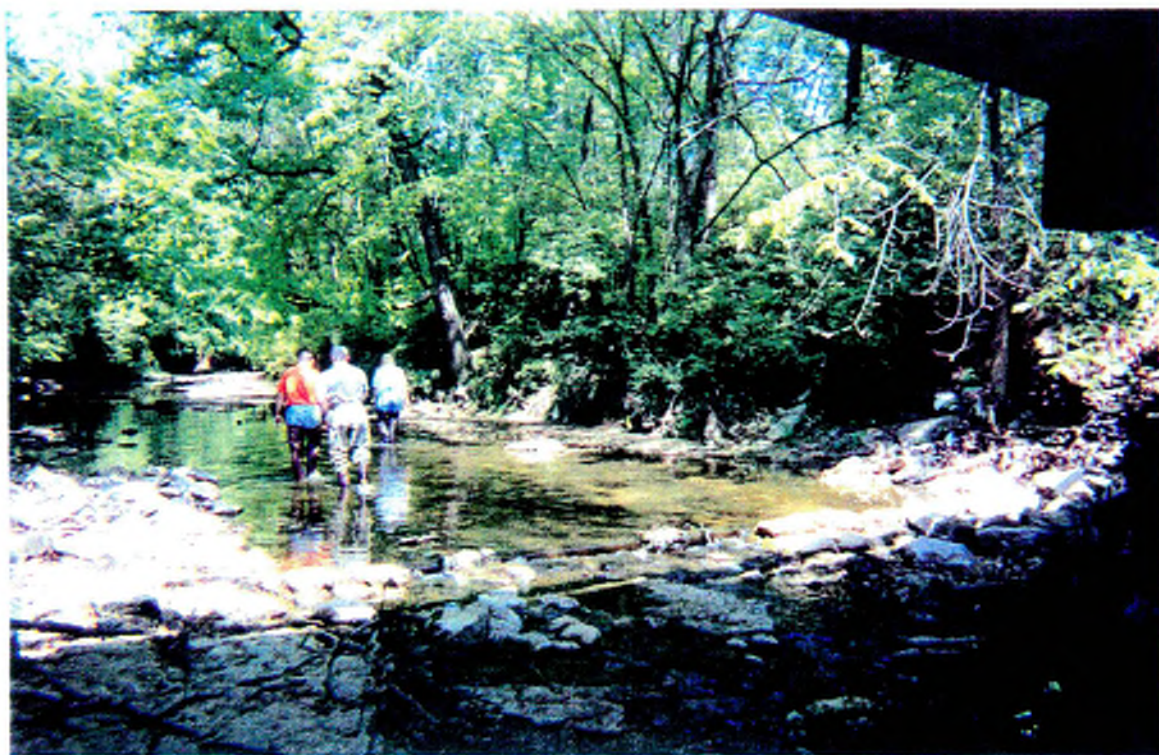
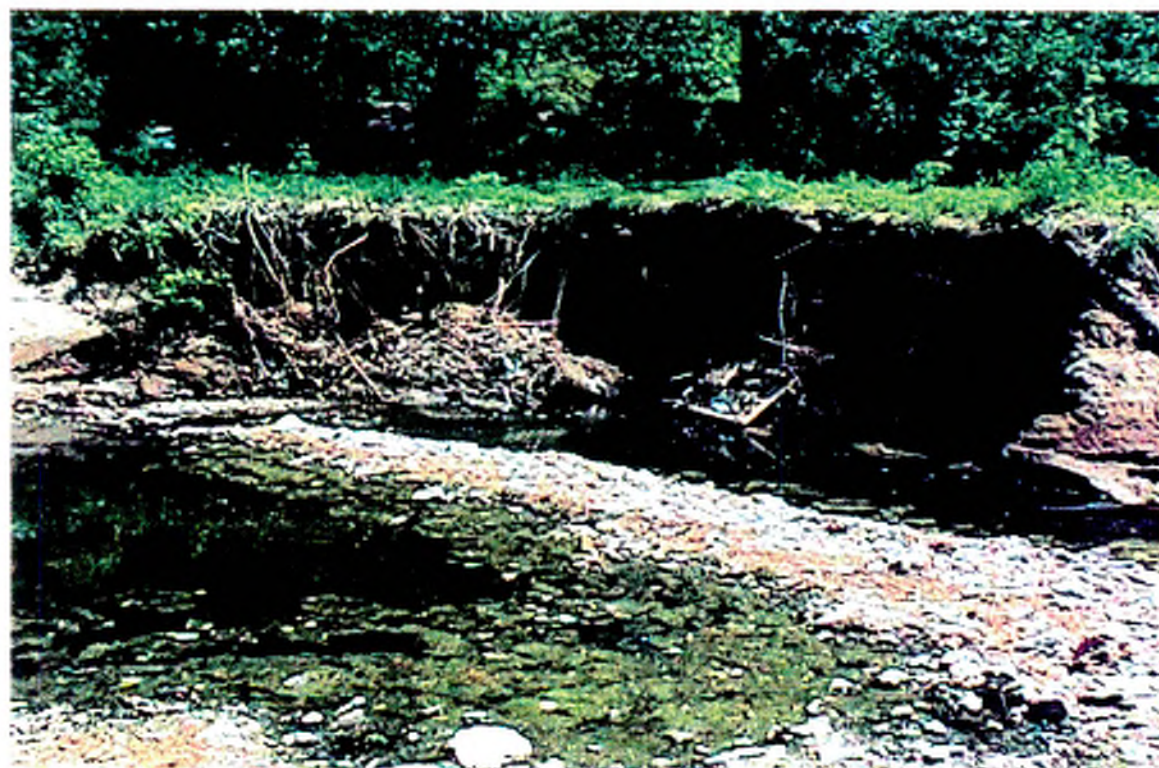
Figure 8-16. Whitecliff Park/Pardee Lane (GC-6)

Two problems are occurring in Whitecliff Park along Gravois Creek. The creek, from the mouth of Mulberry Creek to the city limit boundary of Crestwood, exists in a natural channel configuration. The first problem is erosion that is damaging the banks of the channel. The other problem is the flooding in the parking area southeast of the Park Service Road Bridge and rear yards of 8711-8737 Pardee Lane. The majority of the park is flooded during the 15-year event, with 5 feet of water overtopping the bridge.

conveyance of flows during large flood events. If this flood bench is created, the stream may ultimately realign itself through the flood bench area eliminating the erosion concerns on the opposite bank. Even if realignment does not occur, the erosive forces on the opposite bank will be reduced during large flood events due to the large channel cross-section. Some introduction of native riparian species should be performed in the flood bench area to promote the establishment of desirable plant species and preclude the establishment of undesirable vegetation. However, in general, the flood bench area should be allowed to develop naturally.
