STORMWATER REPORT

CRESTWOOD STORMWATER

MASTER PLAN

CRESTWOOD, MISSOURI 63126

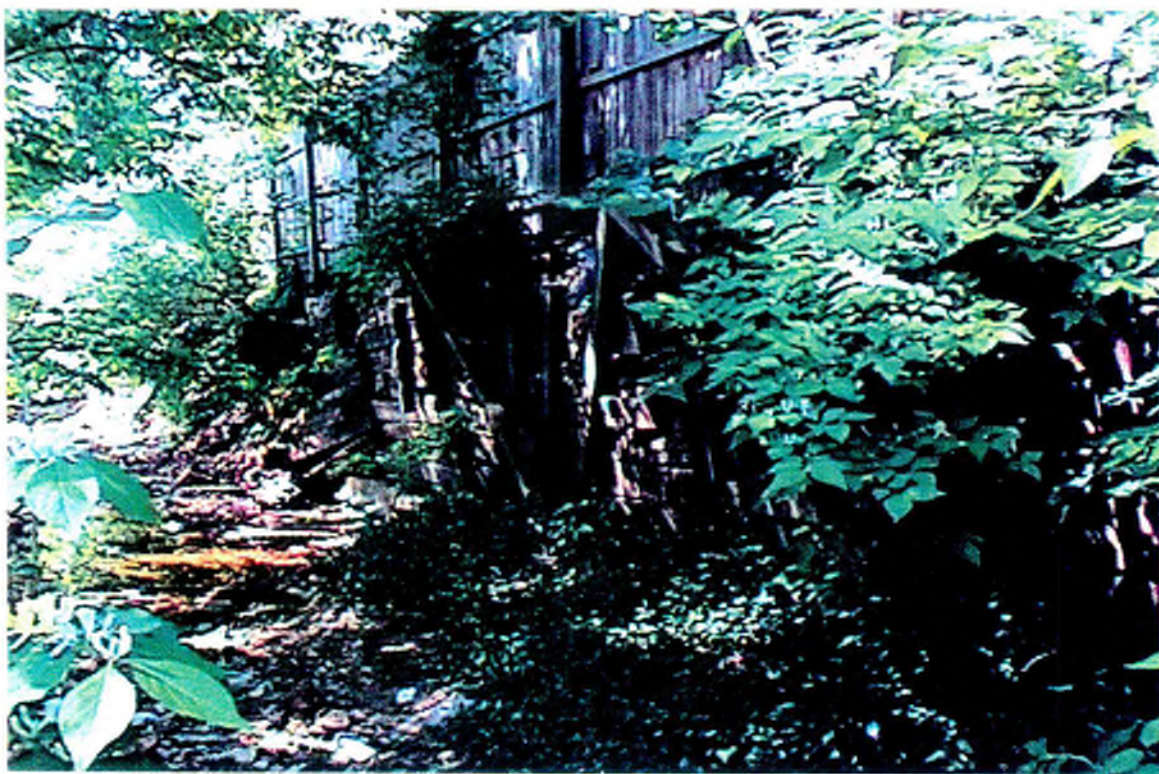
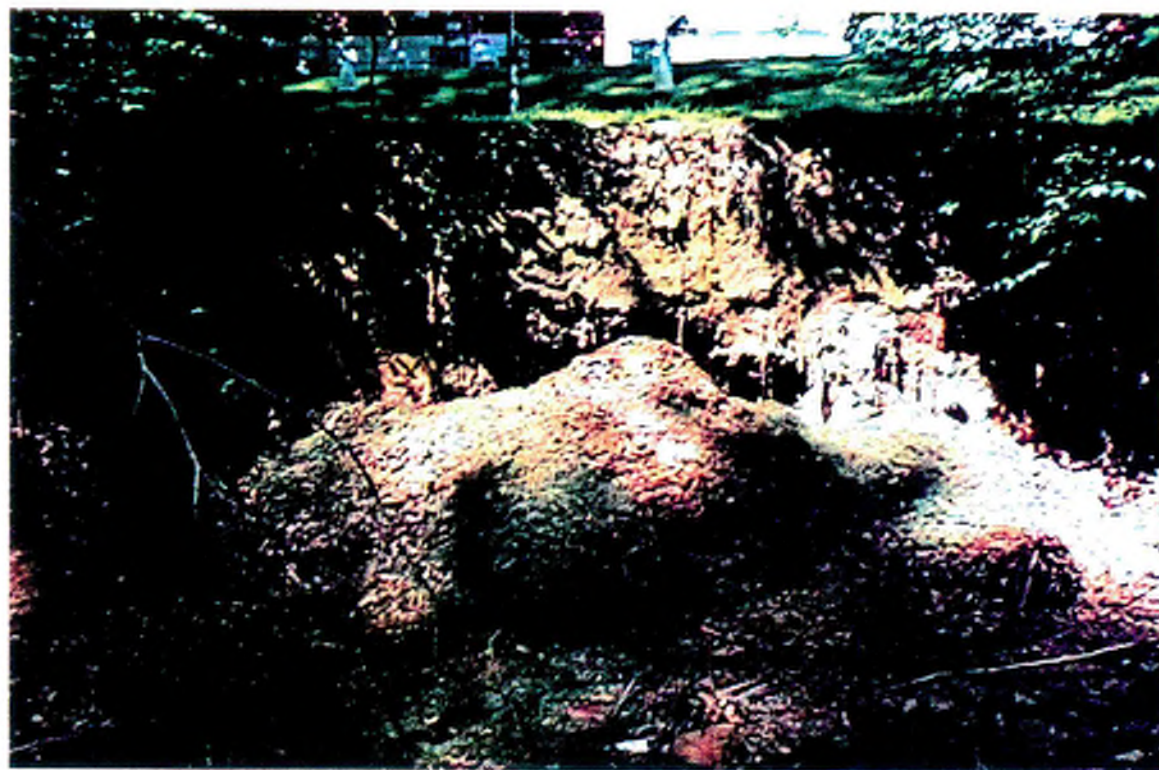
Figure 8-19. Blackthorn Drive to Grant Road (GC-7)

The natural channel between Grant Road and Blackthorn Drive, for the block lying parallel to Heather Drive, is eroding. This channel alignment has an existing slope of 2.2-percent with flow velocities of 7 feet per second (fps) for the 2-year storm. Some portions of the channel have concrete linings, which increase the erosive velocities in these areas. Bank stabilization is needed throughout the reach. Two alternative solutions were evaluated:

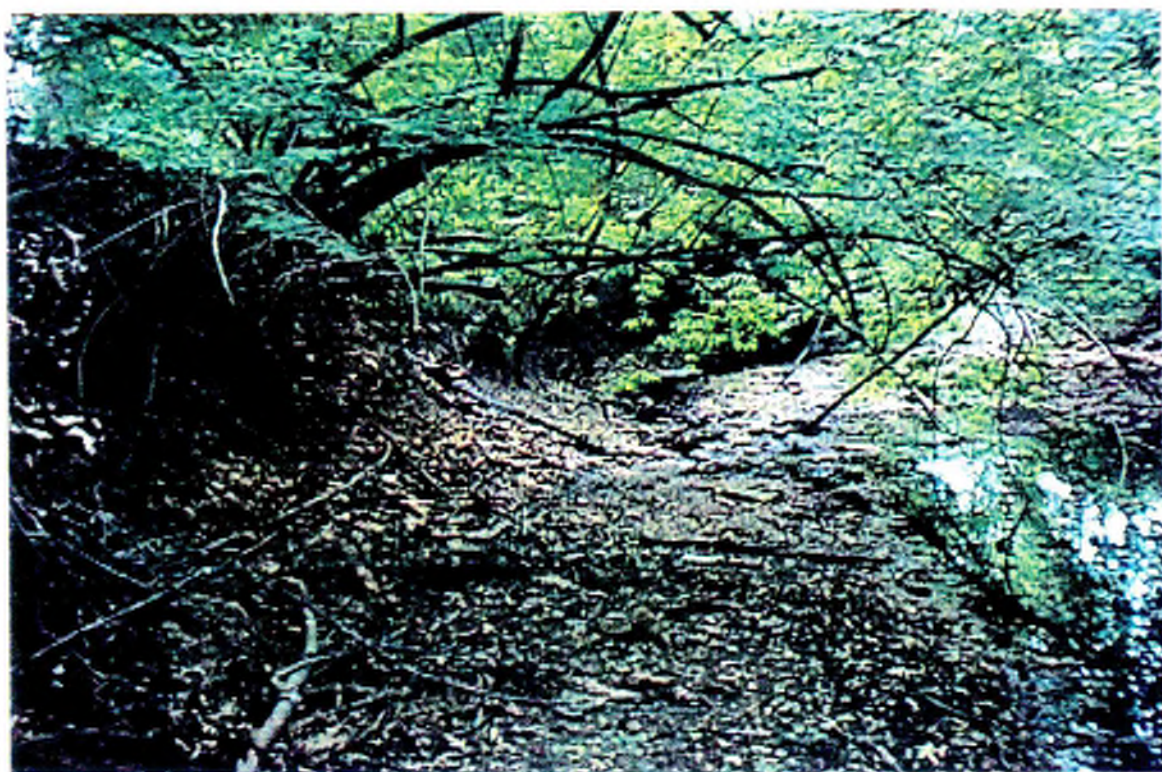
Figure 8-22. 700 Block Fieldcrest Drive (GC-8)

Street and home flooding is occurring in the vicinity of 644 to 708 Fieldcrest Drive due to inadequate gutters and curb inlets, and the undersized twin 48-inch RCP under Fournier Drive. MSD identifies this project as GCMB-130, which recommends replacing the existing culvert under Fournier Drive with a larger double box culvert, flood proofing 736 Paddock Court for 100-year protection, and providing approximately 400 feet of stream maintenance along drainage ditch.

The recommended solution is Alternative 2. Space limitations make it difficult to implement the necessary biostabilization components; therefore, structural solutions are advised at this location. Vegetative stabilization may be implemented in conjunction with the gabion basket solutions in zones of transition adjacent to the structural systems to provide a more aesthetically pleasing improvement in the backyards of several properties.

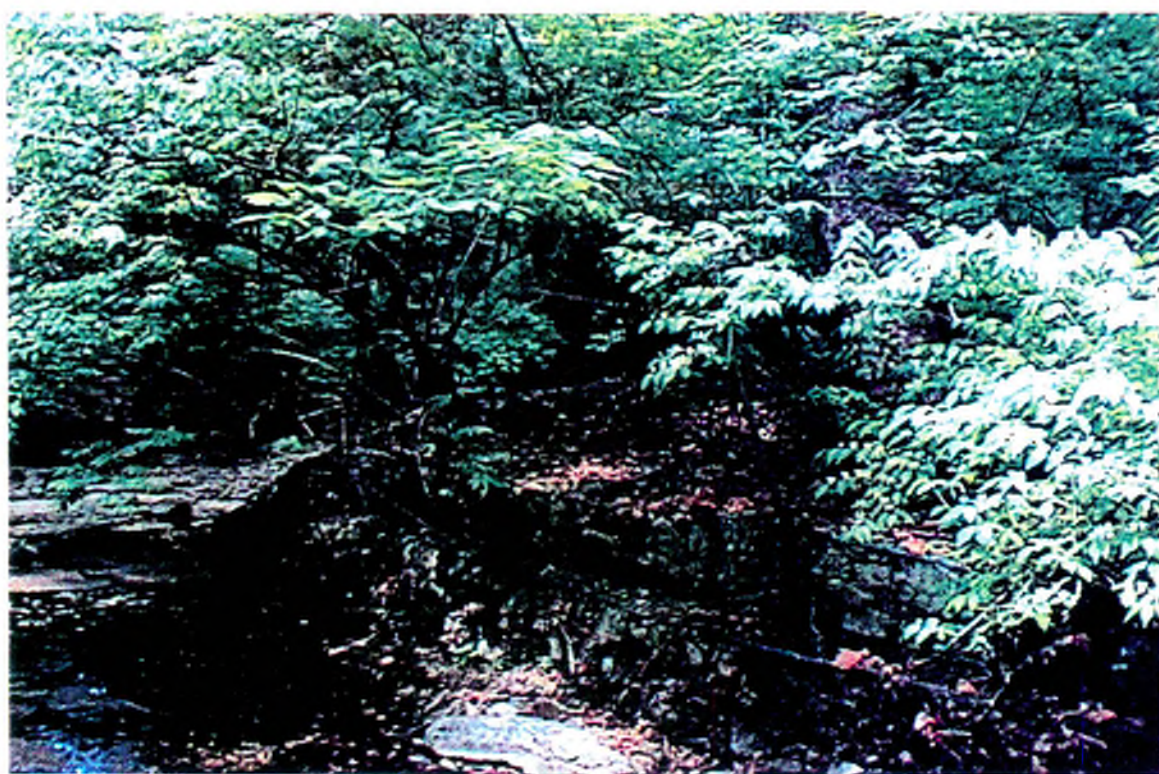
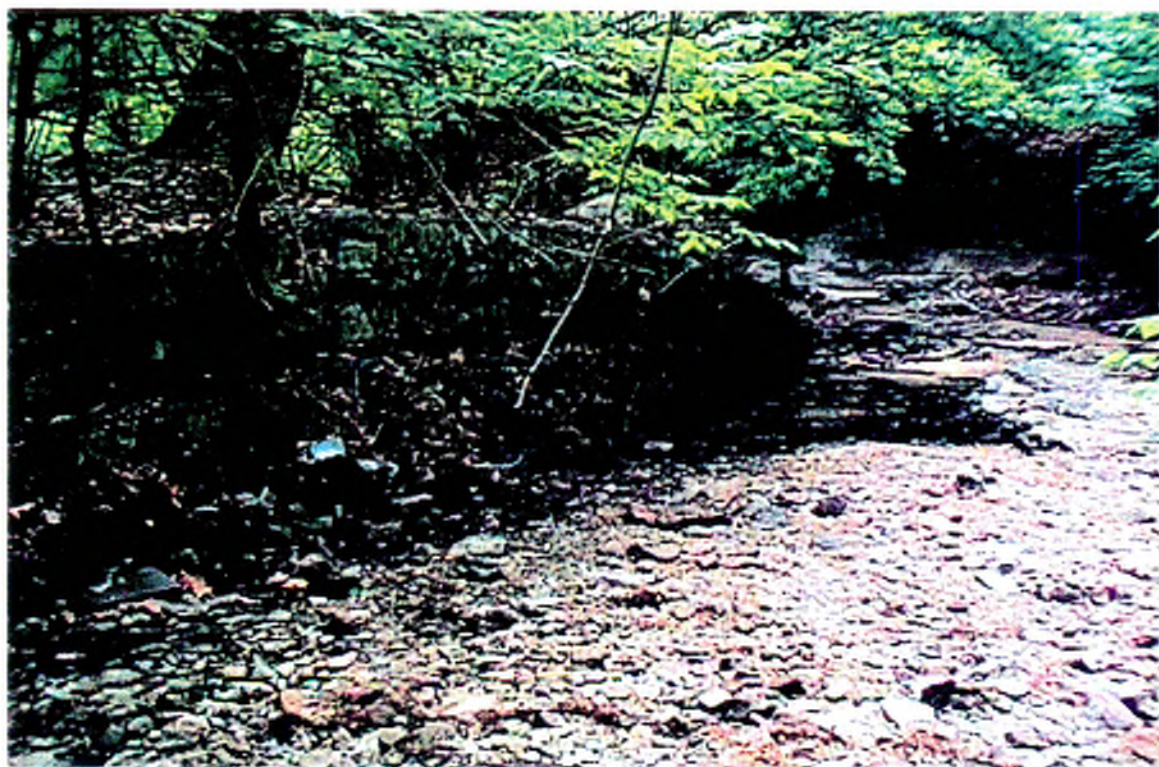
Figure 8-26. 1022 Diversey Drive (GC-10)

The existing gabion walls along the west bank of Gravois Creek in the vicinity of 1022 Diversey Drive are damaged. The entire wire basket foundation of the lower baskets is corroded and failing for about 200 feet of channel reach. In addition, higher flows have caused the wall to topple in a 40-foot section of this reach. Two alternatives were evaluated:

The recommended solution is Alternative 1, which includes the development of a flood bench and biotechnical stabilization to restore the aesthetic park setting.

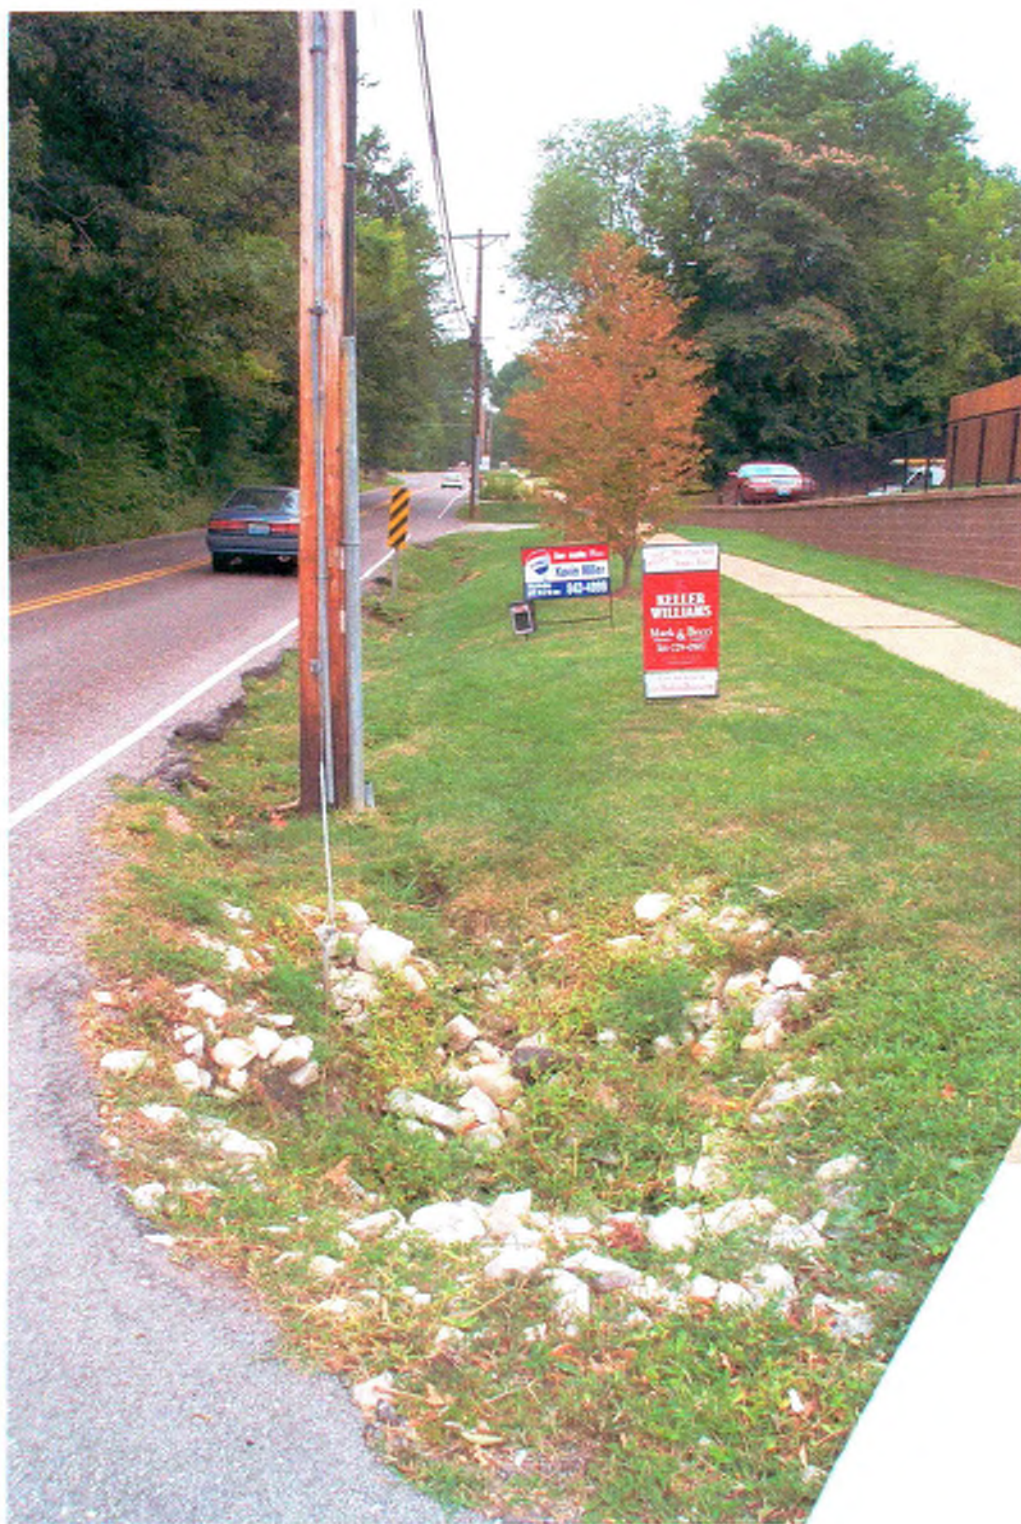
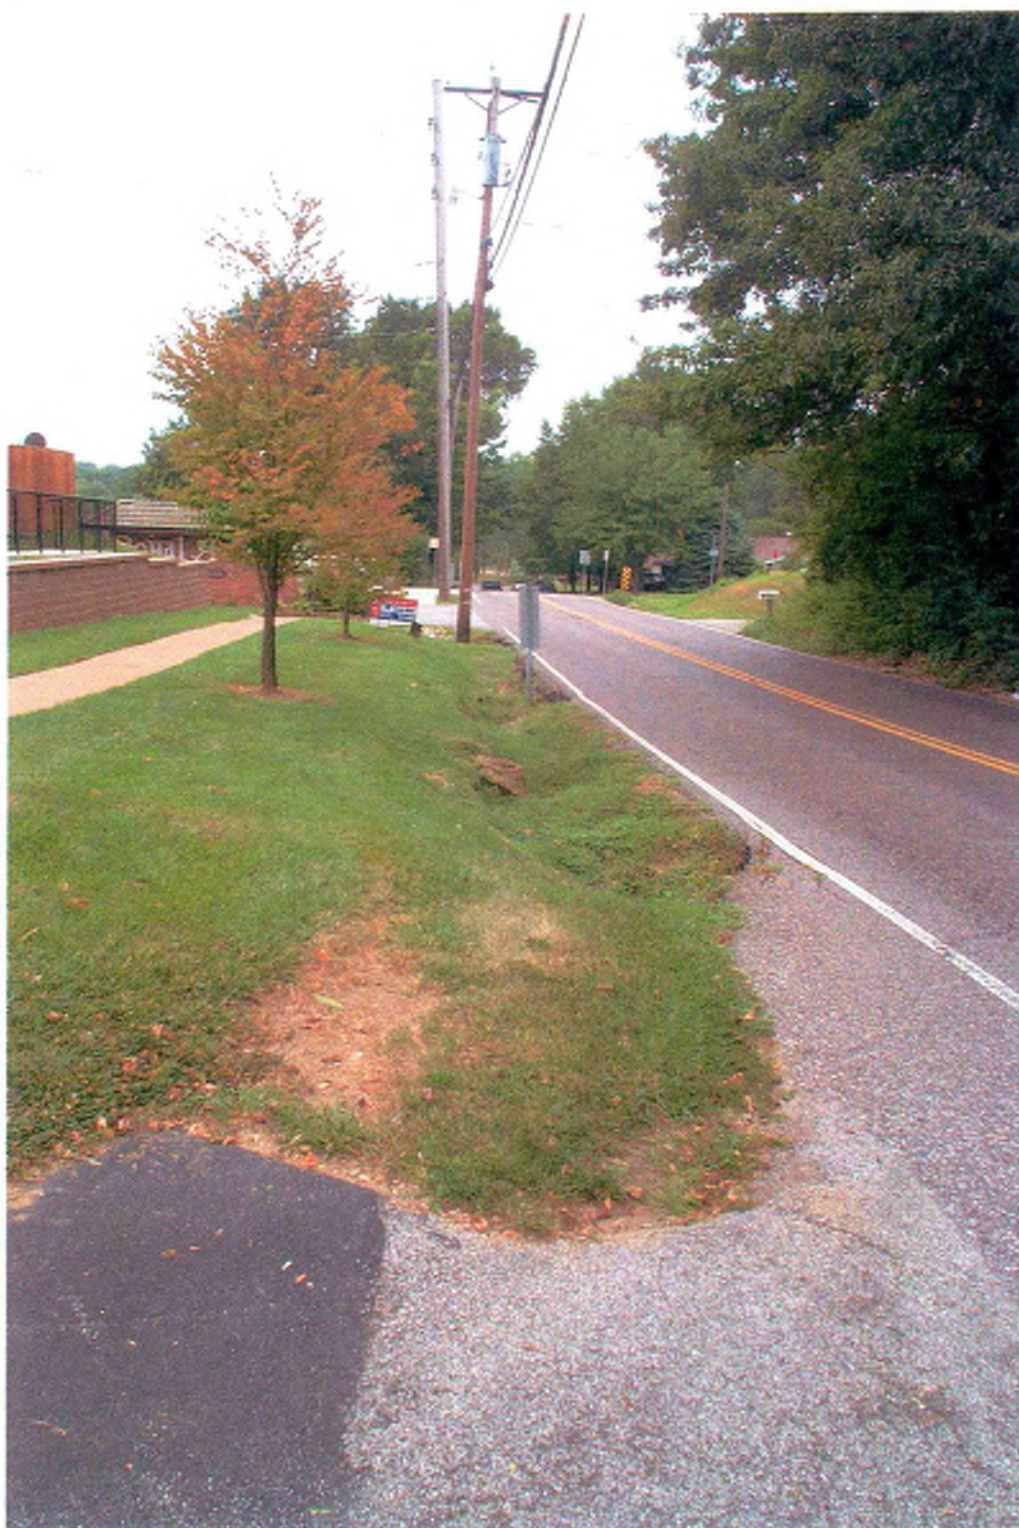
Royal Arms (GC-11)

The existing grass parkway between Pardee Road and the sidewalk at the Royal Arms Condominium Complex is eroding. Storm water discharges from an existing 12" RCP and flows in a ditch within the parkway until it collects again at an 18" RCP just north of the south entrance to Royal Arms Condominiums. The ditch is eroding, aesthetically unpleasing, and a potential hazard for motorists driving off the edge of Pardee Road.

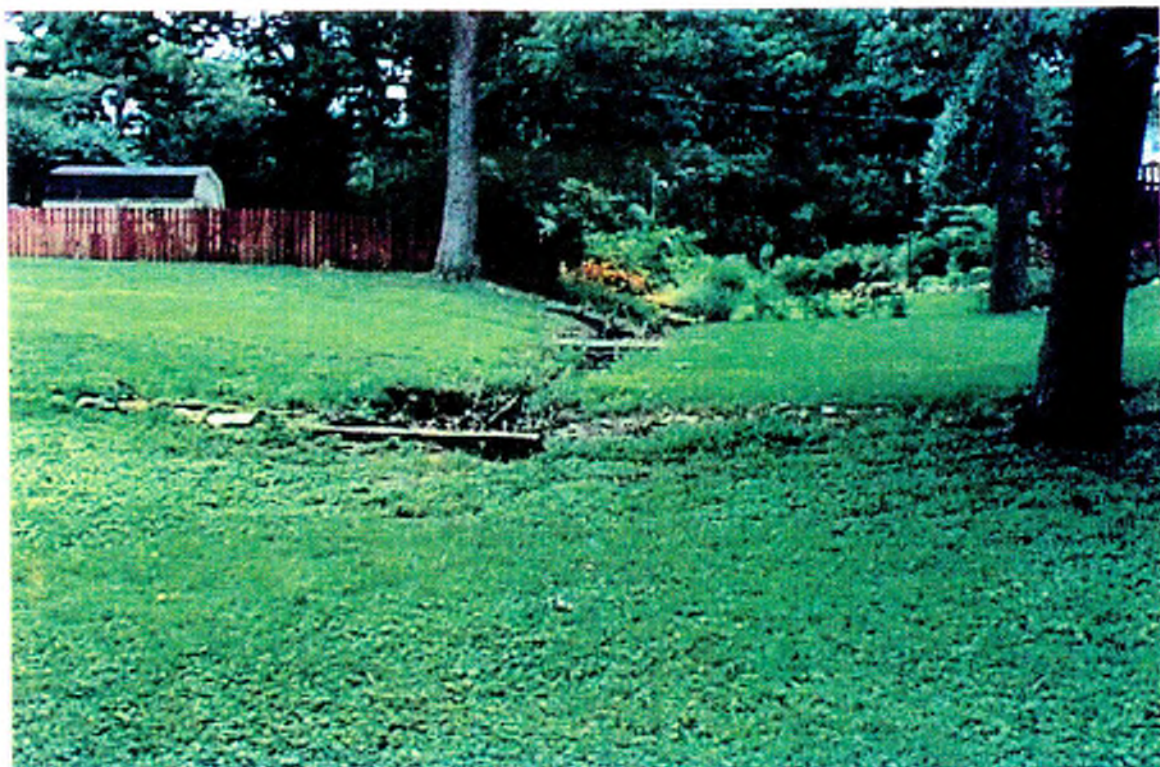
Figure 8-29. 9724 - 9700 Greenview Drive (KC-1)

Erosion is occurring in the backyards of residences between 9704 and 9720 Greenview Drive. Concentrated surface runoff, which originates from upstream impervious areas of parking lots and Sappington Road, flows down a steep slope before emptying into the creek, which has caused gulley erosion in the backyards. The gulleys begin downstream from the 12-inch RCP outfall at 9720 Greenview Drive. Three alternative solutions were considered.

Due to the considerable upstream drainage area and impervious area, the recommended solution is Alternative 1, extend pipeline system, which can easily be tied into the existing drainage system and will improve the aesthetics of the backyards. If channel incising or erosion begins to occur above the proposed system, then the area should be treated according to Alternative 3.

Recommended Action: Replace the 24-inch RCP behind 9704 Greenview and extend the system 300 feet to 9720 Greenview to eliminate the gulley erosion in these backyards. New area inlets should be added to this problem area.

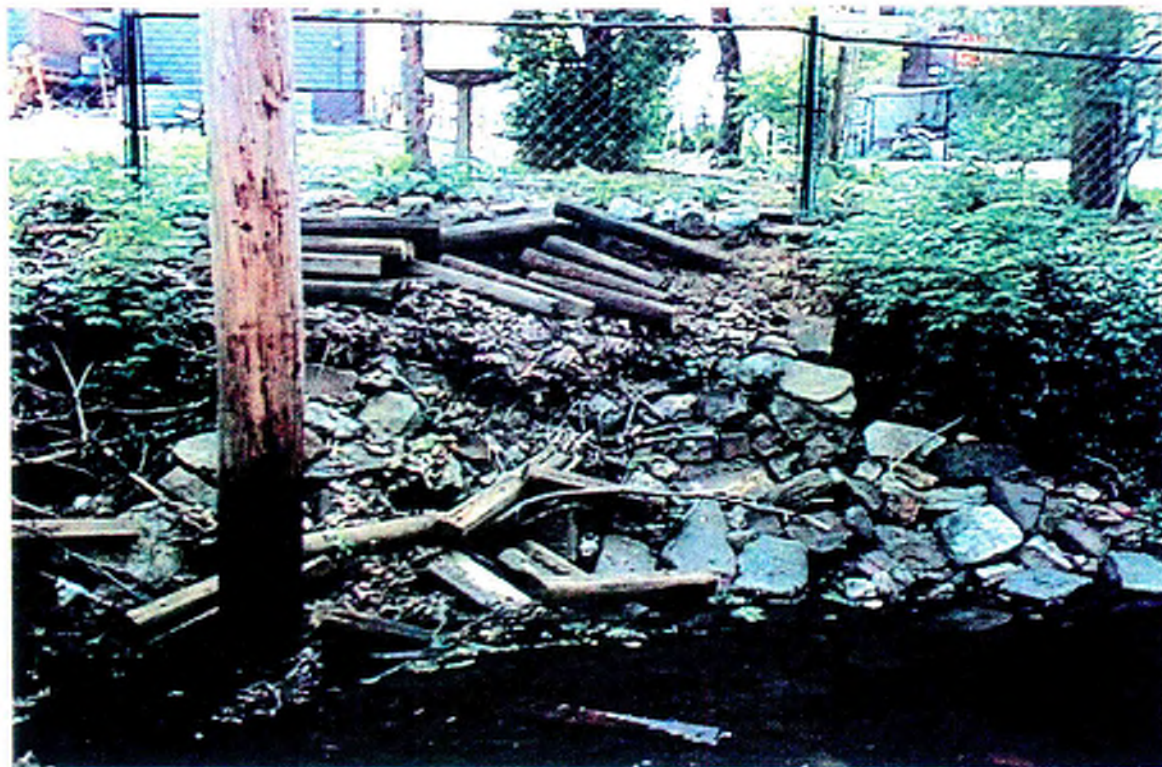
Figure 8-31. 1000 - 1012 Banyon Drive (KC-2)

Erosion is occurring along Kirkwood Creek east of Banyon Drive between 1000 and 1028 Banyon Drive. The bank erosion is threatening fences and utilities along the rear yards of Banyon Drive. Two alternatives were evaluated:

The recommended solution is Alternative 1, streambank biostabilization, which will maintain the aesthetics of the channel. Alternative 2, construction of a concrete lined channel, would cause high channel velocities that could pose a safety concern.

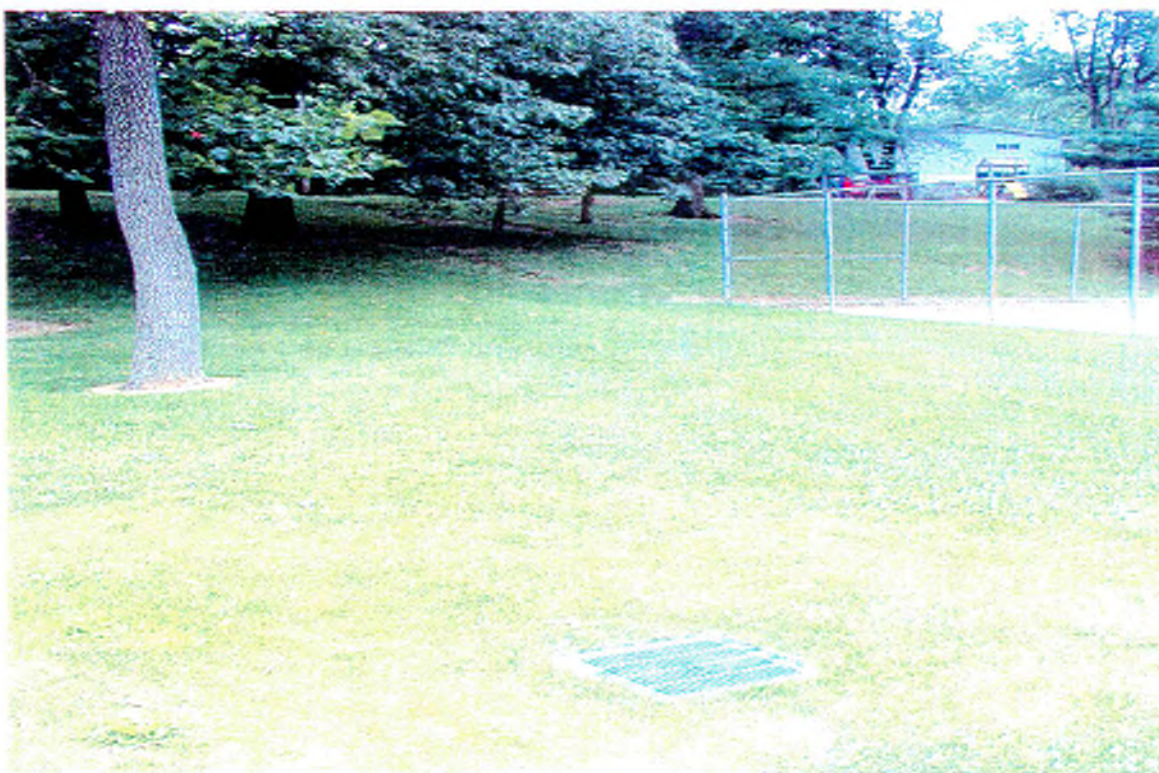
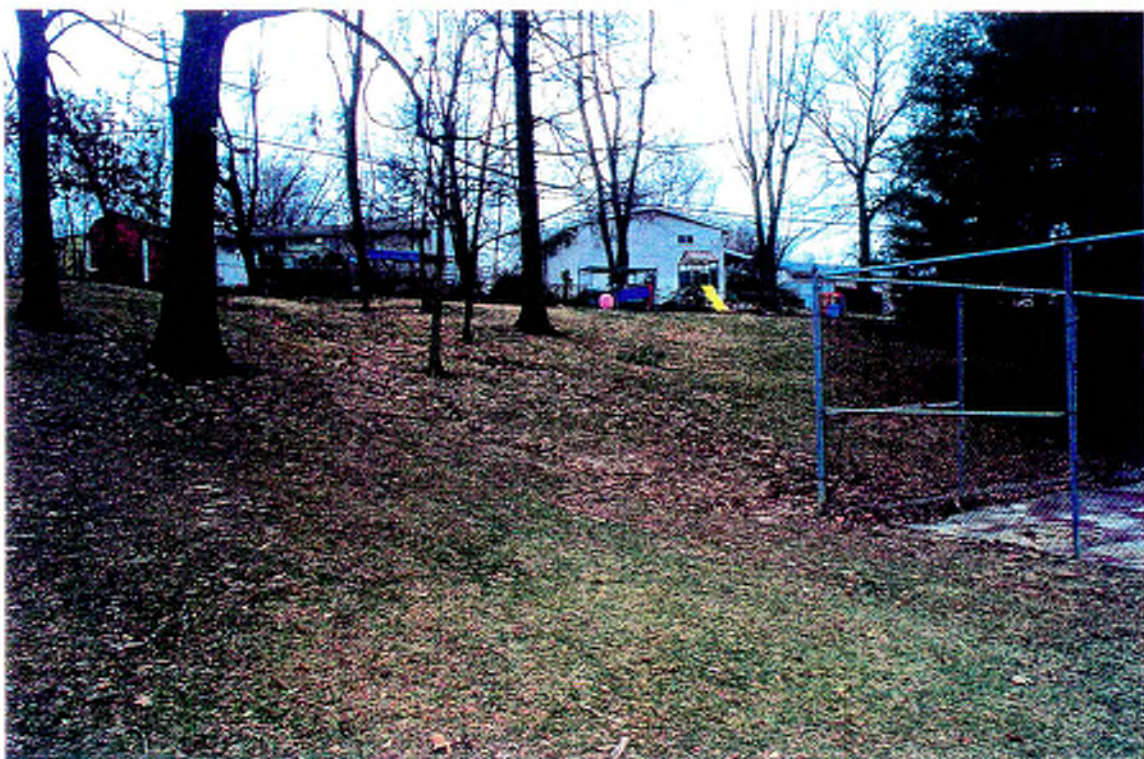
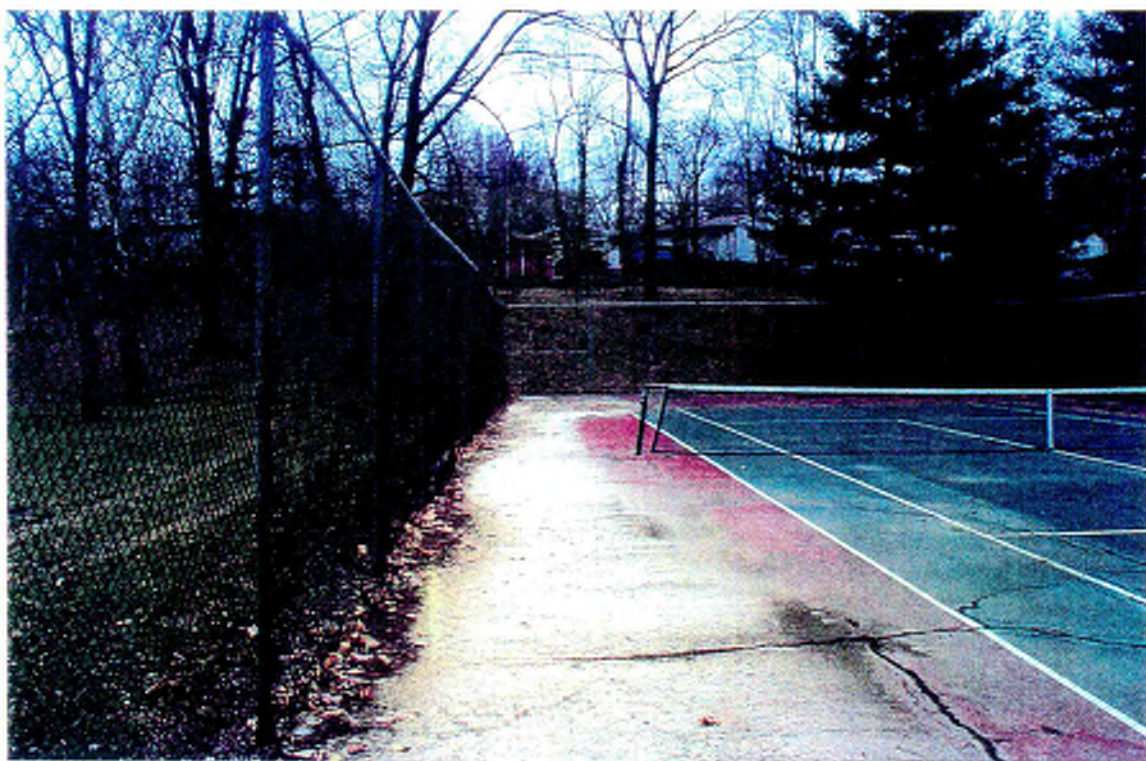
Figure 8-33. Spellman Park (KC-3)

The parks department has reported that sedimentation occurs on the tennis courts in Spellman Park as a result of erosion occurring on the hill to the south. The hill is experiencing a shallow concentrated flow with high velocity due to the steep, 20-percent grade of the hill. The recommended solution involves two components:

- **Component 1 - Erosion control.** This involves a new swale and erosion control mats, such as a soil-filled rolled erosion control product (RECP) covered with a turf type sod. A Turf Reinforced Matrix (TRM) is one type of RECP recommended on this project. Another erosion control solution includes traditional rock materials to prevent further erosion, since the slope is heavily shaded. The TRM option would include 80 feet of soil-filled erosion control product. The entire area should be over seeded with a shade tolerant fescue species.

- **Component 2 - Drainage system.** A berm should be constructed at the base of the hill to collect the runoff and divert it away from the courts to the area inlets located east of the courts, and adjacent to the playground. The berm should be constructed to a maximum height of 12 inches. The berm would be approximately 160 feet long and would have a drainage swale with 2-percent grade on the south side that directs runoff to the northeast. The berm should begin on the south side of the tennis courts, then bend at the corner of the courts and extend north to at least the midpoint of the east side of the courts.

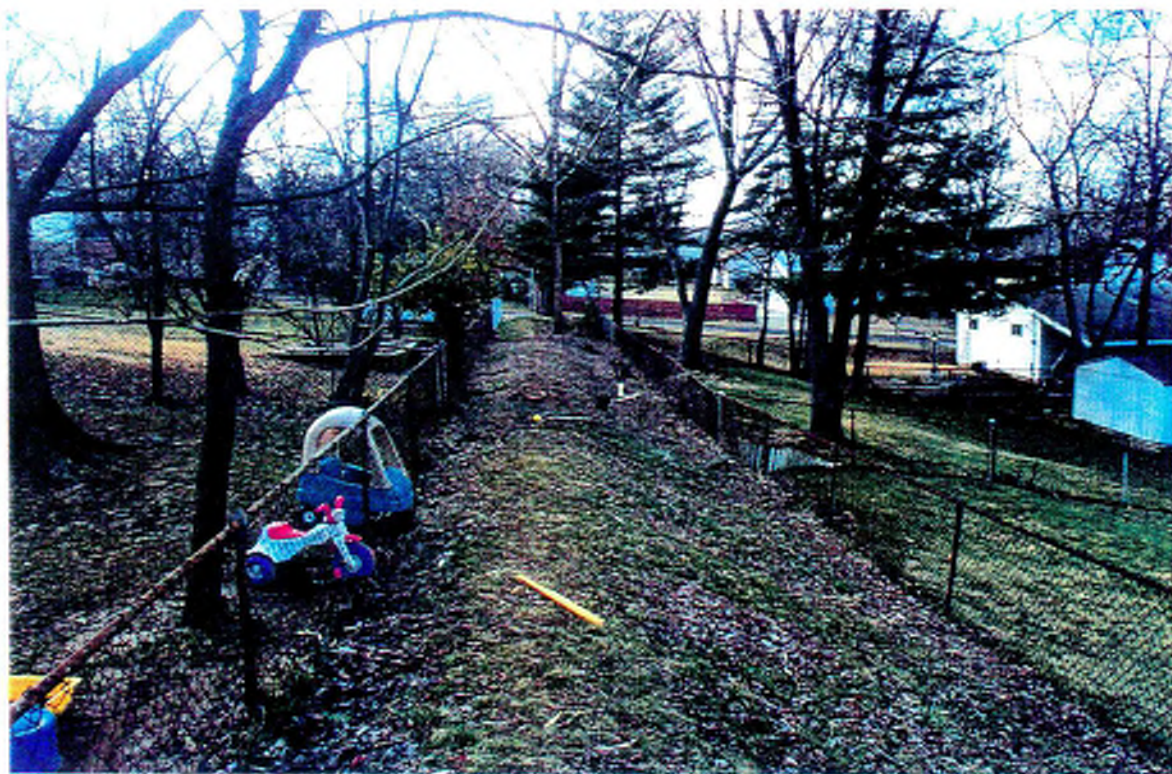
Figure 8-37. 546-538 Aspen Drive (KC-4)

Residents are experiencing flooding due to runoff from neighbors uphill and south of 546 and 542 Aspen Drive. The runoff bypasses an existing berm and collects in the backyards due to steep slopes. The existing east-west berm has settled and has flattened, which prevents the diversion of runoff to the west.

The recommended solution includes the reestablishment of 180 feet of berm along the south property line. The berm will have an associated swale on the south or uphill side with a designed grade of 2 percent grade to the west. The restoration of the berm will route the runoff to Spellman Avenue. The estimated probable project cost is \$3,000.

Recommended Action. Reestablish 180 feet of berm along the south property line.

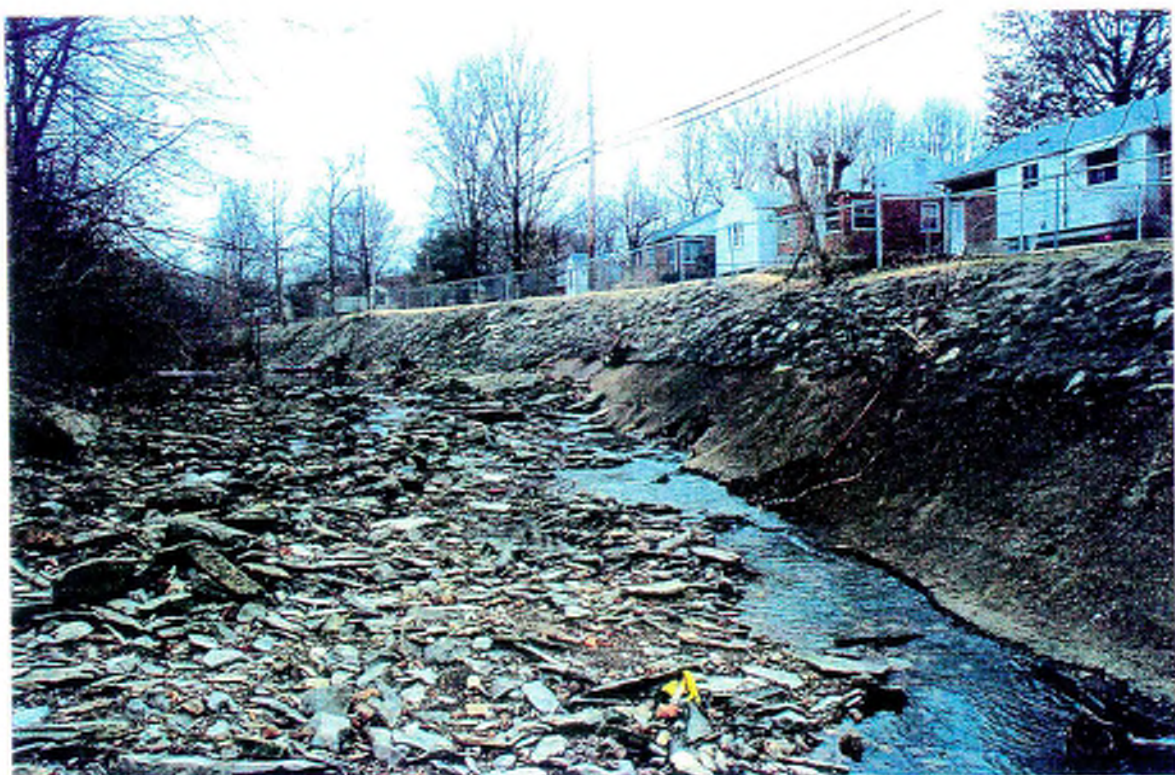
Figure 8-39. 9440-9448 Lodge Pole Lane (MC-1)

The structural armoring on the north bank of the channel between 9440 and 9448 Lodge Pole Drive is experiencing varying degrees of deterioration and erosion. This erosion threatens fences behind these homes. Areas of grouted riprap are being undermined at the toe of the sidewall slope.

Problem Description: Structural armoring on the north bank of the channel between 9440 and 9448 Lodge Pole Drive is experiencing varying degrees of deterioration and erosion. The erosion threatens fences behind these homes.

The recommended solution, Alternative 2, involves replacing and rehabilitating the structural armoring of approximately 150-foot section of the channel's north bank to prevent further property damage.

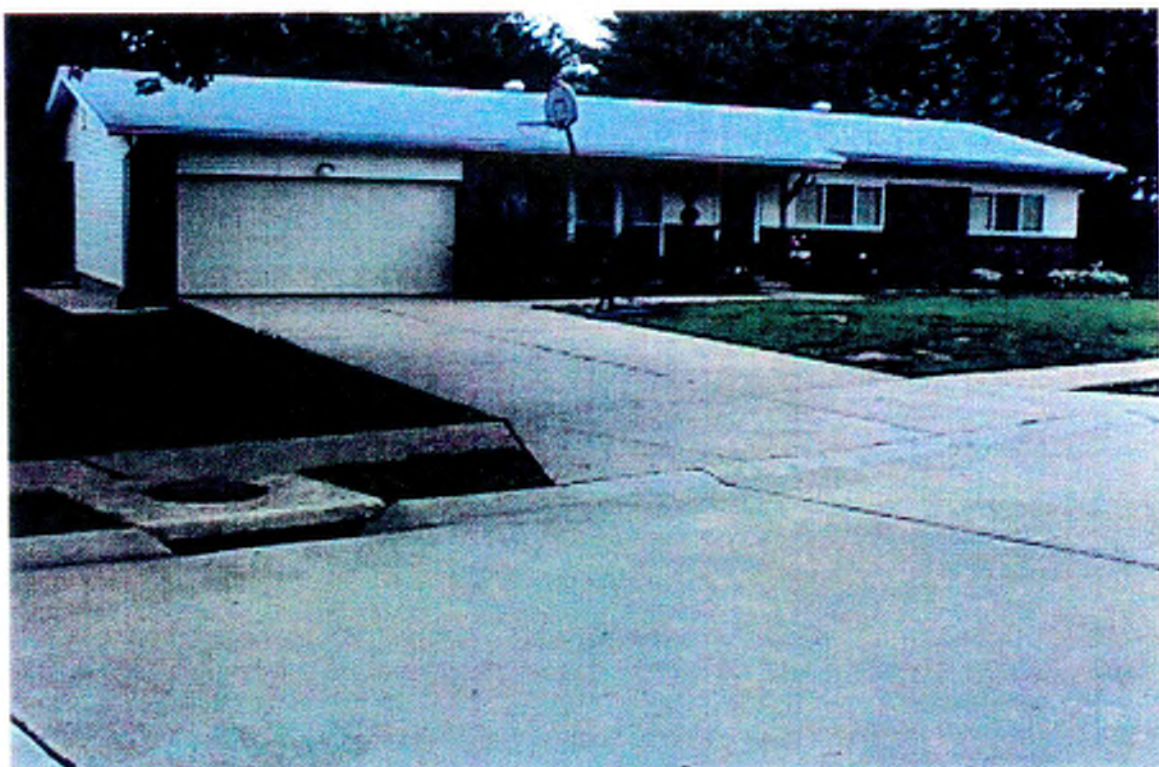
Figure 8-41. 9319 Lawndale Drive (MC-2)

Residents at 9319 Lawndale Drive and 9301 Cherrybrook Lane have experienced building and street flooding, and yard erosion. The flooding is being caused by two undersized curb inlets, labeled 26L1-198D and 26L1-197D, which straddle Lawndale Drive between the two residences identified above. Another potential contributor to the problem could be debris clogging the drainage pipe between the 42-inch outfall and area inlet 26L1-185D. Both curb inlets are located at the low point of the vertical profile of Lawndale Drive. Stormwater bypasses other upstream curb inlets, which are located east and west along Lawndale Drive. This is caused by the steep grades, which reduce the capacity of the curb inlets.

The recommended solution includes installing two additional curb inlets at the sump location, one on each side of the street, to handle the stormwater bypass from the upstream inlets. In addition, the 12-inch RCP that connects the existing curb inlets, will need to be replaced with 35-feet of 24-inch RCP. Also, minor grading will be required at 9301 Cherrybrook to establish a 2-percent grade toward the street and area inlet 26L1-185D. The estimated probable project cost is \$26,000.

Recommended Action: Install two additional curb inlets at the sump location, on each side of the street. Replace 12-inch RCP with 35-feet of 24-inch RCP.

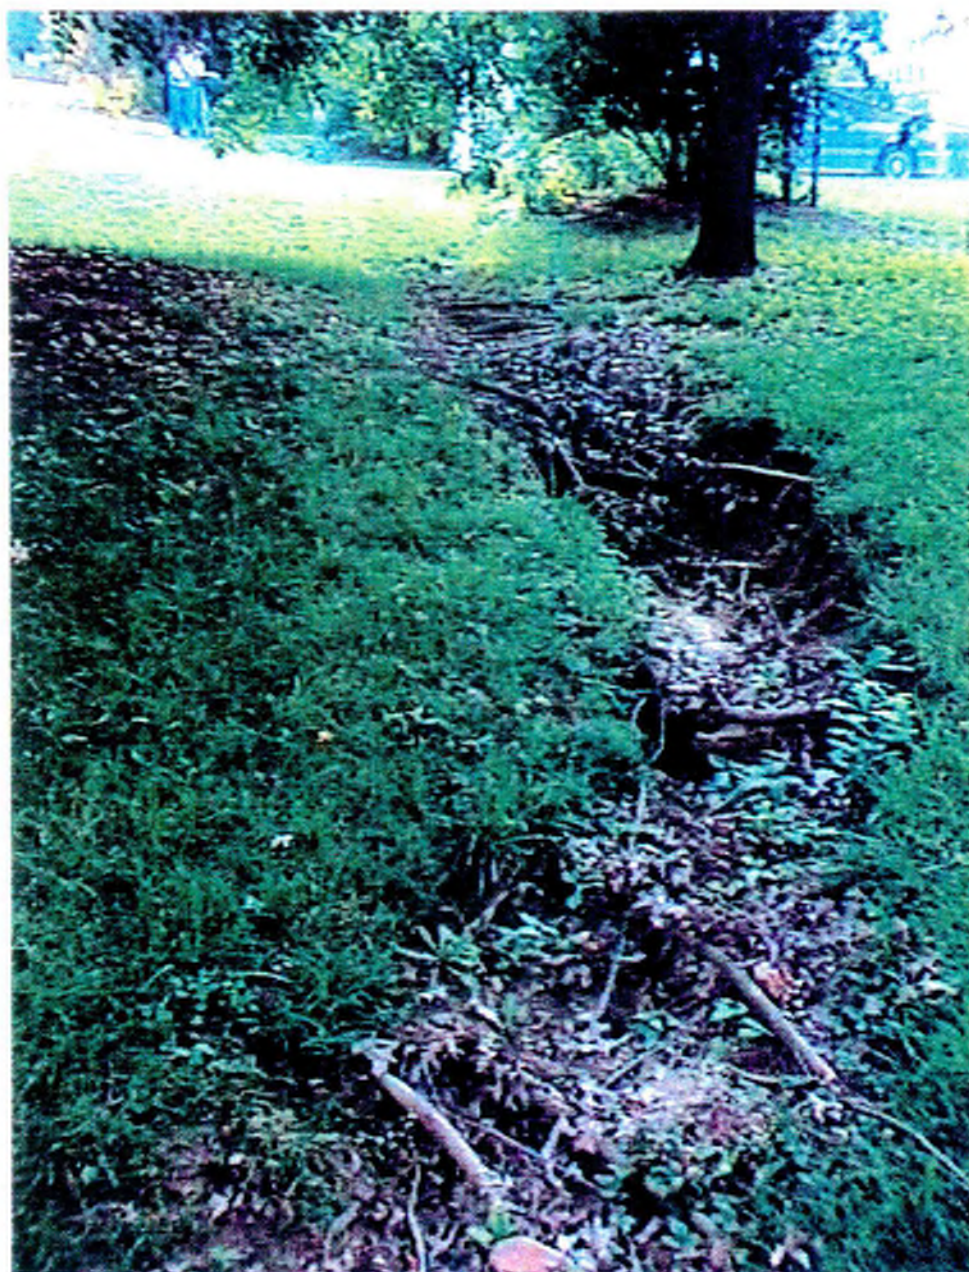
Figure 8-43. 9518 - 9534 Pine Spray Court (MC-3)

Residents are reporting erosion in their backyards between 9518 and 9534 Pine Spray Court. Erosion has resulted from shallow concentrated flow that becomes a drainage channel as it discharges into area inlet 26L1-166D. Without repair and stabilization, the channel will continue to erode, widen, down cut, and migrate upstream in the backyards of 9518, 9526, and 9534 Pine Spray Court. Two alternative solutions were evaluated:

The recommended solution is Alternative 1, erosion control mat, which will provide an aesthetically pleasing improvement and will minimize the disruption of existing trees, fences, and utilities in these backyards.

Recommended Action: Install approximately 260 feet of new swale with erosion control mats

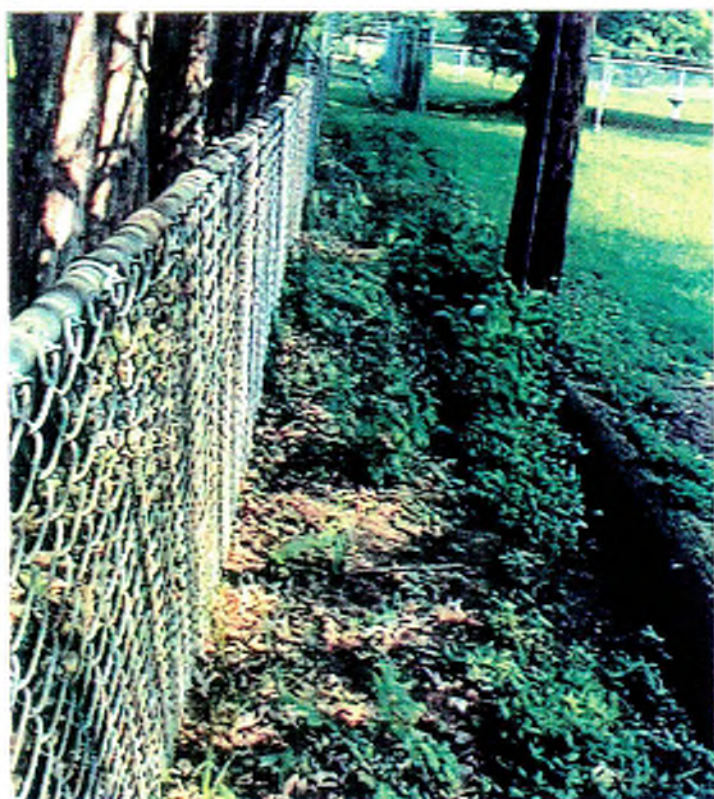
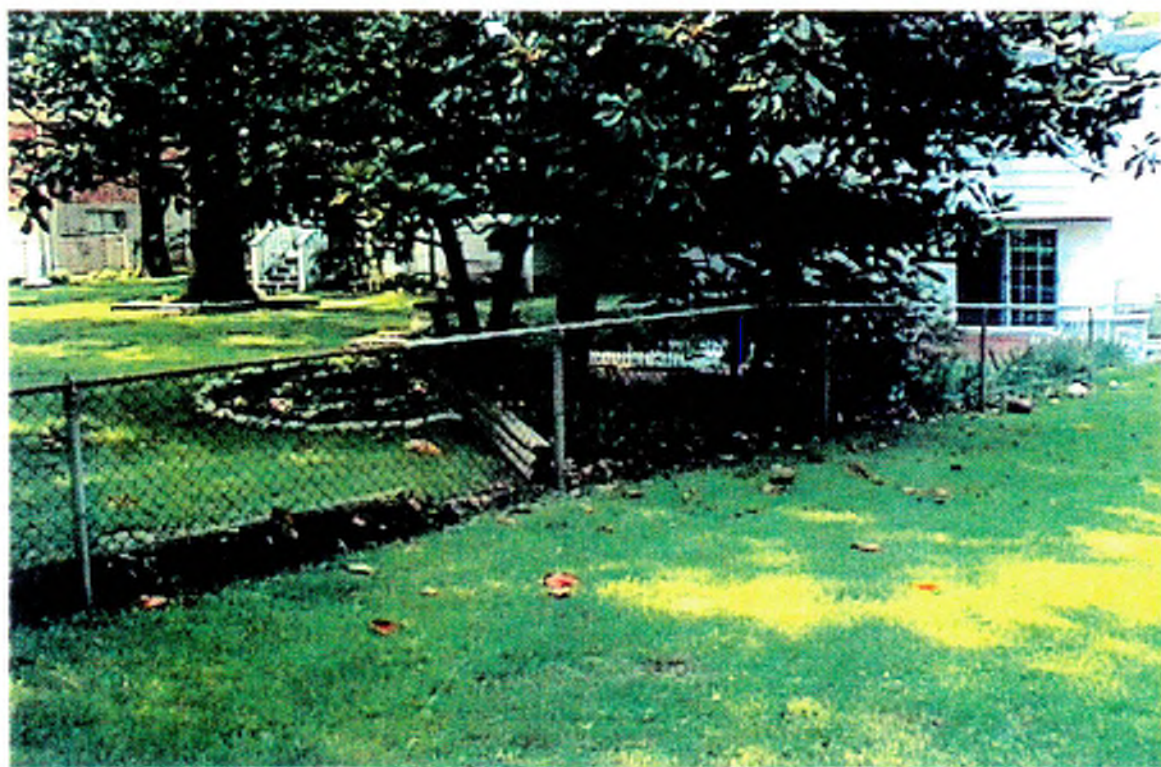
Figure 8-45. 9528 Craigwood Terrace (MC-4)

Residents at 9528 Craigwood and 9523 Garber have reported building and yard flooding on their property. Poor grading in the backyards prevents stormwater runoff from reaching the existing area inlet, labeled 26L1-095D. Two alternative solutions were evaluated:

The recommended solution is Alternative 1, grass swale, which is more cost-effective than the enclosed system and will require less maintenance.

Recommended Action: Regrade the ground behind 9528 and 9524 Craigwood toward area inlet 26L1-095D. Install 170 feet of earthen berm, 1-foot high, with associated grass-lined swale on the south side of the berm.

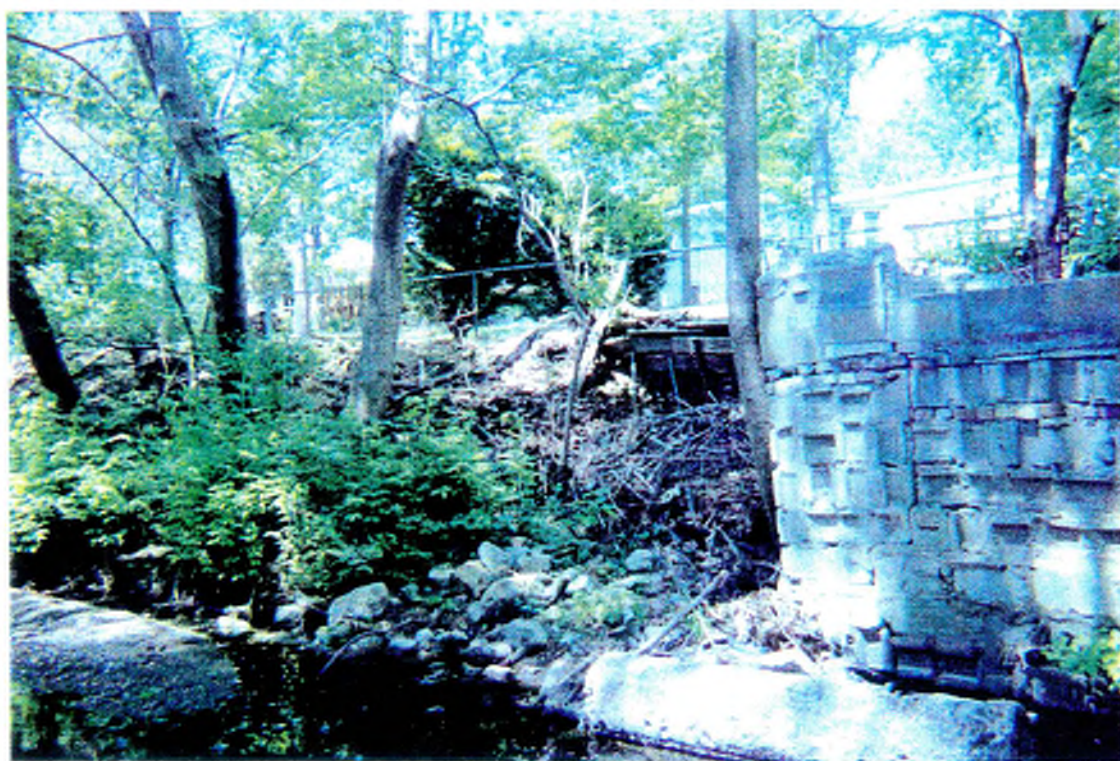
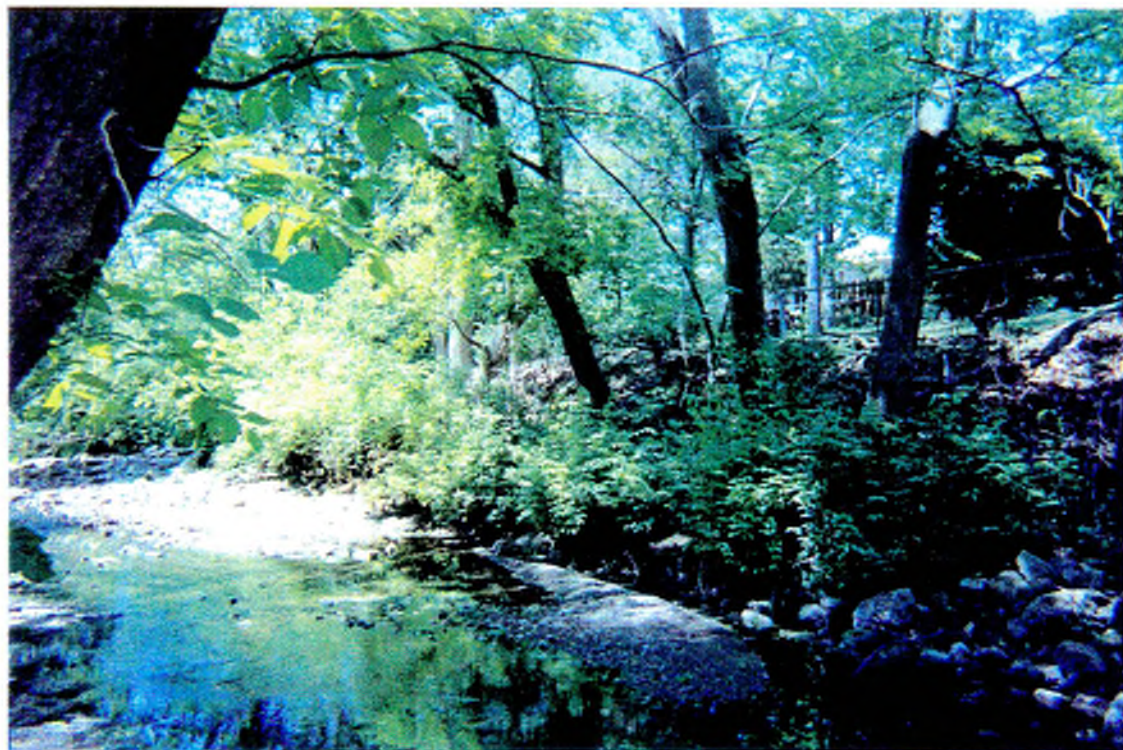
Figure 8-48. 9600 Block Yorkshire Estates Drive (MC-5)

Flooding of structures is occurring along the north bank at 9616 and 9620 Yorkshire Estates Drive, and erosion is occurring between 9648 and 9616 Yorkshire Estates Drive on the north bank. Two alternative solutions were evaluated:

To alleviate the erosion, 880 feet of bank stabilization should be installed on the north bank of Mulberry Creek, which includes removing the failing structural wall systems, and replacing it with a geogrid-reinforced fill slope RECP. The base of the slopes in the area consists of natural rock, which provides superior toe stabilization of the banks. Erosion is occurring in other areas where rock is not present. These areas should be sloped back and stabilized with vegetation. The stream banks could be stabilized through the use of a Turf-Reinforcing Matrix (TRM) and a Wire Turf Reinforcing Matrix (WTRM). Since vegetation is not viable stabilization alternative near the low water line, structural assistance is often necessary to insure the toe remains stable. Applicable technologies include organic logs or stone. Re-vegetation should be done with native, woodland and riparian species. The estimated probable project cost is approximately \$536,000.

Recommended Action: Install 250 feet of 4-foot high floodwall, for the residents at 9616 and 9620 Yorkshire Estates Drive. Bank stabilization should be applied to 880 feet of the North bank of Mulberry Creek.
