STORMWATER REPORT

CRESTWOOD STORMWATER

MASTER PLAN

CRESTWOOD, MISSOURI 63126

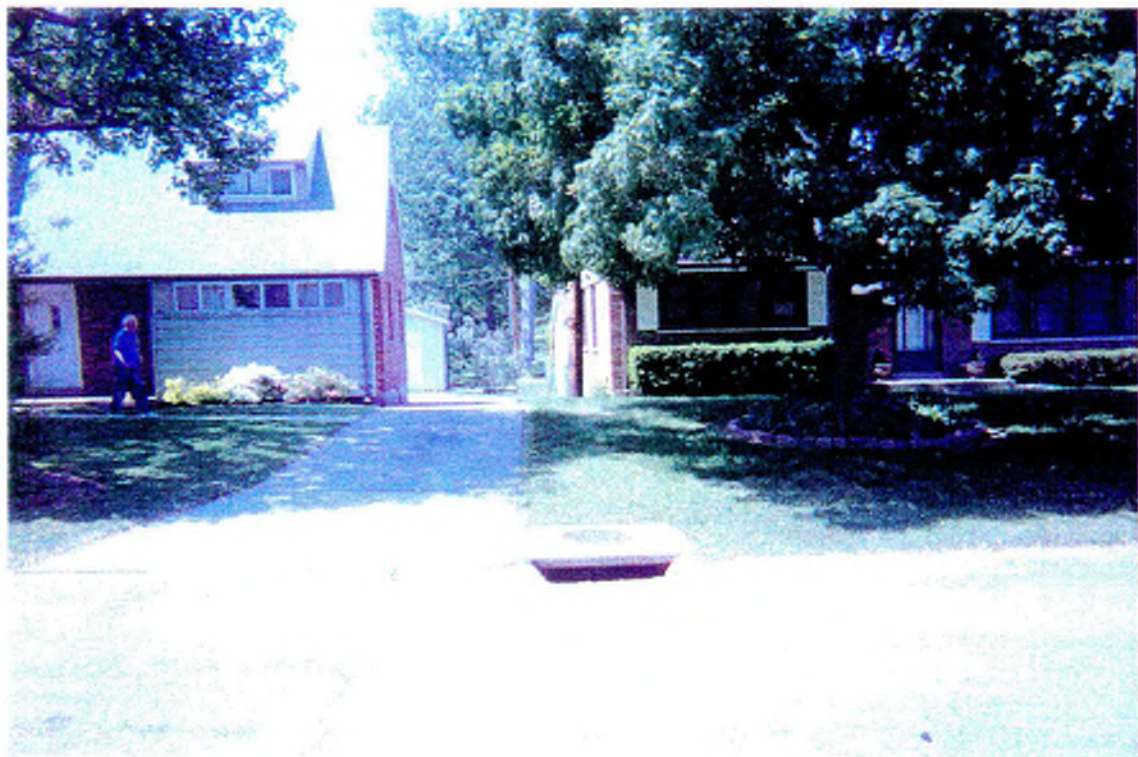
Figure 8-51. 9871 - 9873 Twin Vista Drive (MC-6)

Building flooding occurs between 9781 and 9783 Twin Vista Drive, caused by two area inlets, labeled 25L4-060D and 25L4-061D, that surcharge. No overflow channel exists to drain the surcharge runoff downstream. In addition, the existing 42-inch line between the two residents is undersized. Three alternative solutions were evaluated:

Building flooding occurs between 9781 and 9783 Twin Vista Drive, caused by two area inlets, labeled 25L4-060D and 25L4-061D, that surcharge. In addition, the 42-inch between the two residents is undersized.

The recommended solution is Alternative 2, floodproof home, which is the most cost-effective solution.

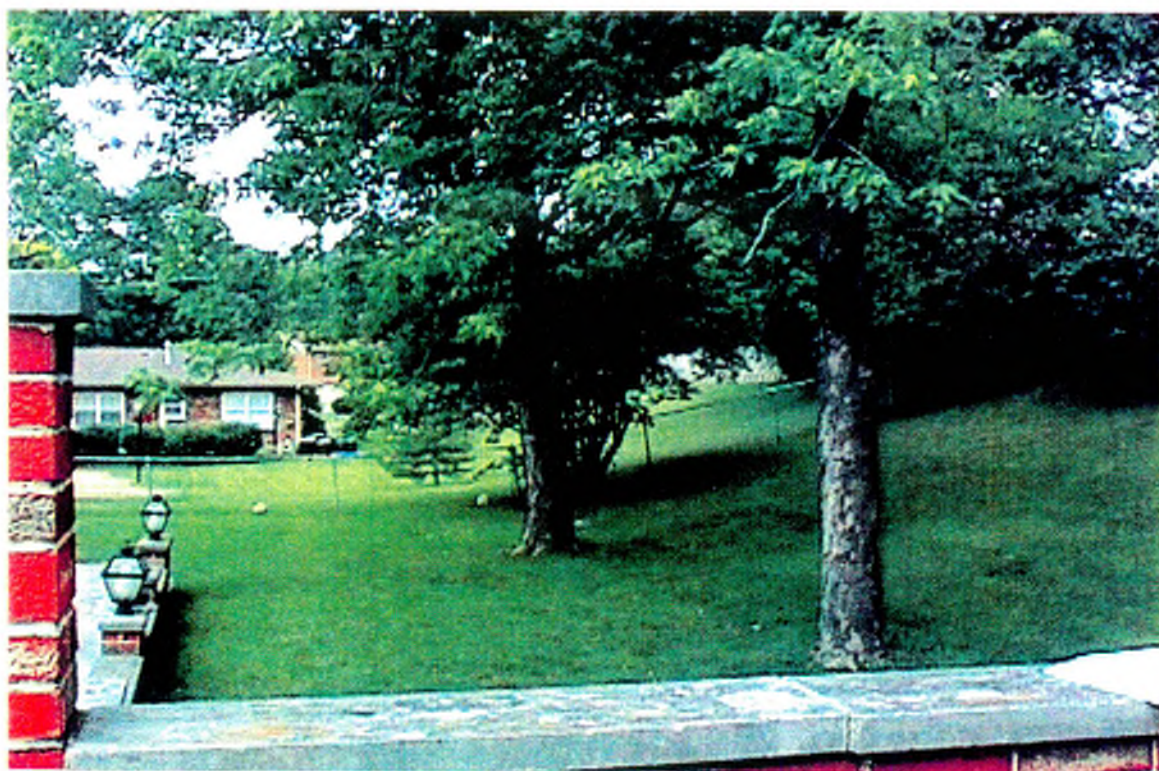
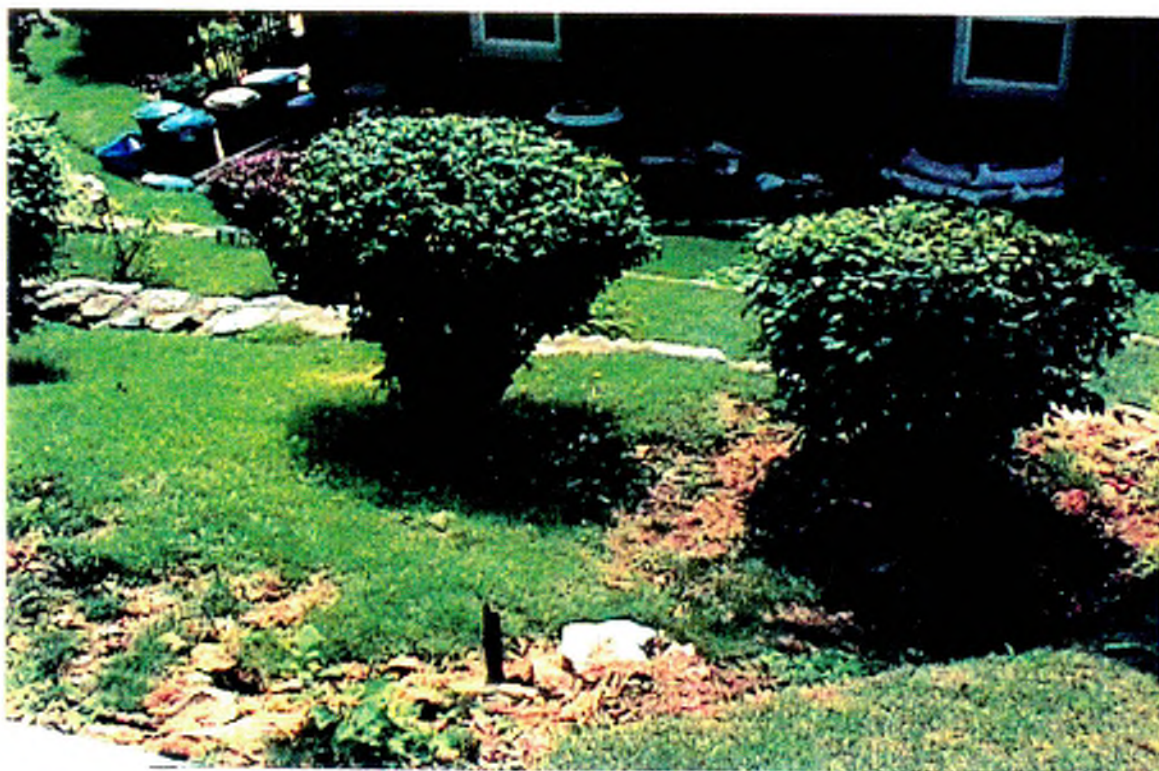
Figure 8-53. 8900 Block Lindenhurst Drive (MC-7)

Residents between 8966 and 8978 Lindenhurst Drive have building flooding and erosion in their backyards. In an effort to mitigate the problem, the resident at 9656 Lindenhurst has placed sandbags at the basement window on the east side of the home and constructed a narrow channel to divert the runoff away from the building, while the resident at 8968 Lindenhurst has reported standing water in their backyard. Finally, the resident at 8963 Belmar Court has a poorly constructed retaining wall, which is causing erosion in the backyard. The recommended solution involves four components:

Recommended Action: Install a backward drainage system with two area inlets that ties into the curb inlet 361.1-007D, on Lindenhurst Drive. Provide grading around area inlets to eliminate excessive bypass from runoff

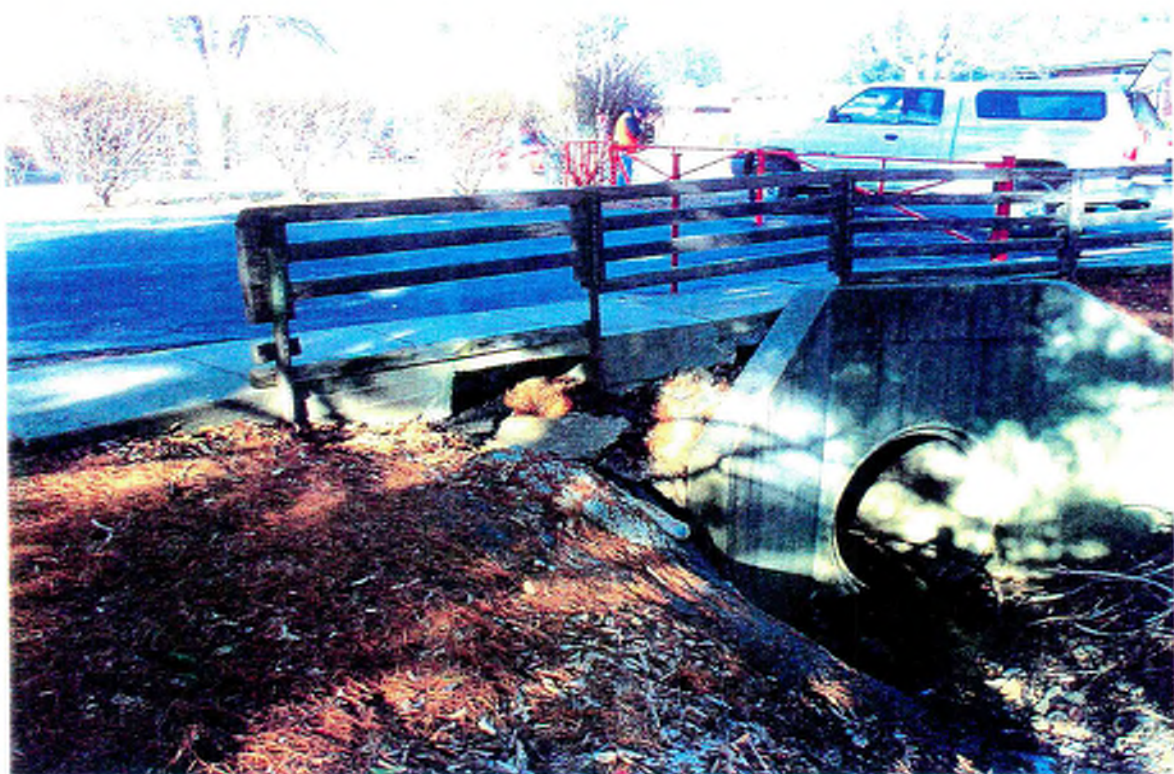
Figure 8-56. Crestwood Park Entrance (MC-8)

A 54-inch RCP extends beneath the east entrance to Crestwood Park. An existing curb inlet that drains to the culvert is in poor structural condition and is causing erosion at the entrance of the culvert. The recommended solution involves replacing the existing curb inlet and installing a grate system, or trench drain, that extends across the park entrance. The estimated probable project cost is approximately \$12,000.

Problem Description: An existing curb inlet that drains into a 54-inch RCP is in poor structural condition and is causing erosion at the entrance of the culvert.

Recommended Action: Replace the existing curb inlet and install a grate system, or trench drain, that extends across the park entrance.

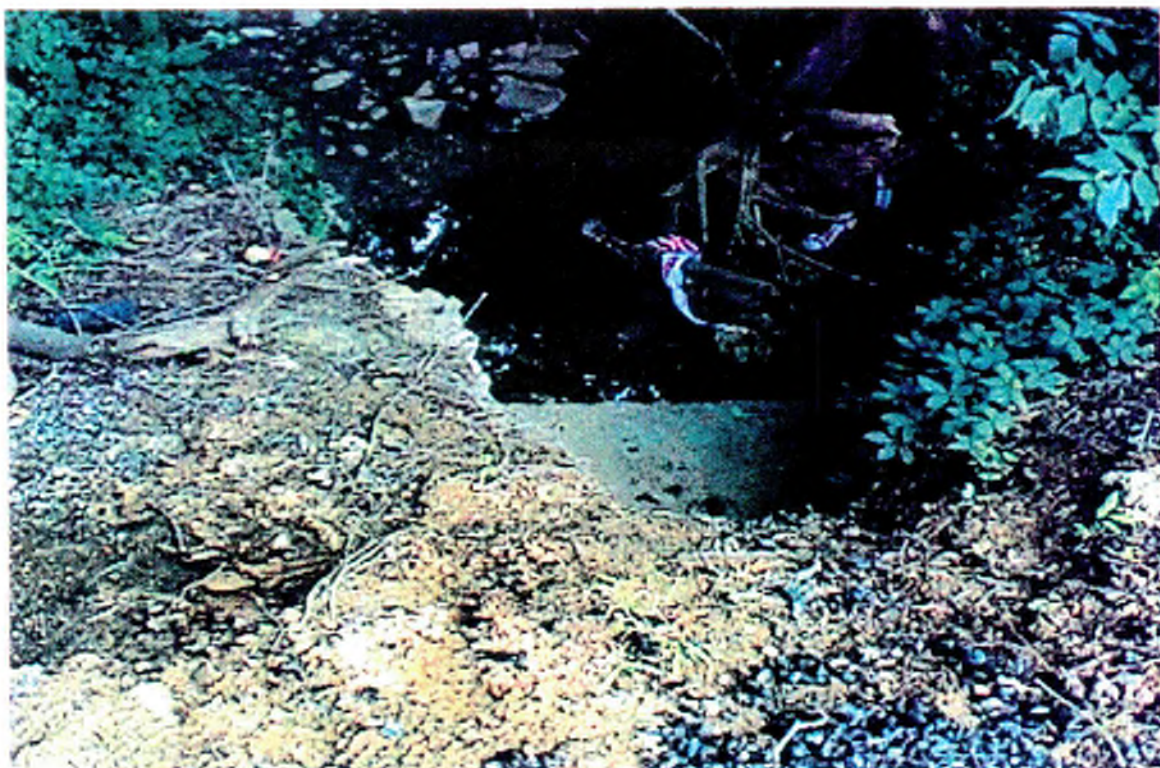
Figure 8-58. 8940 Craighurst Terrace (MC-9)

The parks department has reported that maintenance equipment is unable to easily access the west end of Crestwood Park due to the dense vegetation and limited access across the tributary channel. Two alternatives were evaluated:

The recommended solution is Alternative 2, channel maintenance, which is more cost-effective and will preserve the aesthetic appearance of the natural creek.

| Recommended Action: | Remove unnecessary debris and vegetation along the channel to provide a more aesthetically pleasing natural system, and to provide stream restoration immediately downstream of the outlet pipe adjacent to property 8940 Craighurst Terrace |

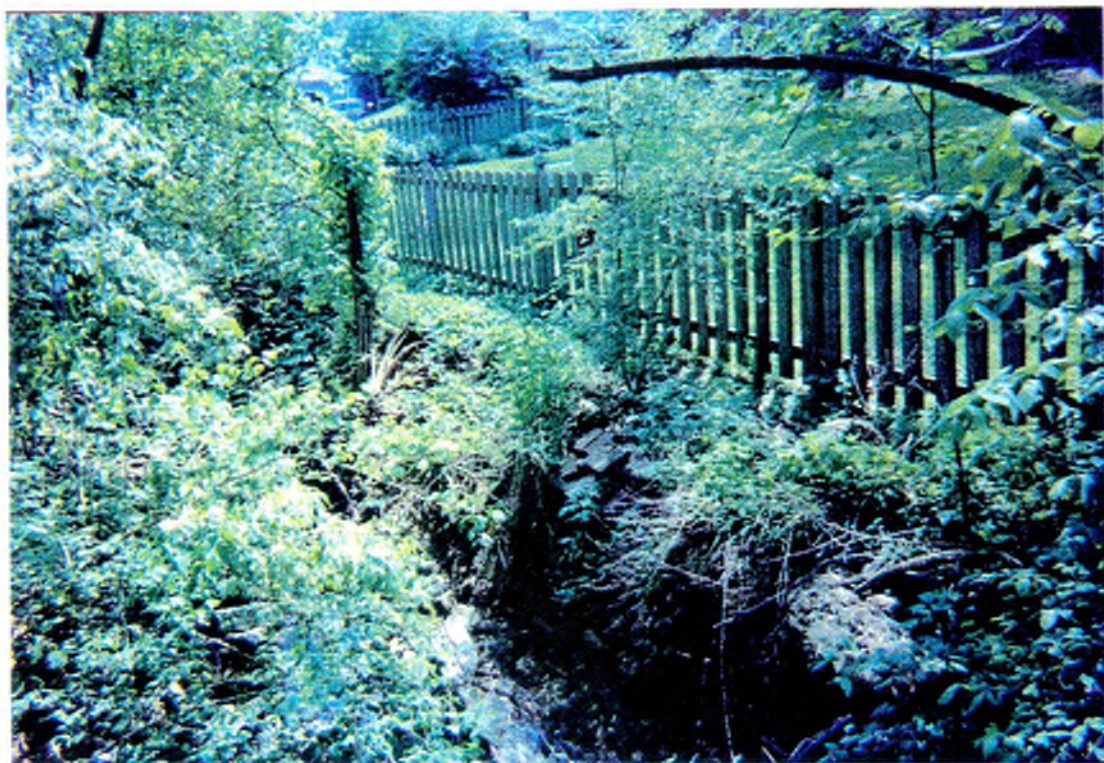
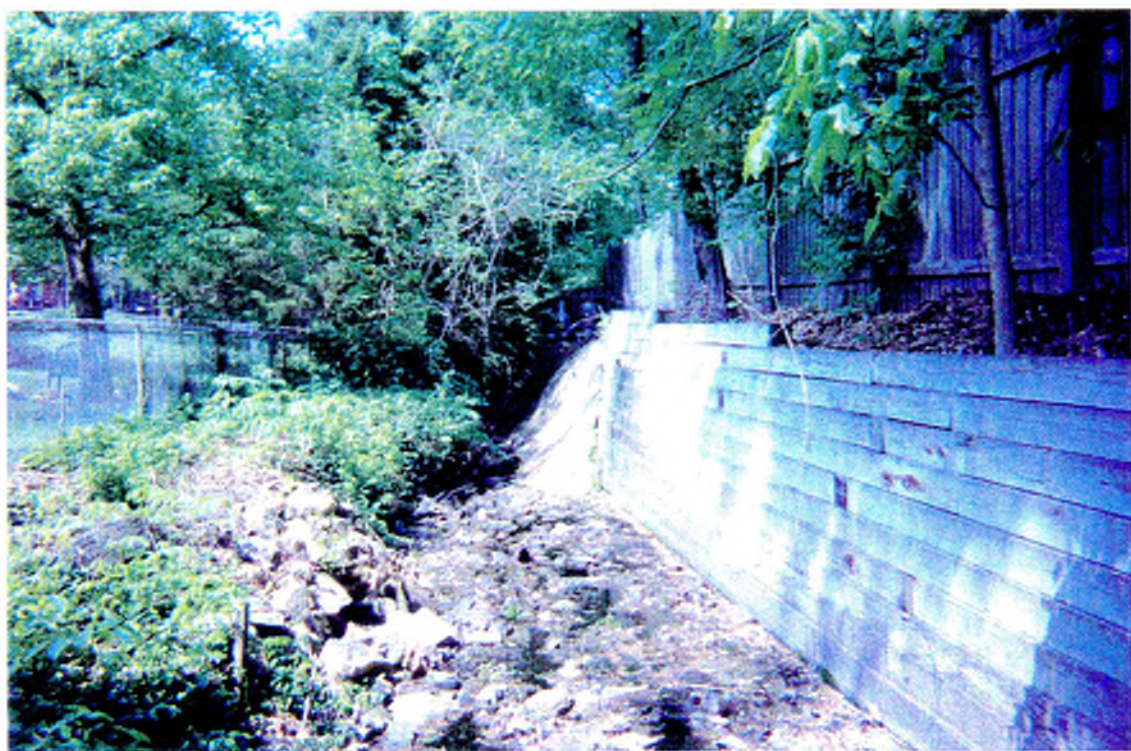
Figure 8-60. 900 Block Maple Grove/Sky Crest (MC-10)

The natural channel between Sky Crest Drive and Maple Grove Drive, for the block lying upstream of Meadowfern Drive, is eroding. This channel alignment is not naturally occurring, and the existing slope of 2.6-percent is high enough to cause erosive velocities of 15 to 20 fps. Erosion and down cutting are evident throughout the reach. Three alternative solutions were evaluated:

Recommended Action: install approximately 880 feet of 34-inch RCP, with two junction boxes, and two area inlets.

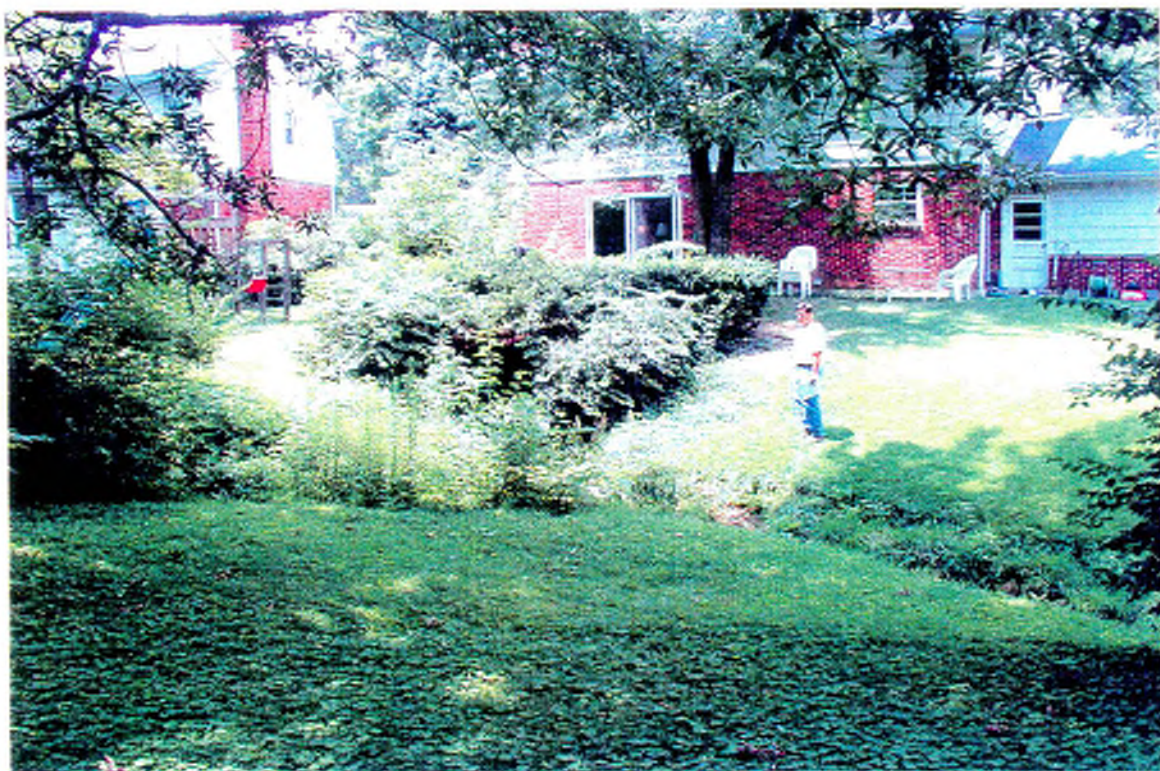
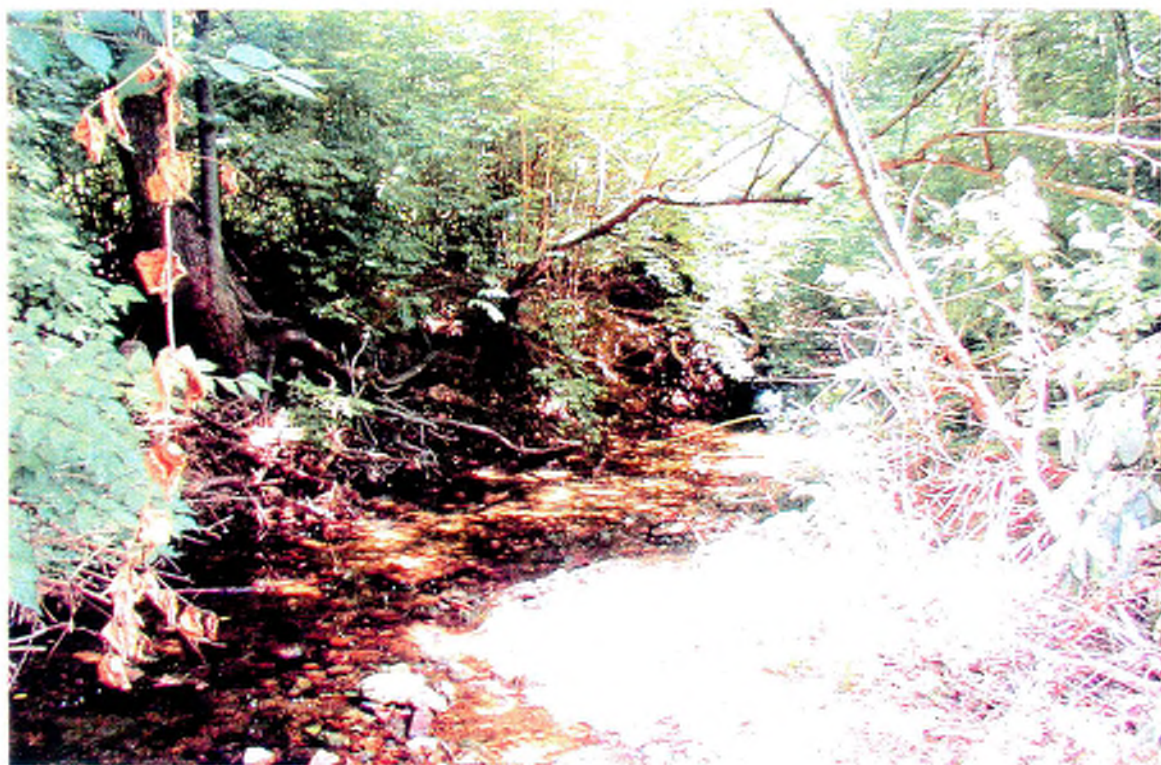
Figure 8-63. Lowill Lane to Crest Oak Lane (MC-11)

Residents have reported stream bank erosion in the backyards of homes behind 9010 Lowill Lane and along a reach between 9004 Lowill Lane and 9904 Harwich Drive for both sides of Mulberry Creek. In addition, residents at 9904 and 9910 Harwich Drive and 10028 Harwich Drive are having flooding problems. The stream is characterized by bank erosion and apparent channel down cutting. The entire reach has been encroached upon by residential development. The channel requires a larger cross-section and longer flow path in order to be naturally stable. When space is available, this reach of channel can be made stable with basic cross-section and alignment alterations. If alterations are not made, stream transition will continue until they are achieved naturally.

Recommended Action: Flood proofing should be implemented at 9904 and 9910 Harwich Drive. A total of 2,620 feet of bioengineered bank stabilization along both banks of Mulberry Creek.

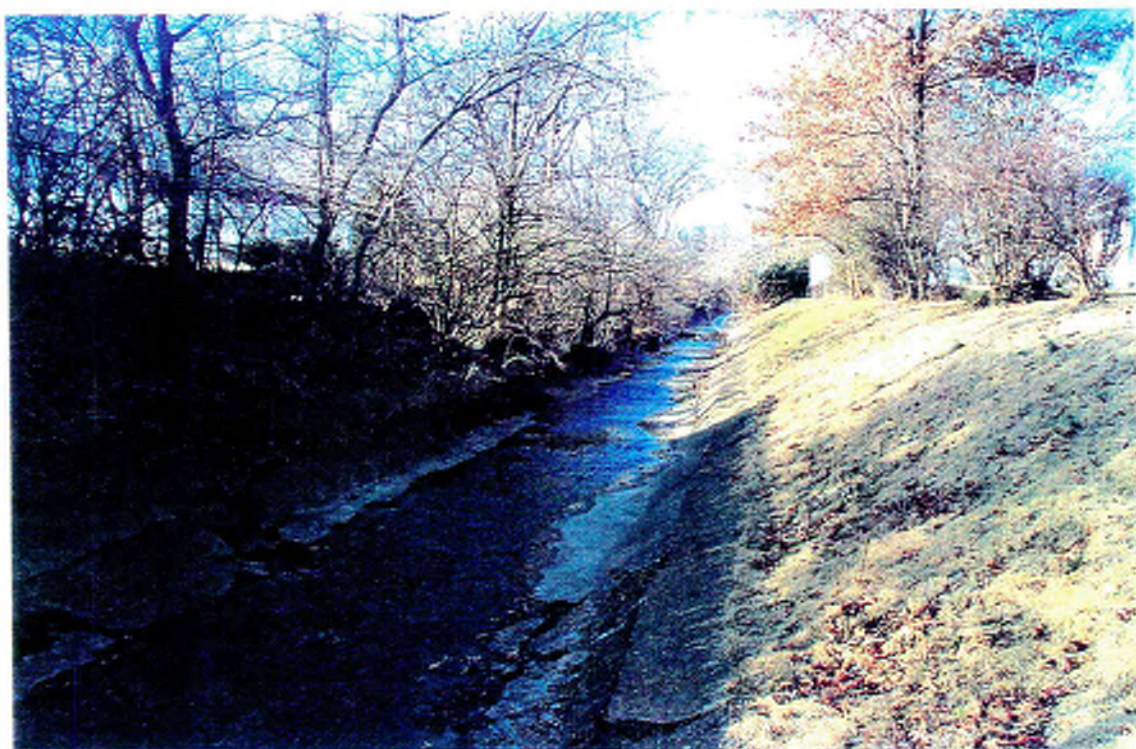
Figure 8-66. 8900 Rudson Lane (MC-12)

The existing concrete channel is deteriorating behind residences 8895 through 8944 Rudson Lane. The 15-year event causes severe velocities over 20 fps based on the existing configuration of the channel, which includes an 8-foot bottom width, 3:1 side slopes, and 1.9-percent channel slope. Two alternative solution were evaluated:

Recommended Action: Replace the concrete channel with a new 855-foot concrete trapezoidal channel.

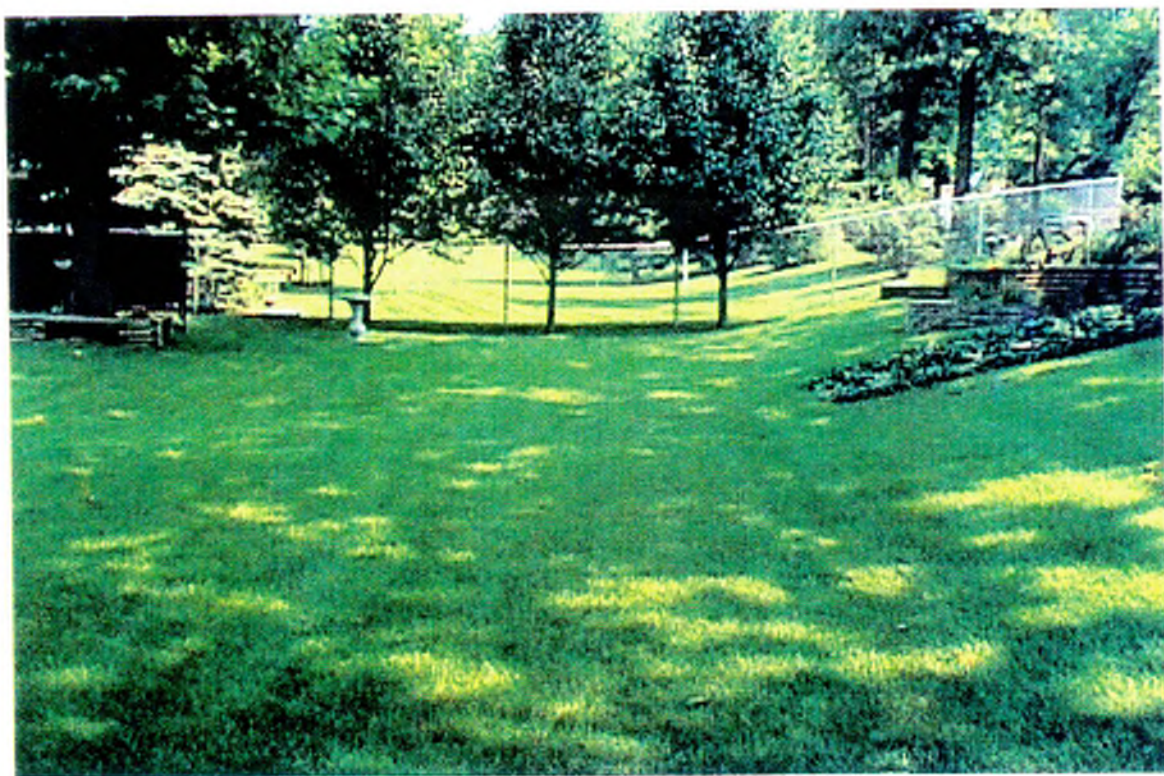
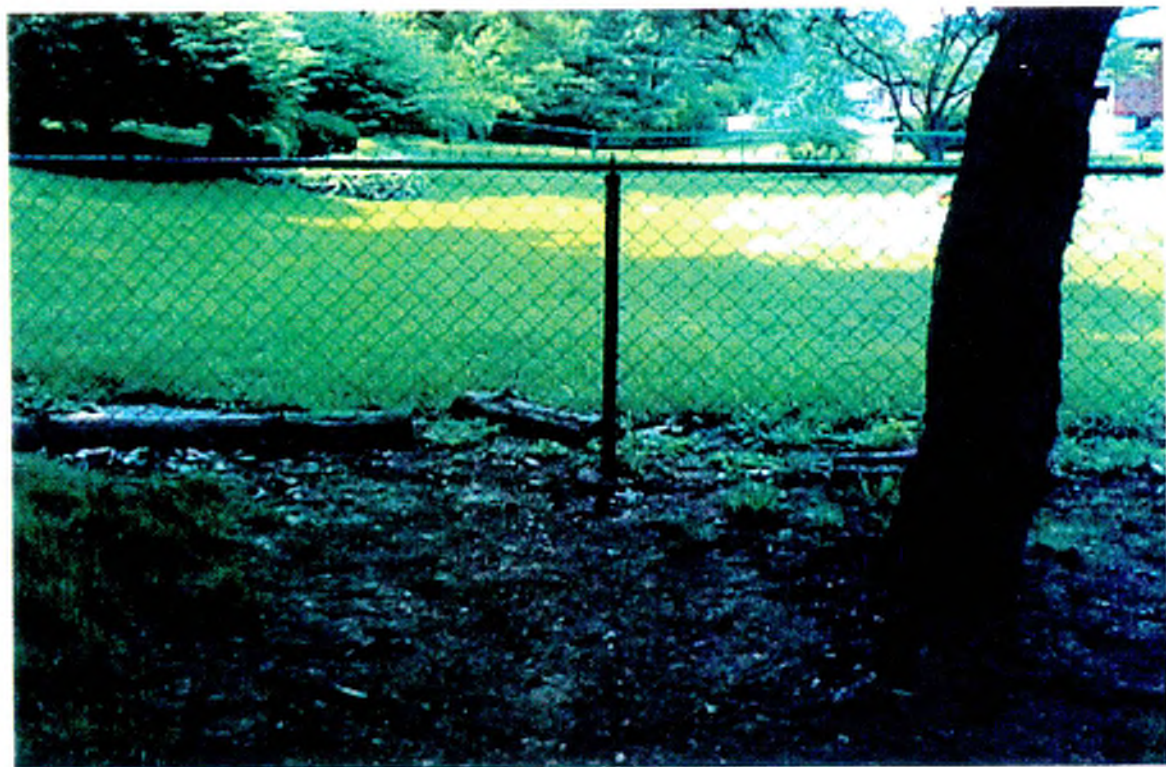
Figure 8-68. 8854 - 8866 Rudson Lane (MC-13)

A localized drainage problem exists in the backyards of residents located between 8854 and 8866 Rudson Lane. Ponding, typically 6 inches deep, occurs in the rear yards of 8862 and 8860 Rudson Lane due to poor grading.

Recommended Action: install a series of two four-sided area inlets behind 8866 and 8872 Rudson Lane.

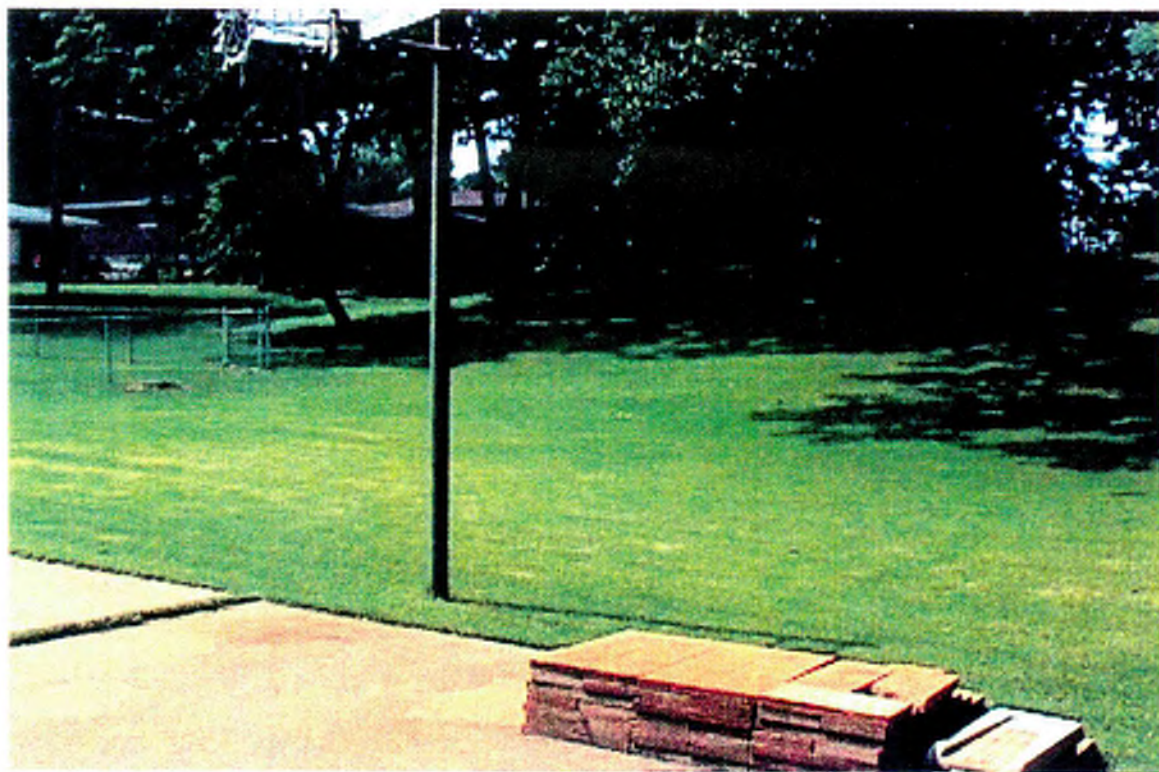
Figure 8-71. 10069 - 10075 Barberton Drive (MC-14)

Excessive stormwater runoff from the field behind 10069 Barberton, drains into the resident's backyard. The resident has complained that water comes from the church to the north and three adjacent residents on Manda Lane. The Manda Lane homes have connected downspouts that drain onto residence 10069 Barberton.

The recommended solution involves two components. The first component involves installing a berm and associated collection swale to capture the runoff from the church lot. The second component is an area inlet that must be constructed at the back corner of the property between 10075 and 10069 Barberton to collect the runoff from the new swale. The area inlet would drain into a new 21-inch RCP that would be connected 135 feet to curb inlet 26M2-061D, located on Barberton. Also, the existing 18-inch RCP beneath Barberton Drive will need to be replaced with 30 feet of 21-inch RCP. The estimated probable project cost is approximately \$50,000.

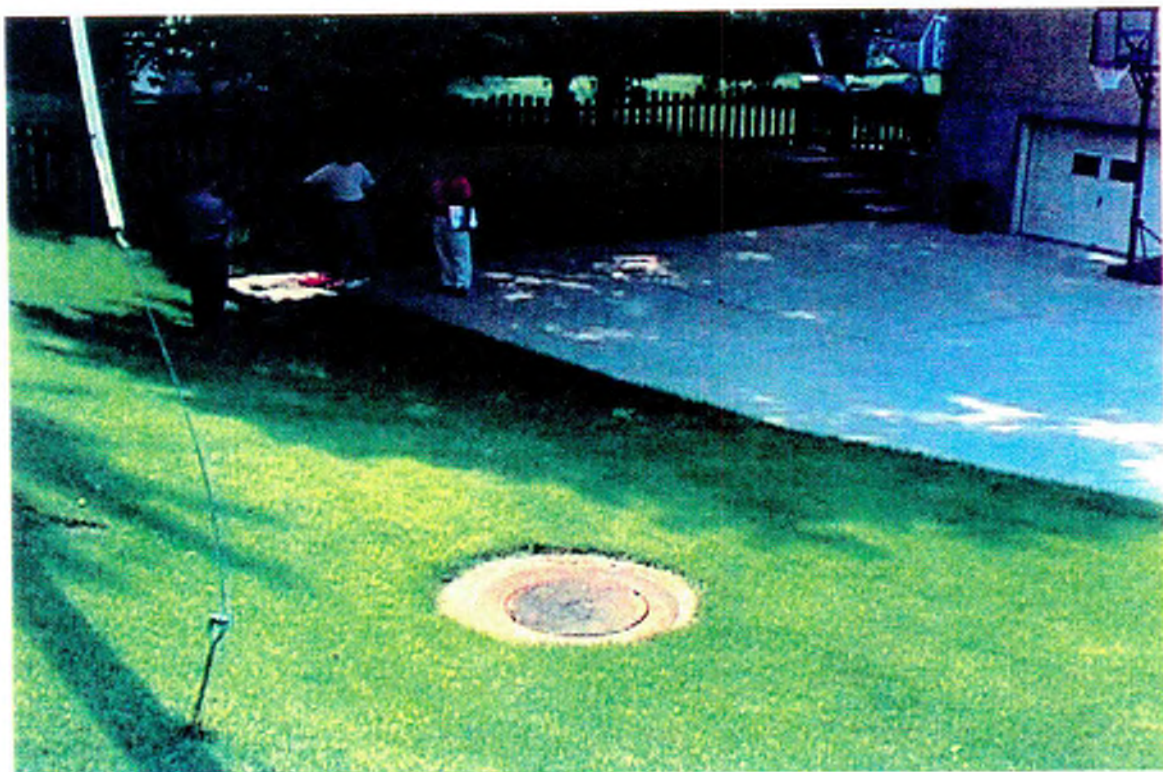
Figure 8-73. 8901 Manda Lane (MC-15)

Flooding is affecting the basement garage at 8901 Manda Lane. Local drainage collects at area inlet 26M2-082D, which drains into the main system through a 12-inch RCP. Surcharge from the area inlet cannot be released downstream due to the lack of an overflow swale to Manda Lane. The capacity of the area inlet's 12-inch outlet pipe, which ties into the 60-inch main system, is significantly undersized for the 15-year event, according to MSD design standards. Also, poor grading in the vicinity of the area inlet is contributing to the problem.

Recommended Action: Replace the existing 12-inch RCP that connects to the main system, with 10 feet of 24-inch RCP. A 2-foot floodwall should be installed across the corner of the driveway to provide a sump around the inlet.

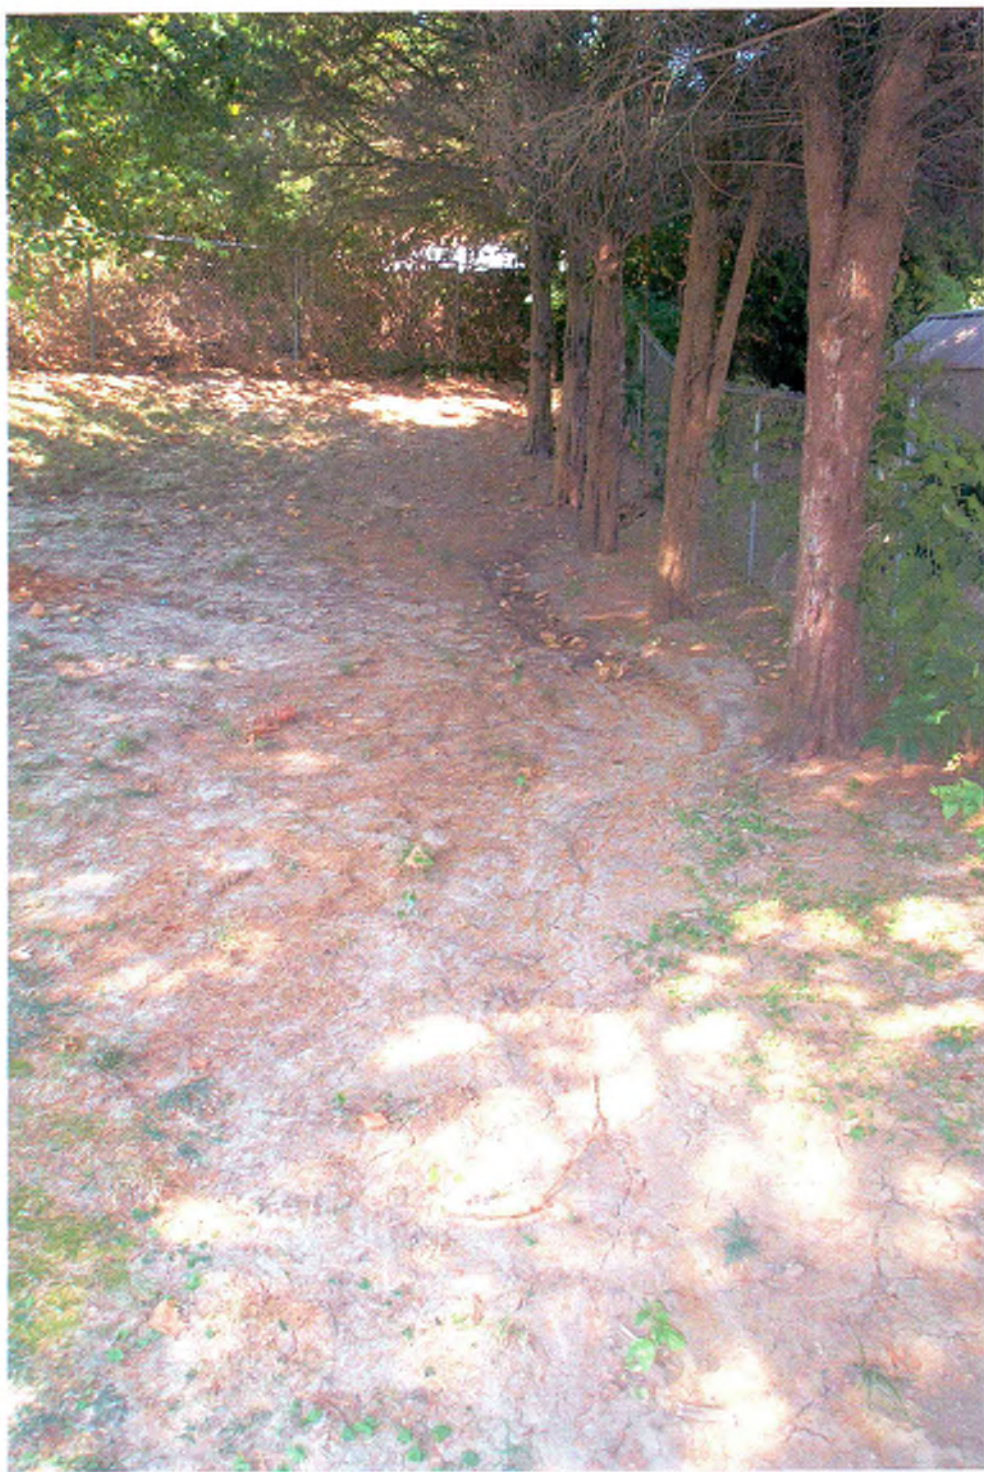
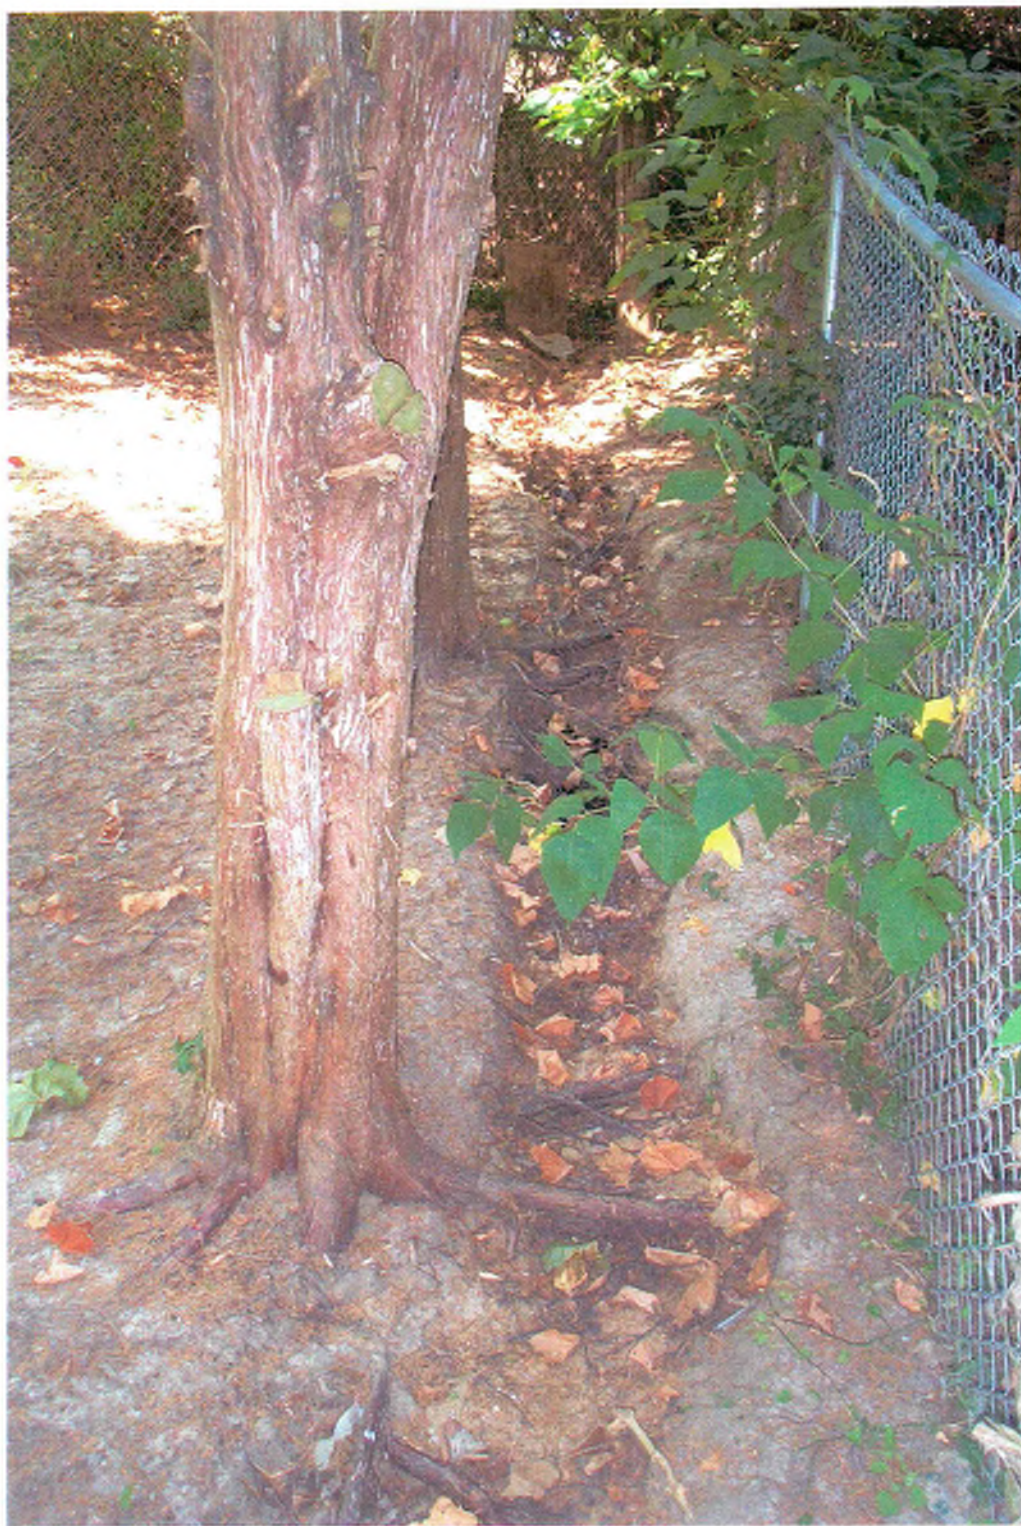
9501 to 9503 Crain Court (MC-16)

Residents at 9501 and 9503 Crain Court are experiencing ponding and erosion problems associated with storm water runoff from a vacant lot at 8510 Old Sappington Road. Stormwater has created a channel at 8510 Old Sappington which channels water to the corner of the above-referenced properties.

The recommended solution involves constructing an area inlet at the southwest corner of 8510 Old Sappington. This area inlet will connect to the existing storm water system near the east property line of 9501 Crain through a new 15" RCP. These improvements will require a storm water easement from 8510 Old Sappington and 9501 Crain Court. The estimated project cost of the recommended solution is approximately \$55,000.

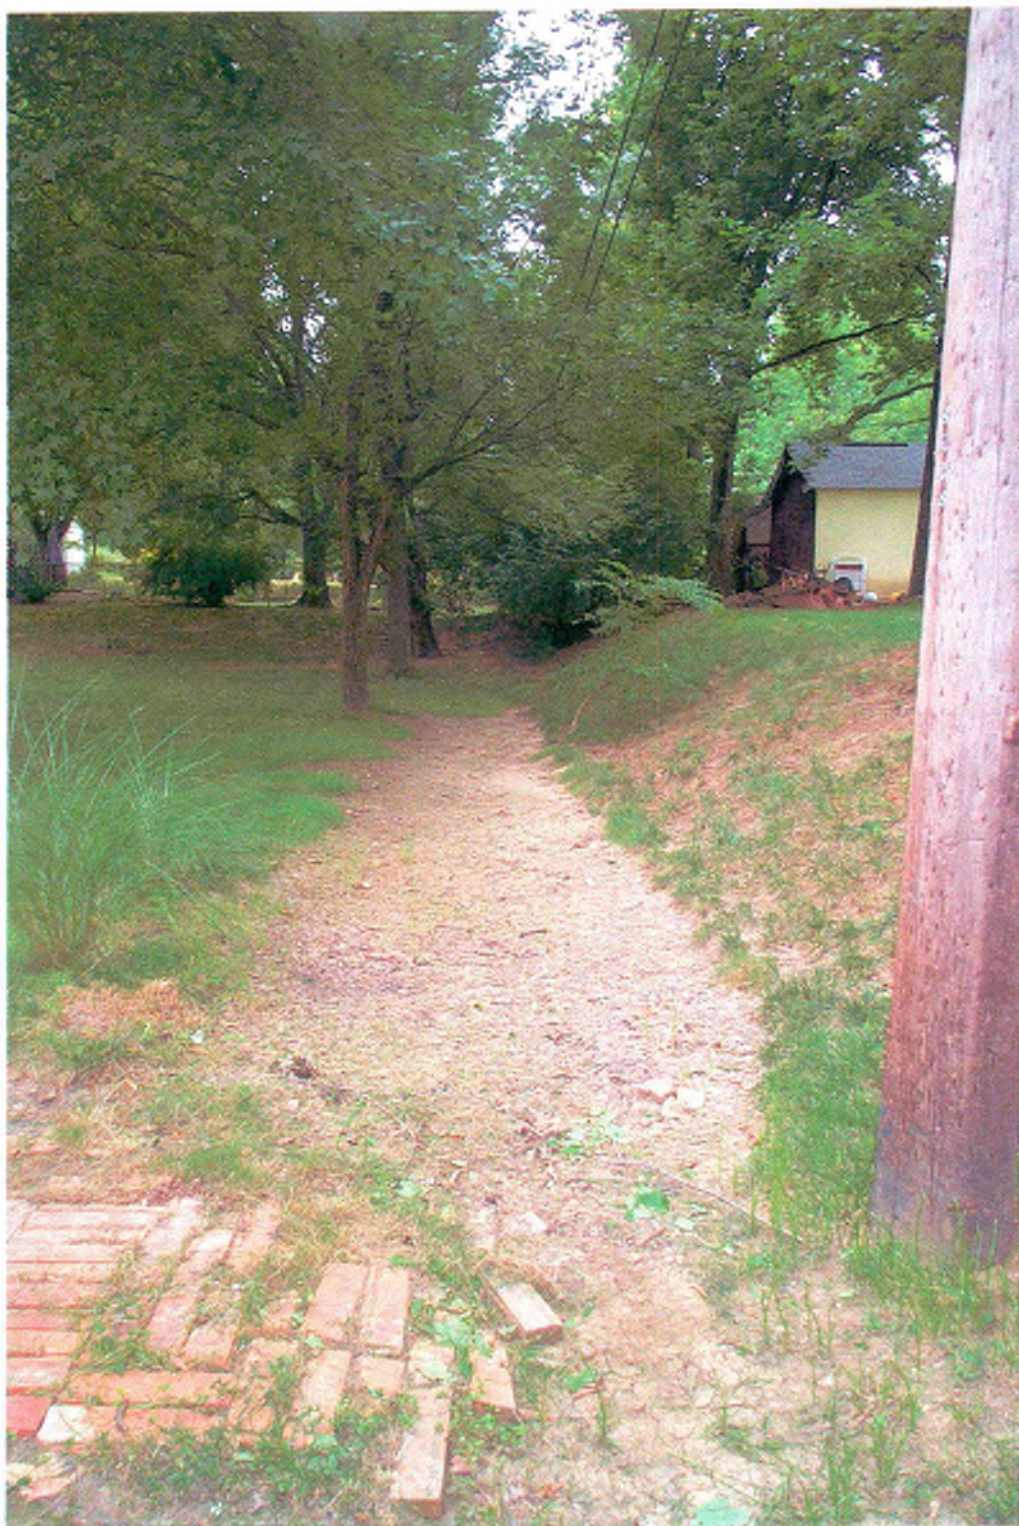
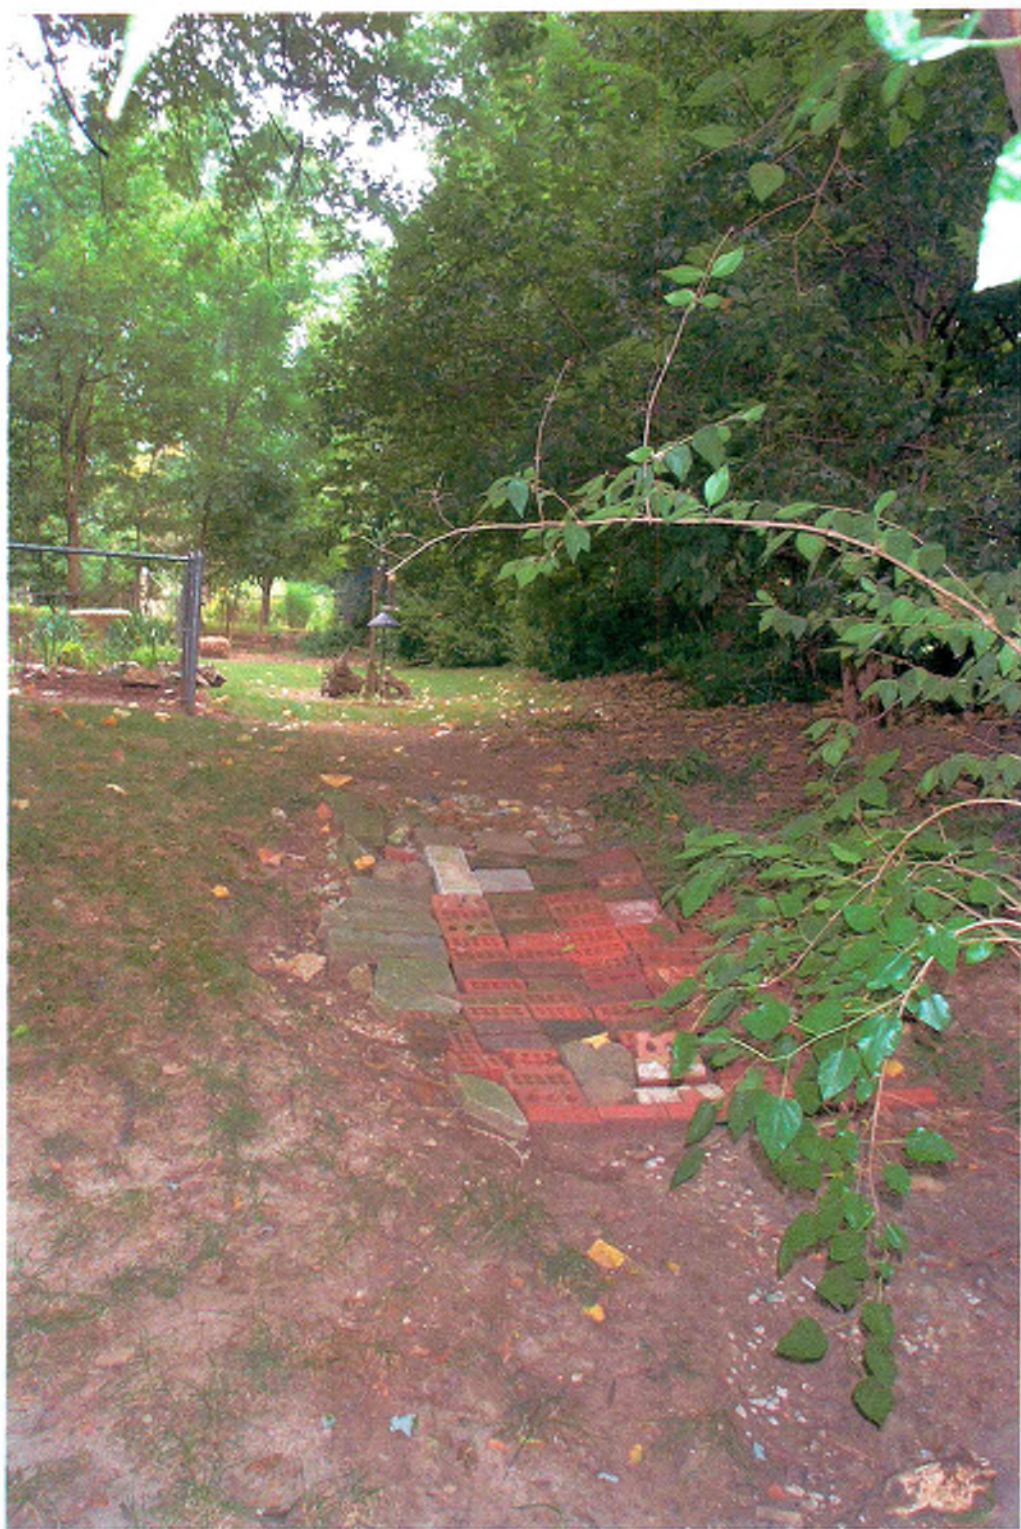
8701-8715 Gayle Avenue (MC-17)

Residents at 8701, 8709, and 8715 Gayle Avenue are experiencing standing water in their rear yards for several days after a rain due to poor rear yard grading. The residents cannot remedy the ponding by regrading alone, due to minimal elevation difference between their rear yards and Crestwood Drive. This ponding is a nuisance and also a possible breeding area for mosquitoes.

Recommended Action: Construct area inlet and 12" RCP which will connect to existing stormwater system on Crestwood Drive. In addition, yards should be regraded to drain toward the new area inlet or the street.
