STORMWATER REPORT

CRESTWOOD STORMWATER

MASTER PLAN

CRESTWOOD, MISSOURI 63126

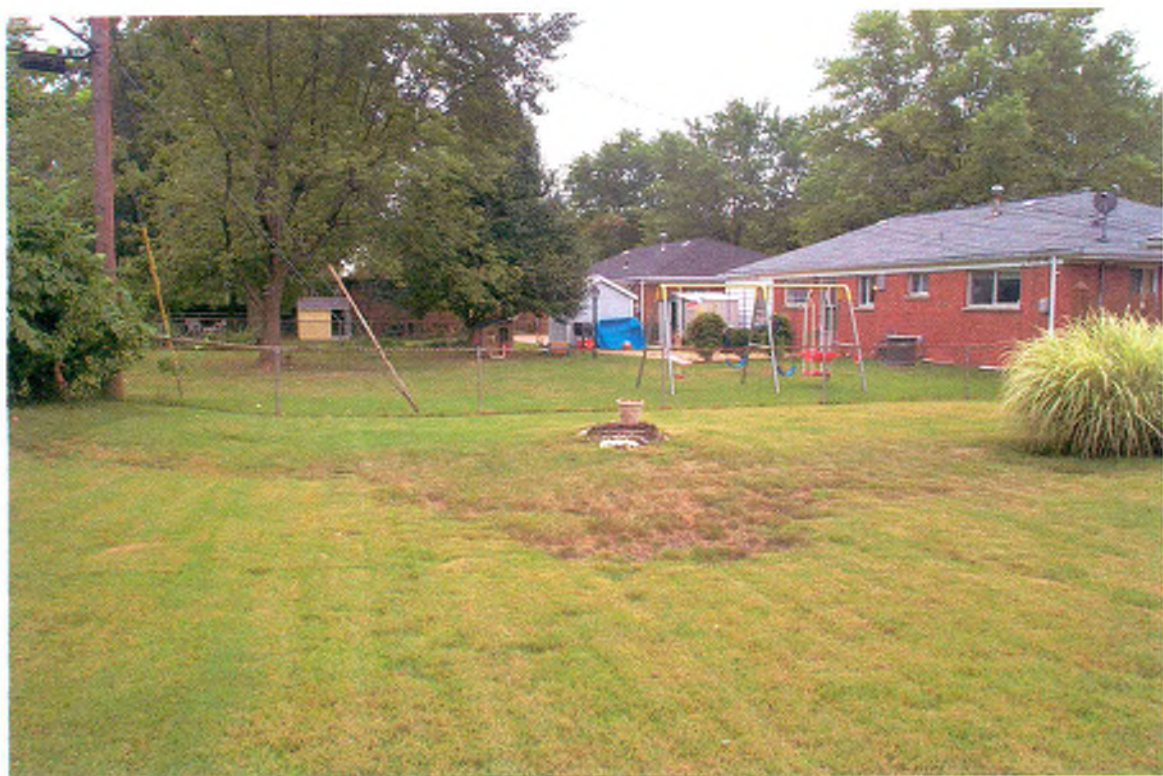
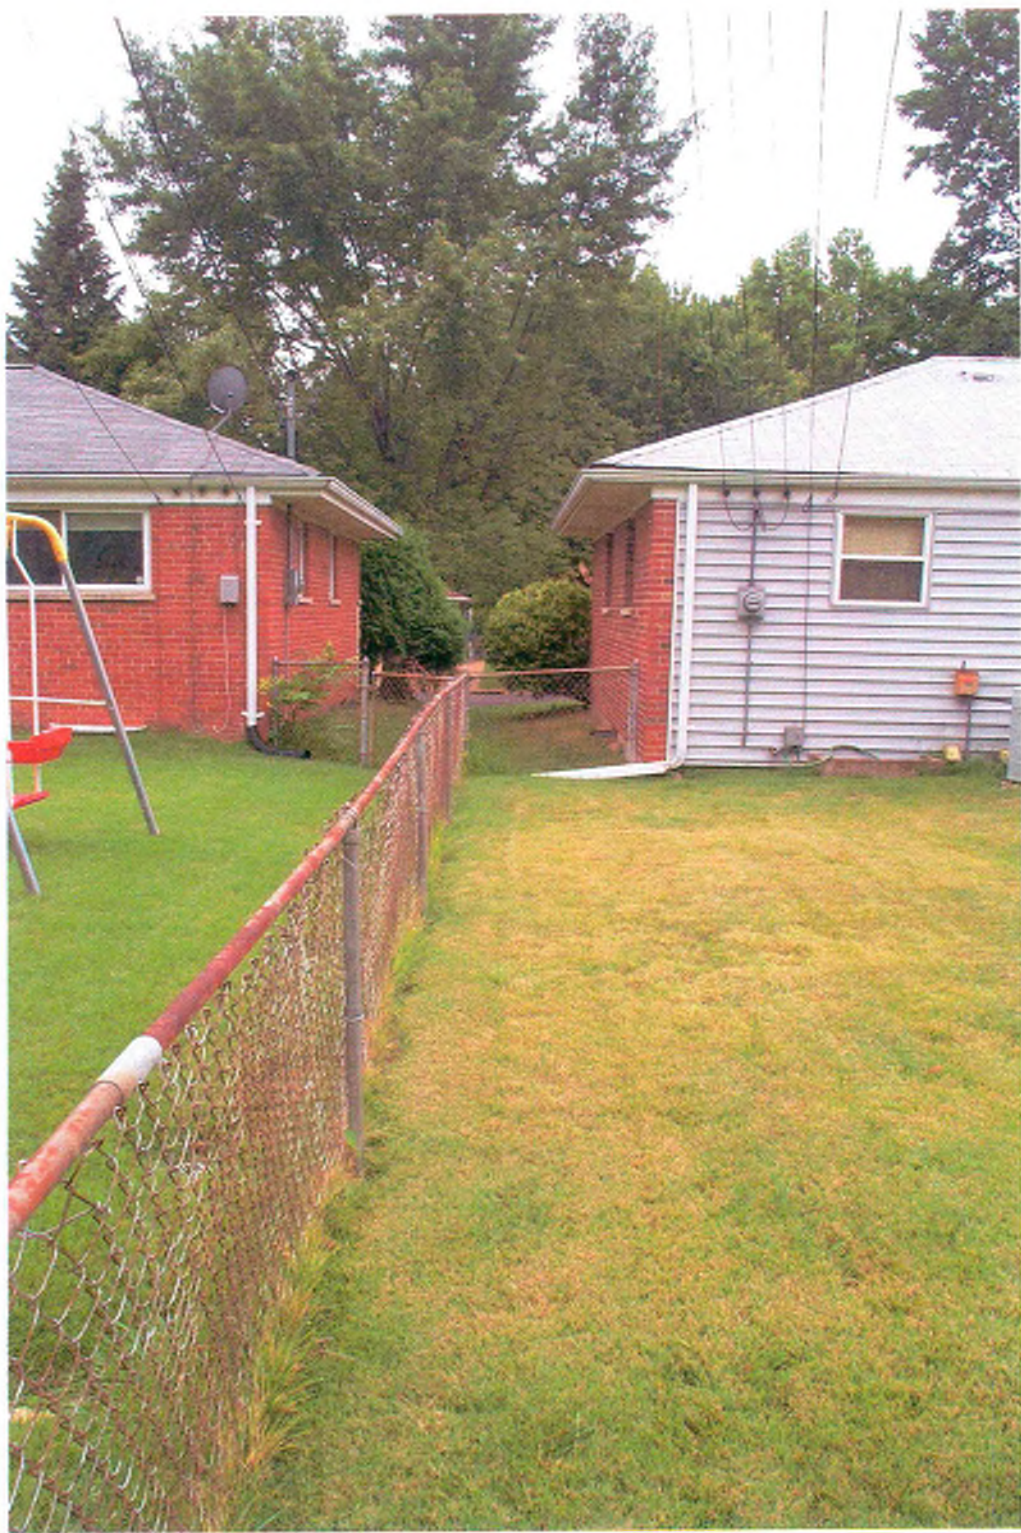
Villa Crest Drive (MC-18)

Residents at 8718 and 8722 Villa Crest Drive are experiencing flooding into their homes due to runoff from properties along Sappington Road and properties to the north on Villa Crest Drive. These residents are also experiencing standing water in their rear yards after rain events.

Recommended Action: Install a new area inlet in the rear yard near the property line of 8718/8722 Villa Crest Drive. This new area inlet will connect to an existing curb inlet on Villa Crest Drive through a new 12" RCP.

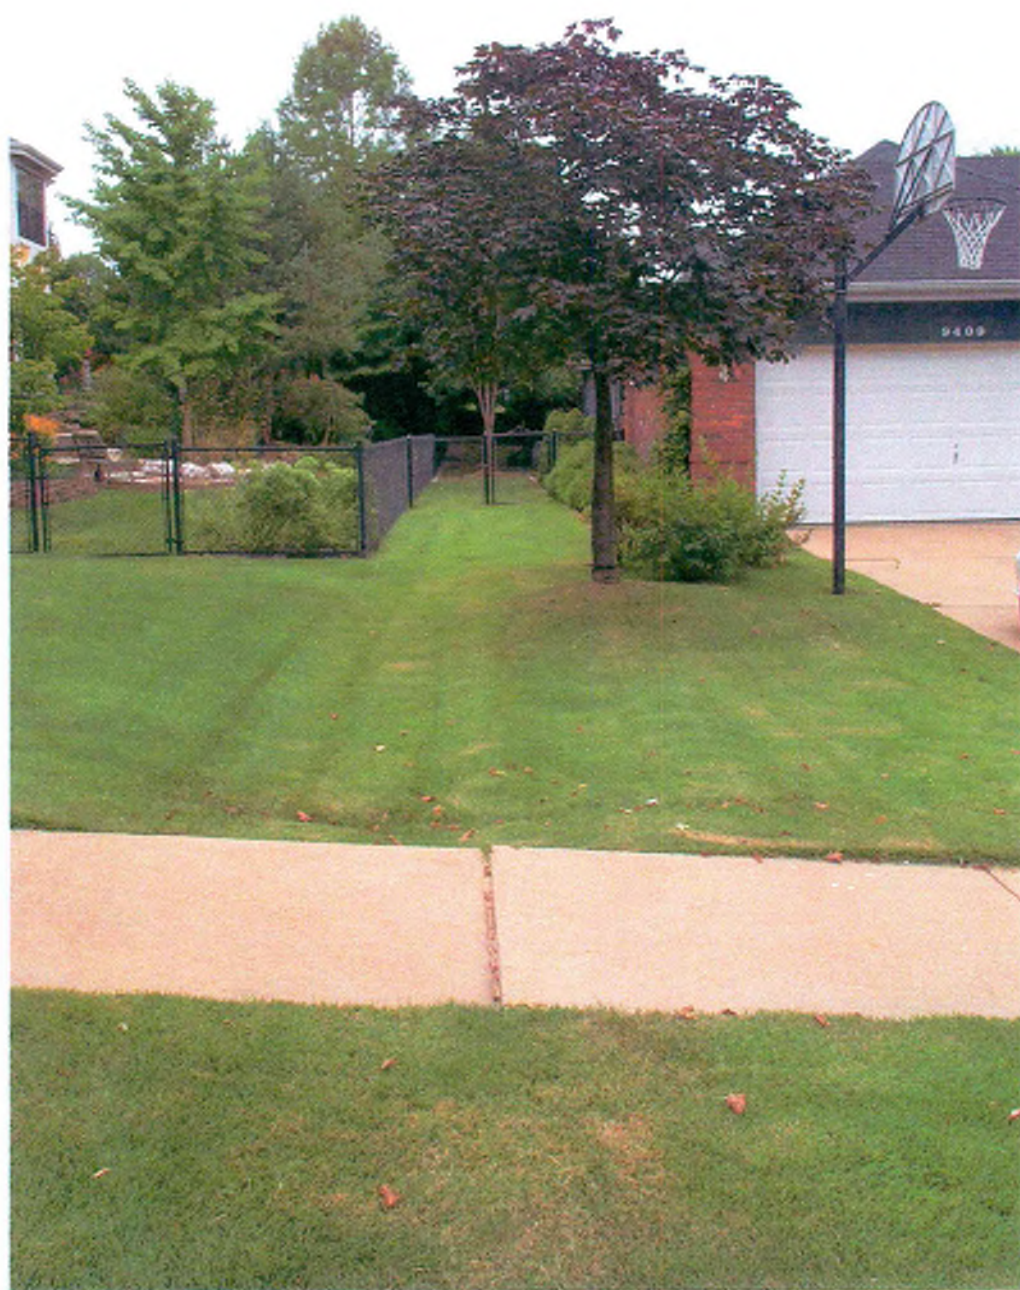
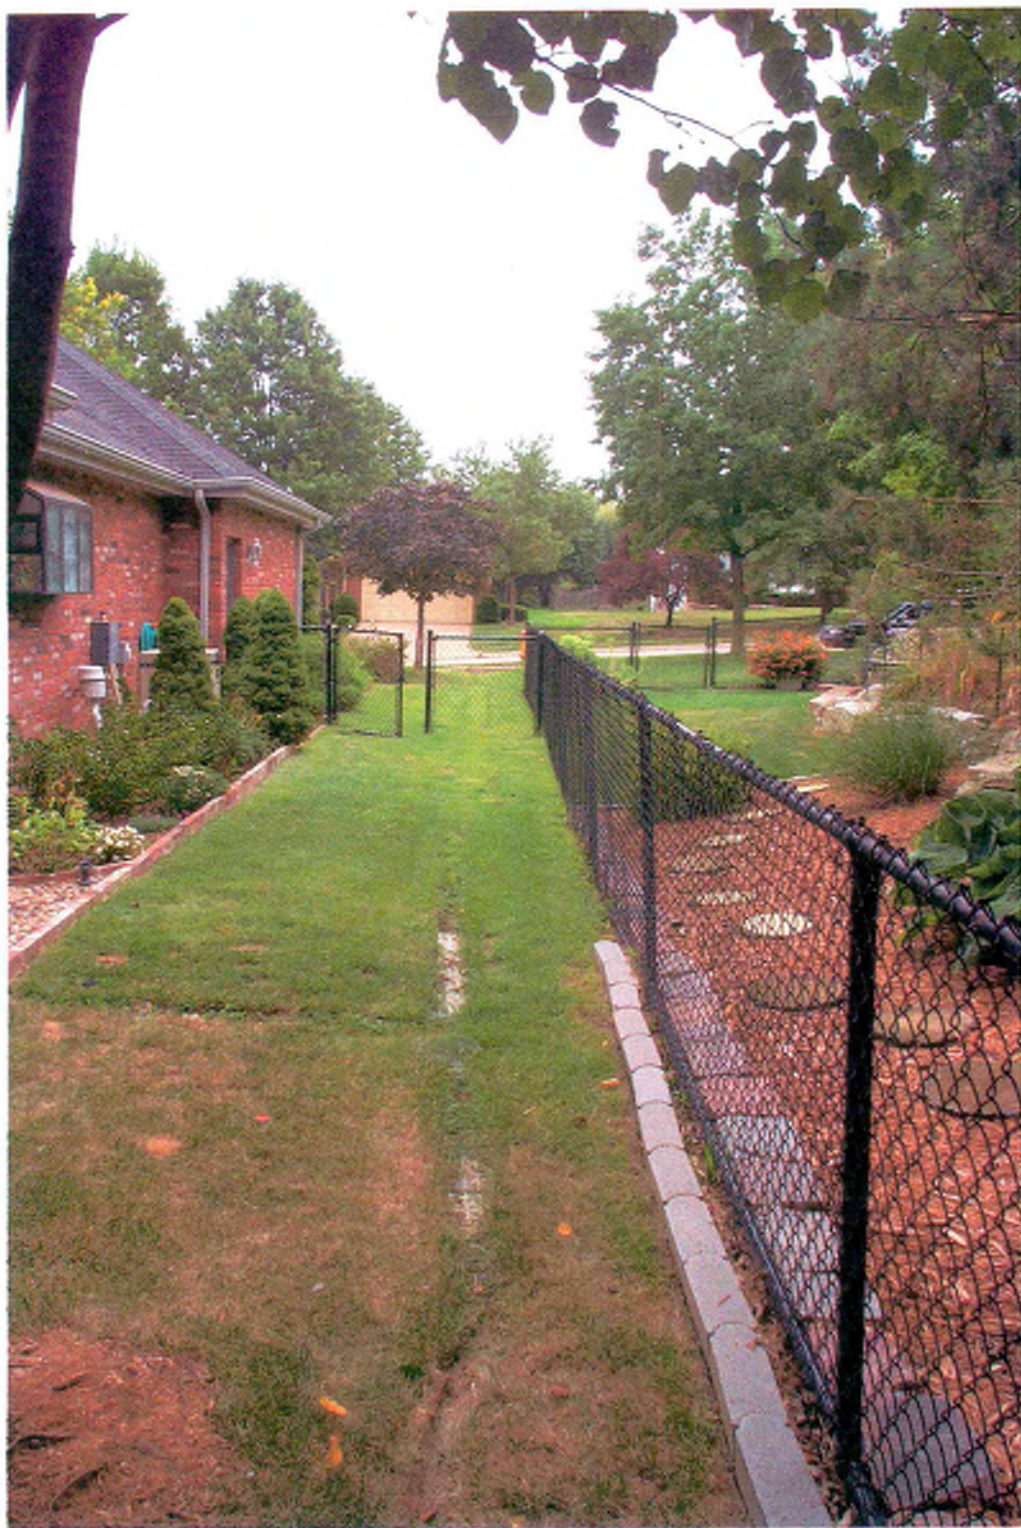
Green Springs Drive (MC-19)

Residents at 9409 Sappington Greens Lane are experiencing flooding problems associated with runoff from adjacent properties at higher elevations. Due to the foundation elevation of 9409 Sappington Greens, and the elevation of Sappington Greens Lane, there is very little that the residents can do to improve their situation. Water enters their basements through cracks in the foundation or over the sill of the foundation. The residents are also experiencing ponding water in their side yard due to poor drainage.

Recommended Action: Install an area inlet in the front yard of 9409 Sappington Greens near the south property line. Inlet will connect to existing storm sewer on Sappington Greens Lane through a new 12" RCP. Side yard of 9409 Sappington Greens will be regraded to drain toward new area inlet and private storm water drains will be connected to the new area inlet.

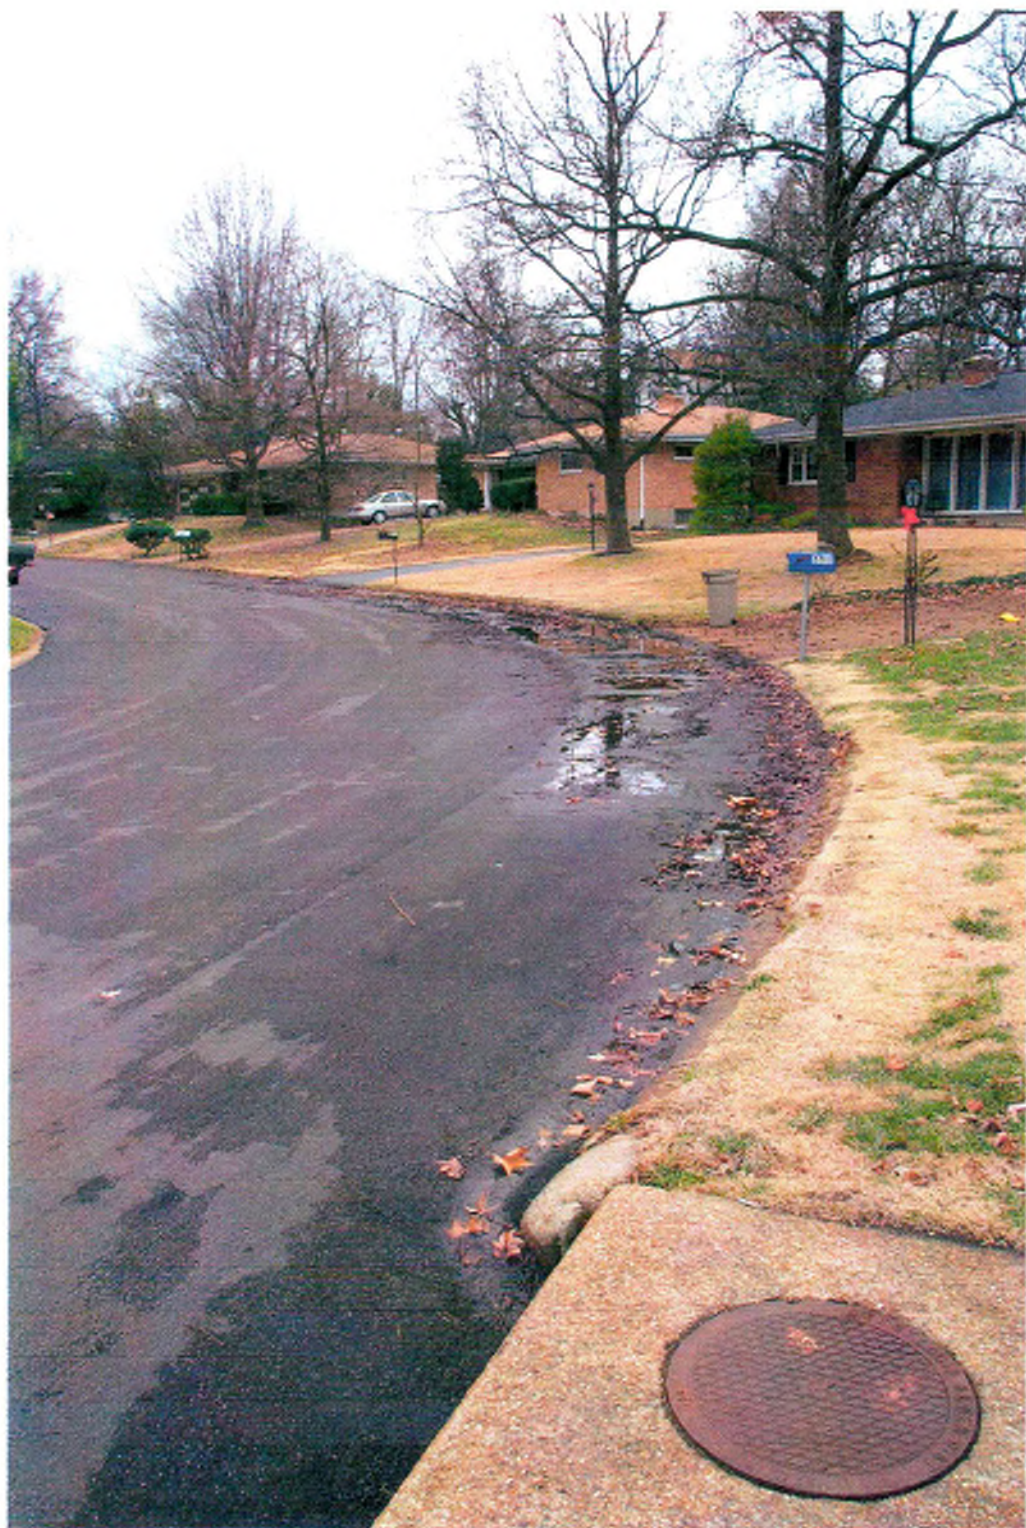
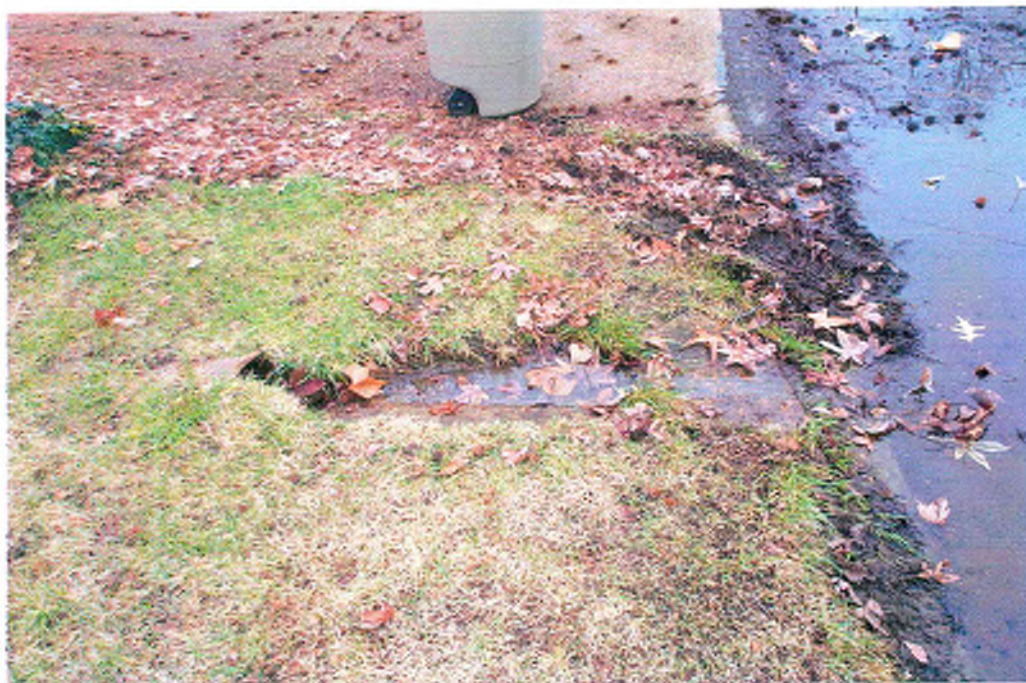
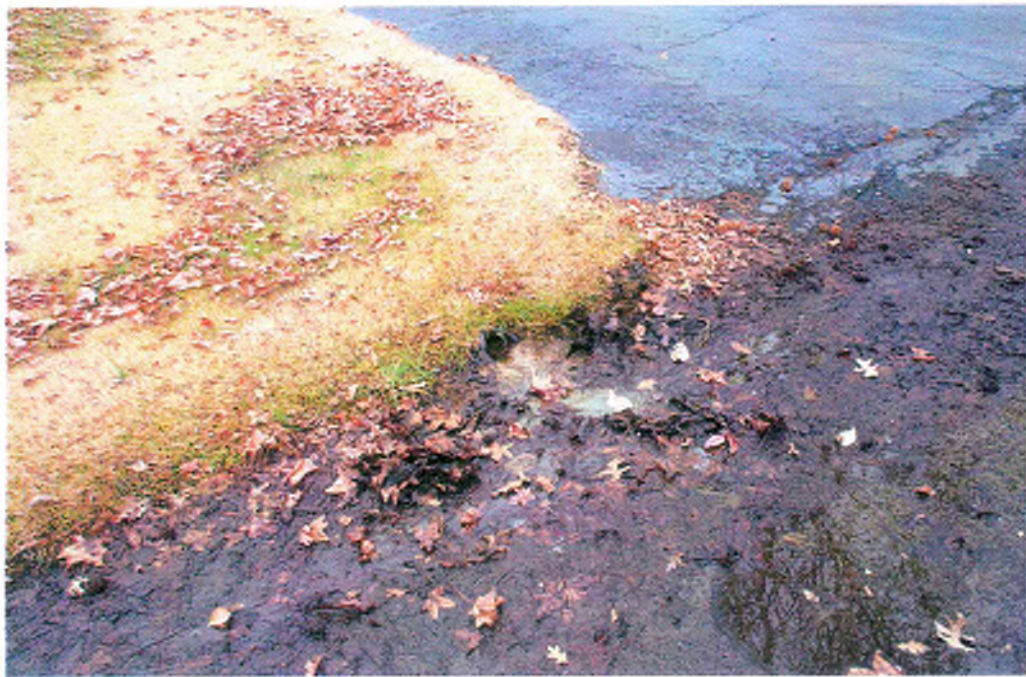
Figure 8-88. 8811 – 8821 Hemingway Drive (MC-20)

Residents at 8811, 8815, and 8821 are experiencing a constant flow of water in the gutter line due to sump pump and private drain line discharge onto the street right-of-way. The continuous flow of water is a nuisance, a cause of street deterioration, a potential mosquito breeding ground, and a road hazard (winter freezing).

Recommended Action: Construct 130 L.F of 4" diameter drain line that connects existing private drain lines and discharges into street curb upstream of existing curb inlet.
